PROPOSED STRUCTURE PLAN & PRIVATE PLAN CHANGE, KARAKA ROAD, DRURY WEST

PRELIMINARY GEOTECHNICAL ASSESSMENT REPORT

Fisher & Paykel Healthcare Properties Limited AKL2022-0214AB Rev 5

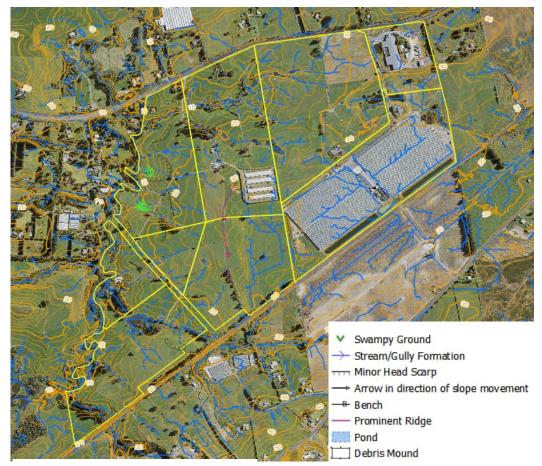
Figure 12: Geomorphology Plan

- In the vicinity of creek at western boundary and the larger tributary in the north of the Site, slope instability features are present, such as minor scarps and debris mounds. Those observed during our walkover are presented on the *Geomorphology Plan*, however it should be noted that not every feature present is recorded, particularly small-scale landslips in gully flanks.

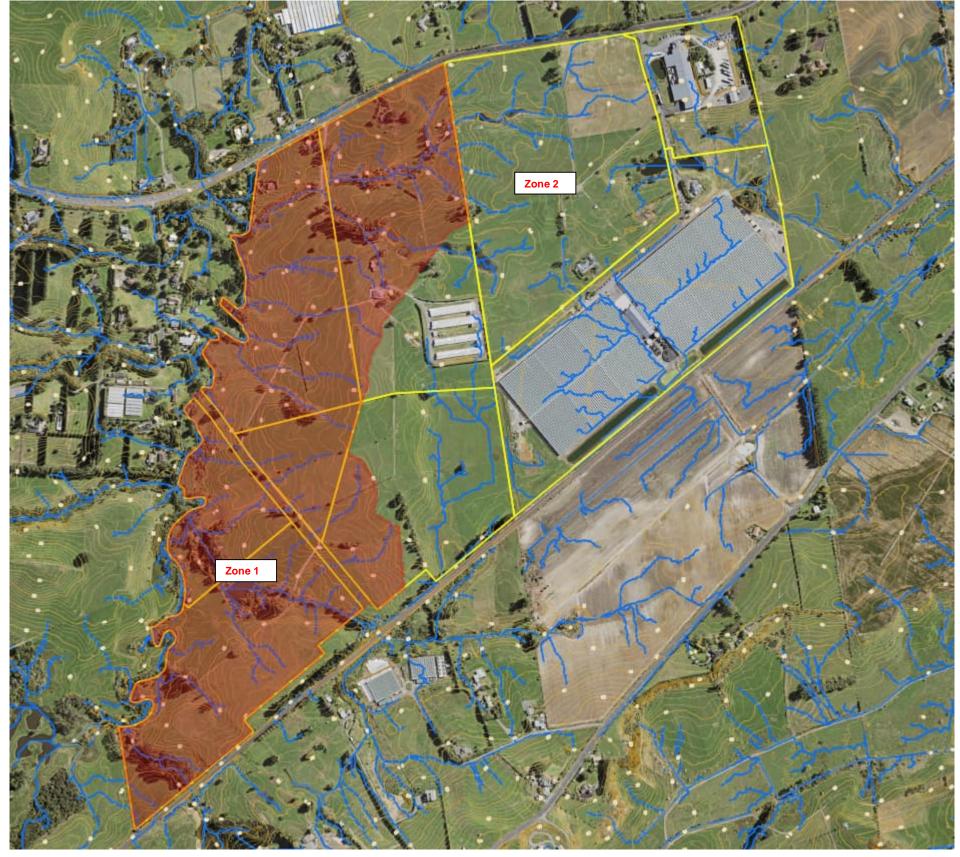
Figure 14: Geohazard Zone Plan

- **Zone 1** encompasses the more frequent instability features observed near the stream and watercourses in the western portion of the Site. We anticipate an esplanade reserve will be applied along the stream edge within this zone also. This zone will require specific investigation and assessment once development proposals area known.
- Zone 2 encompasses the remainder of the Site where instability may still occur but is likely to be more easily remediated with drainage and filling of gullies.

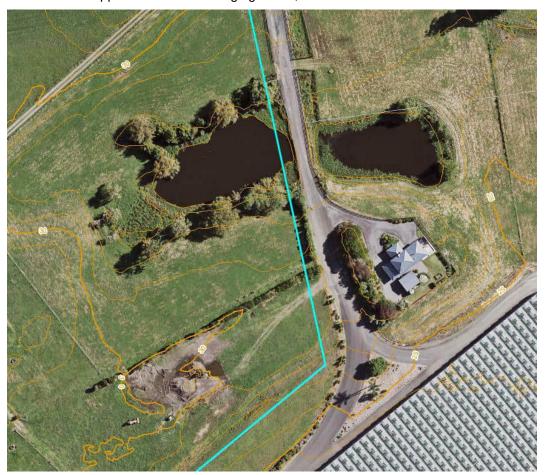
- Large pond depression in the south-eastern corner which extends across the neighbouring boundary
  to the east albeit intersected by a neighbouring driveway which we presume uses a culvert pipe under
  the driveway (see Figure 3 below);
- Also note what appear to be sand dredging works;

Figure 3: Pond in south-east corner of #350. Note the topsoil stockpile works. (2017 Aerial Photo with 1.0m contours from Auckland Council GIS).

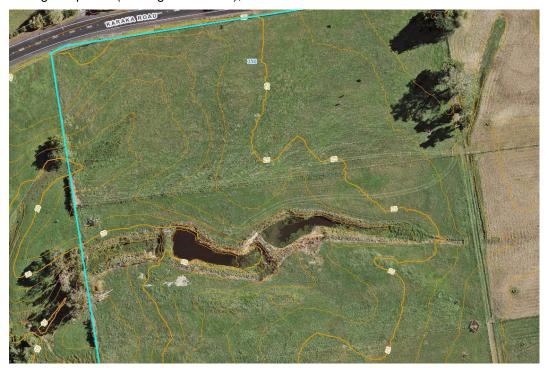
Relatively shallow incised gully in the north-west corner which has been dammed in two locations forming two ponds (see Figure 4 below);

Figure 4: Gully ponds in north-west corner of #350. Note the two dam banks (2017 Aerial Photo with 1.0m contours from Auckland Council GIS).

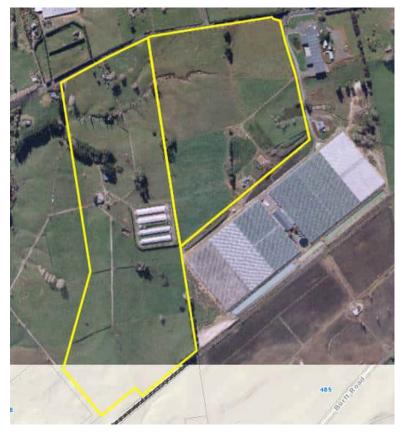
By 2001 (see Figure 11 below), the significantly large glasshouses on the neighbouring property to the south-east were constructed with evidence of a large stockpile of topsoil extending across onto #350. The farmhouses on #350 are also evident.

Figure 11: 2001 historical aerial photo (Retrolens).

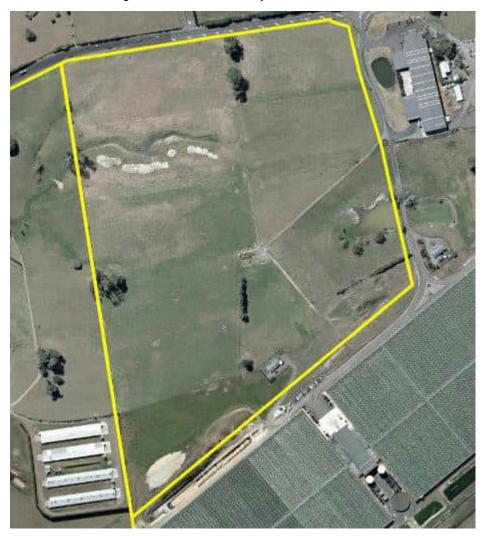
By 2006 (see Figure 12 below), there are stockpiles evident to the south of the northern-gully in #350 whilst there are earthworks evident along the southern boundary of #350. No works are evident in #370.

Figure 12: 2006 historical aerial photo (Retrolens).
