Detailed Site Investigation

395 Fitzgerald Road, Drury

Taha Auto Limited.

Date: 30th April 2025

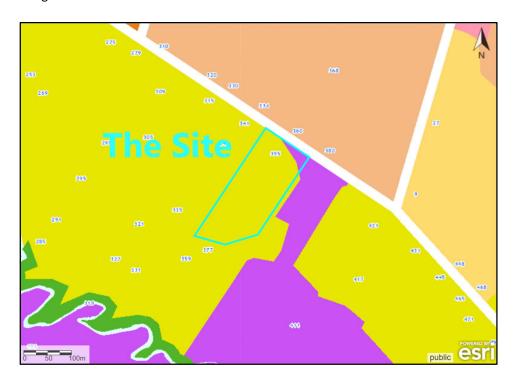
Figure 2: Existing Land Use and Zoning

The land parcel at the site and surrounding land is zoned as Future Urban Zone in the Auckland Unitary Plan as shown in Figure 2^{17} below. A small part of the site in the northeast corner is zoned for light industrial use.

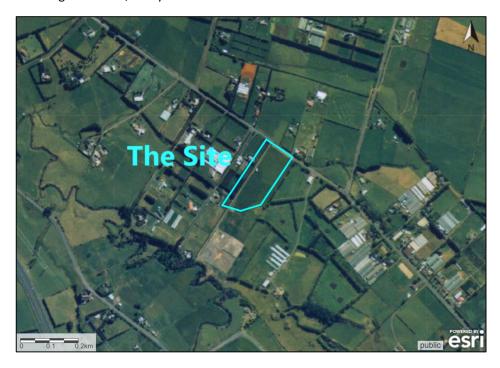
1996 –The site appears to be undeveloped and being used for grazing purposes. A small roadway runs along the northwestern site boundary providing access to the rear of the property. The surrounding area appears to be a mixture of horticulture (including greenhouses) and grazing land.

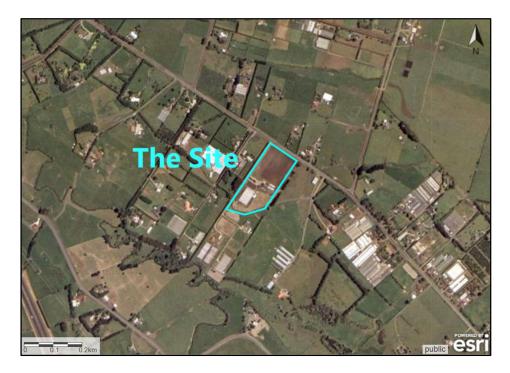
2003/4 – A large greenhouse is now evident in the south of the site together with a residence in the middle. The northern portion of the site appears be under cultivation. Surrounding land continues to be used as horticultural and grazing land.

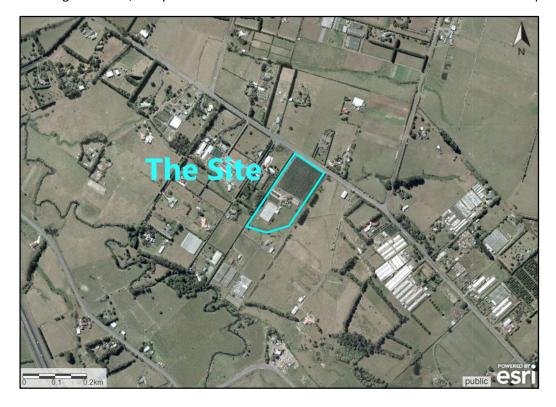
2006 – No changes are apparent at the site, other than clear evidence of cropping taking place in the northern portion. Surrounding land remains largely unchanged.

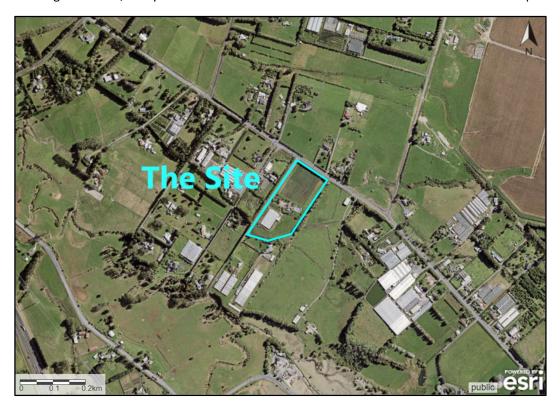
2010 – The site and surrounding land uses remain largely unchanged.

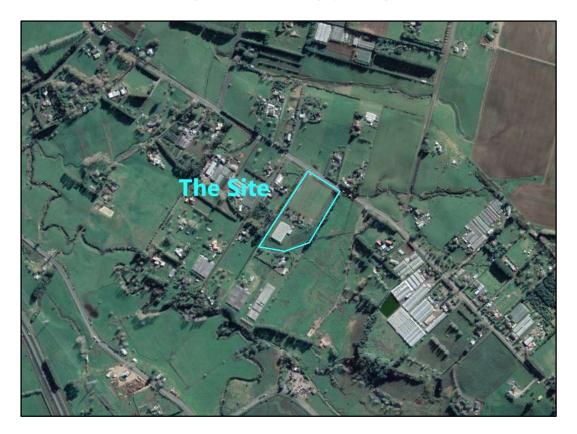
2017 – The site and surrounding land uses remain largely unchanged.

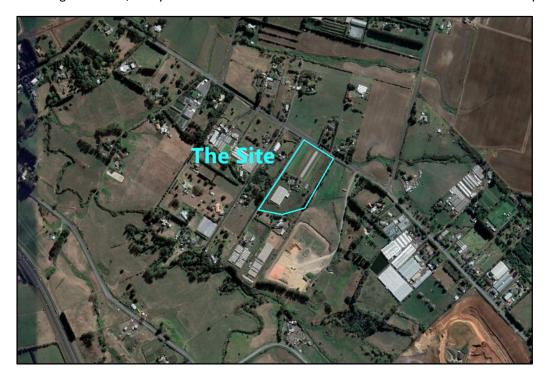
June 2022 – The site remains largely unchanged. Earthworks are underway on land to the south of the site.

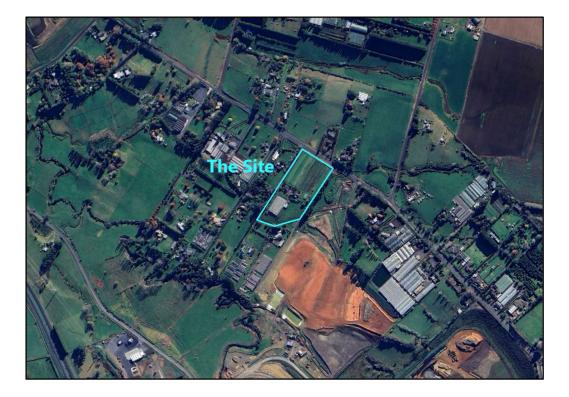
May 2024 – The site and surrounding land uses remain largely unchanged. Extensive earthworks continue on land to the south of the site.

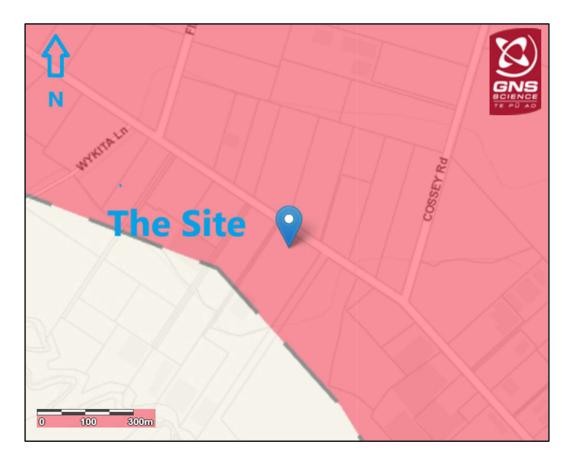
Figure 3: Geological Setting of the Site

- The northern three quarters of the site comprises undifferentiated Kerikeri Volcanic Group basalt lava of South Auckland Volcanic Field. This is described as fine-grained and coarsegrained, porphyritic, olivine basalt, basanite and hawaiite lava flows.
- The southern quarter of the site comprises Middle Pleistocene to Late Pleistocene river and hill slope deposits. This is described as predominantly pumiceous sand, silt, mud and clay, with interbedded gravel and peat.

The geological setting of the site is included in Figure 3 below.

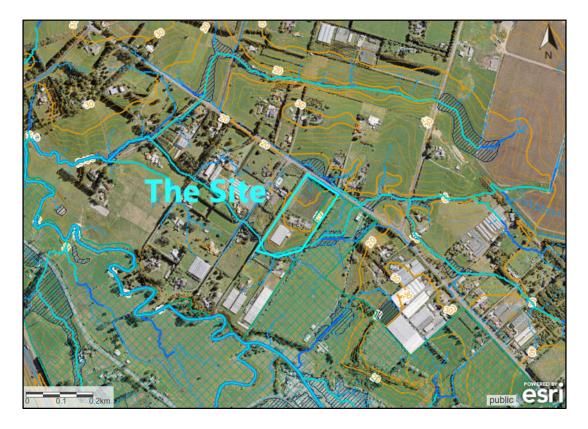
Figure 4: Site Topography and Hydrology

The northern two thirds of the site is fairly level with an elevation of 20 m above sea level. The southern portion of the site drops steeply down to a gully which forms an overland flow path joining the Hingaia Stream. The Hingaia Stream flows to the northwest and empties into the Parurehura inlet of the Manukau Harbour at Drury.

The topography and hydrology of the area surrounding the site are presented in Figure 4.

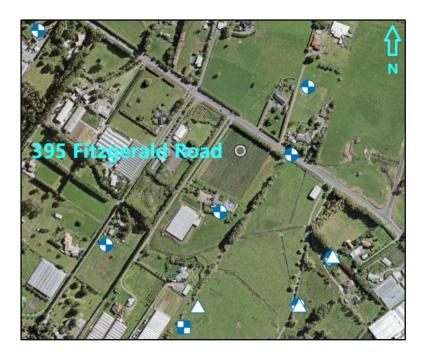
Figure 5: NZGD detail of boreholes proximal to the site.

Information from the New Zealand Geotechnical Database²¹ (NZGD) indicated that a groundwater borehole was drilled on site in 1998 by Kiwi Welldrillers N.Z. The bore was for irrigation purposes, and was installed to 81 m depth. The static water level was listed at 20.7 m bgl. The borelog, and well construction details are included in Appendix 9.

A number of groundwater bores are located nearby to the site (Figure 5 below). These were also drilled in the 1980's and 1990's for irrigation purposes, and are deeper than 50 m.

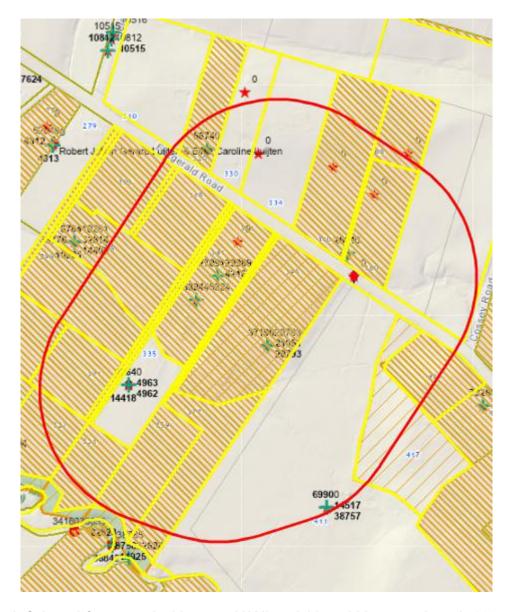
Figure 1: Selected Consents, Incidents and HAIL activities within approximately 200m of the subject site

The Council database was searched for records of the following activities within approximately 200 metres of the site and results are displayed in Figure 1 below:

The HAIL activity hatching in Figure 1 only reflects whether a site has been identified as a HAIL site (both verified and non-verified) by the Council and the type of HAIL associated with the site. This does not confirm whether the site has been formally investigated or the contamination status of the property (e.g. contaminated, remediated etc.). Additionally, due to limitations within Council's records, the specific HAIL activity is not included in the data for all properties. For further information on any of these known HAIL sites, a subsequent site contamination enquiry can be lodged for the specific property (up to 5 adjacent properties can be covered in one request).
