Carrington Road upgrade archaeological assessment

**report to
Beca
and
Auckland Transport**

Date: 4 August 2025

Reference: 24-1594

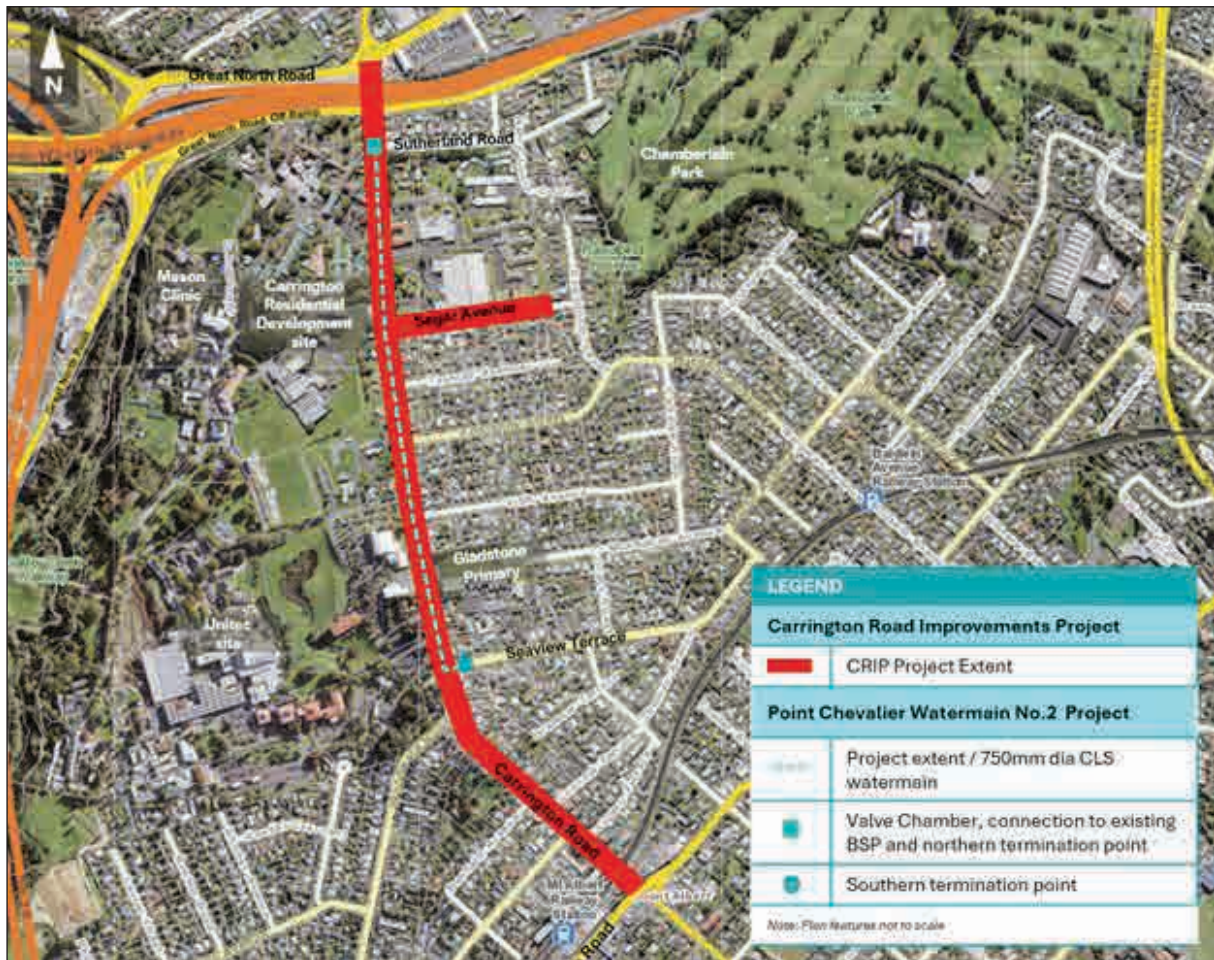
Figure 2. Project overview including Carrington Road Improvements and the Point Chevalier Watermain.

Unless otherwise noted, the CRIP and Watermain projects are referred to collectively in this report as 'the Project'. The Project extent is shown at Figure 2. A full Project Description can be found in Section 3 of the Assessment of Effects on the Environment (AEE) report.

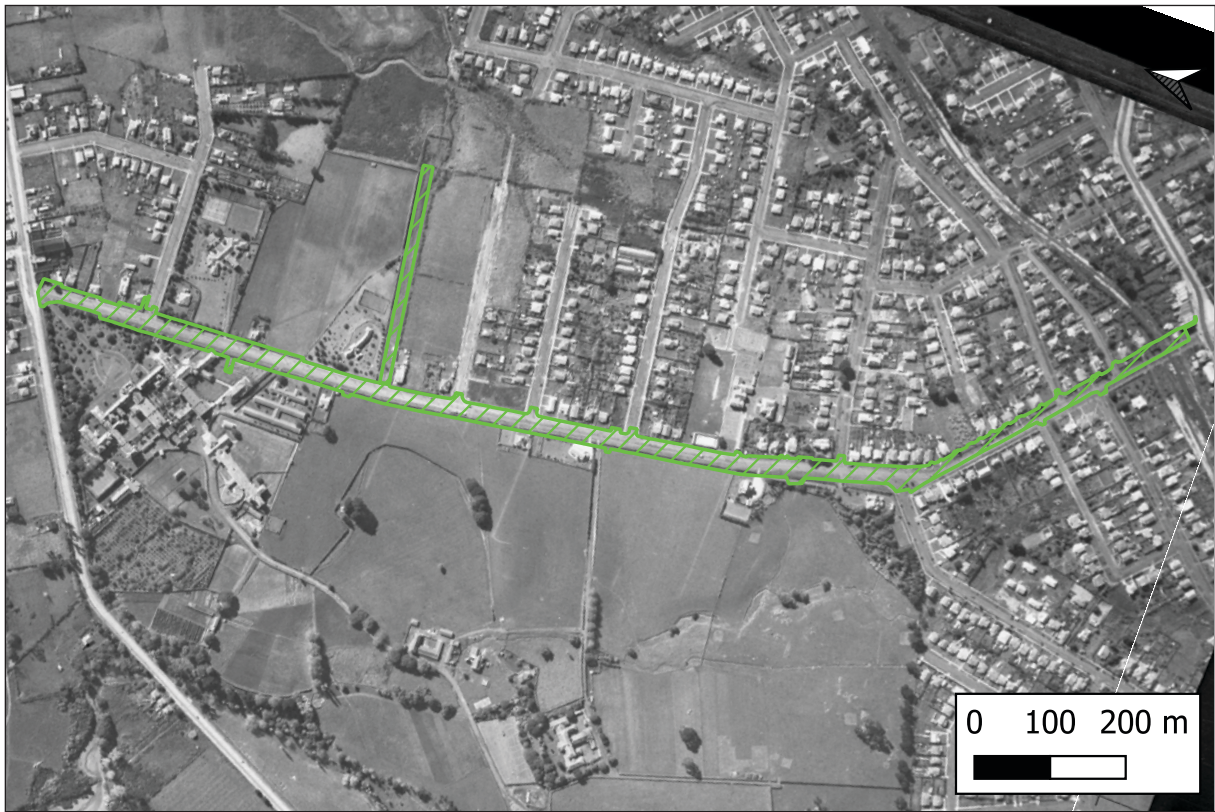
Figure 3. 1940 aerial photograph showing Carrington Hospital, with the works footprint in green.

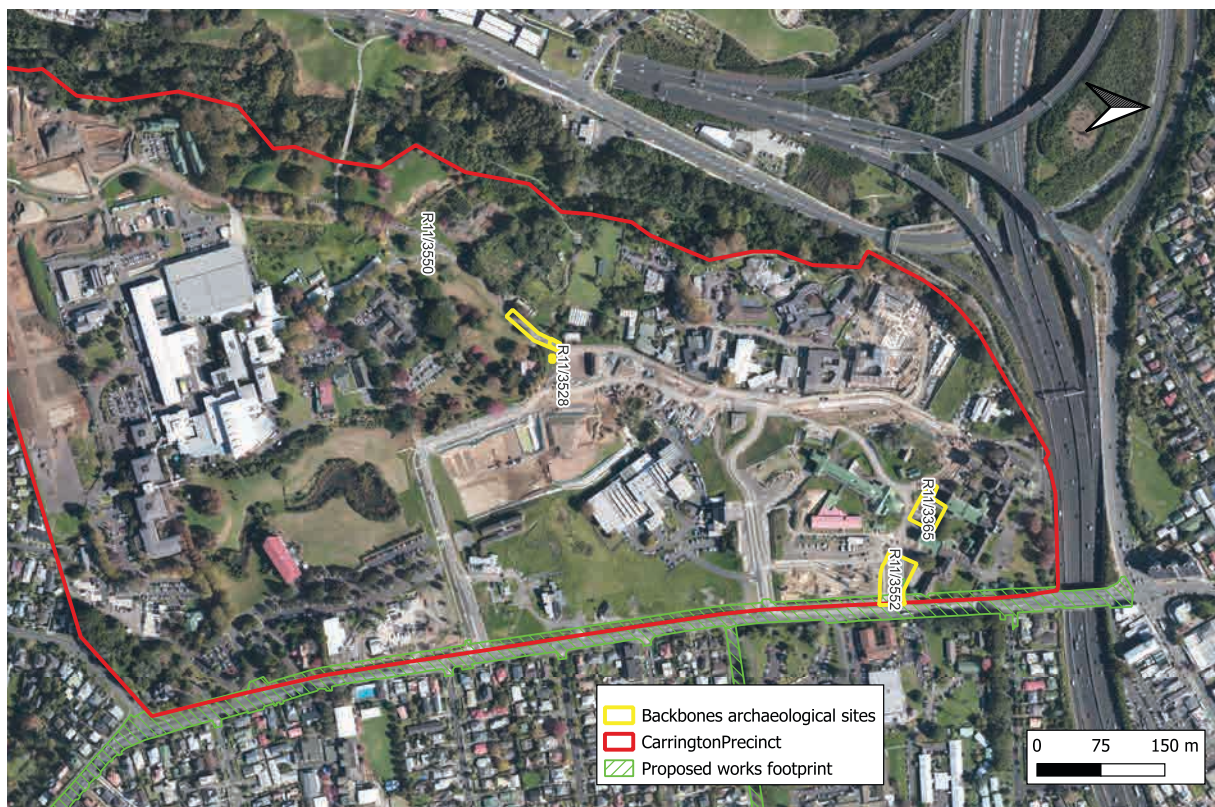
Figure 6. Archaeological sites recorded or updated during Carrington Backbone works.

Five new archaeological sites were recorded during monitoring for the Carrington Backbone works project (Figure 6). Pathway construction next to the Mt Albert Pump Station and directly adjacent to R11/3336 (former Carrington Hospital milking shed), uncovered a 19th century midden, including shell, ceramics and tobacco pipe stems (R11/3551), located 80 m northwest of the proposed works. 100 m northwest of the proposed works, underneath a 19th century road, was a pre-European Māori shell midden (R11/3528). Investigation of this midden found that it appeared to be the remains of a large feature with dark fill, and lenses of shell midden. The feature currently measures approximately 4.5 x 2.5 m, though its size and shape have probably been extensively modified over the last 150 years. It was vertically truncated, with several different road building events covering the feature, as well as having several service trenches cut through the feature. A partial primary crouched burial, part of which had been removed at some stage by a service trench, was uncovered beneath the midden. The resulting feature is therefore a collection of in situ and disturbed deposits criss-crossed with modern services. The 19th century road overlying the midden, which was also visible underneath the modern road in several other service trenches and pits across the area, was recorded as R11/3553. An additional shell midden (R11/3550) was recorded beneath a modern road 130 m west of the proposed works. A tobacco pipe stem was found in the direct vicinity of the midden, but their relationship is unclear.

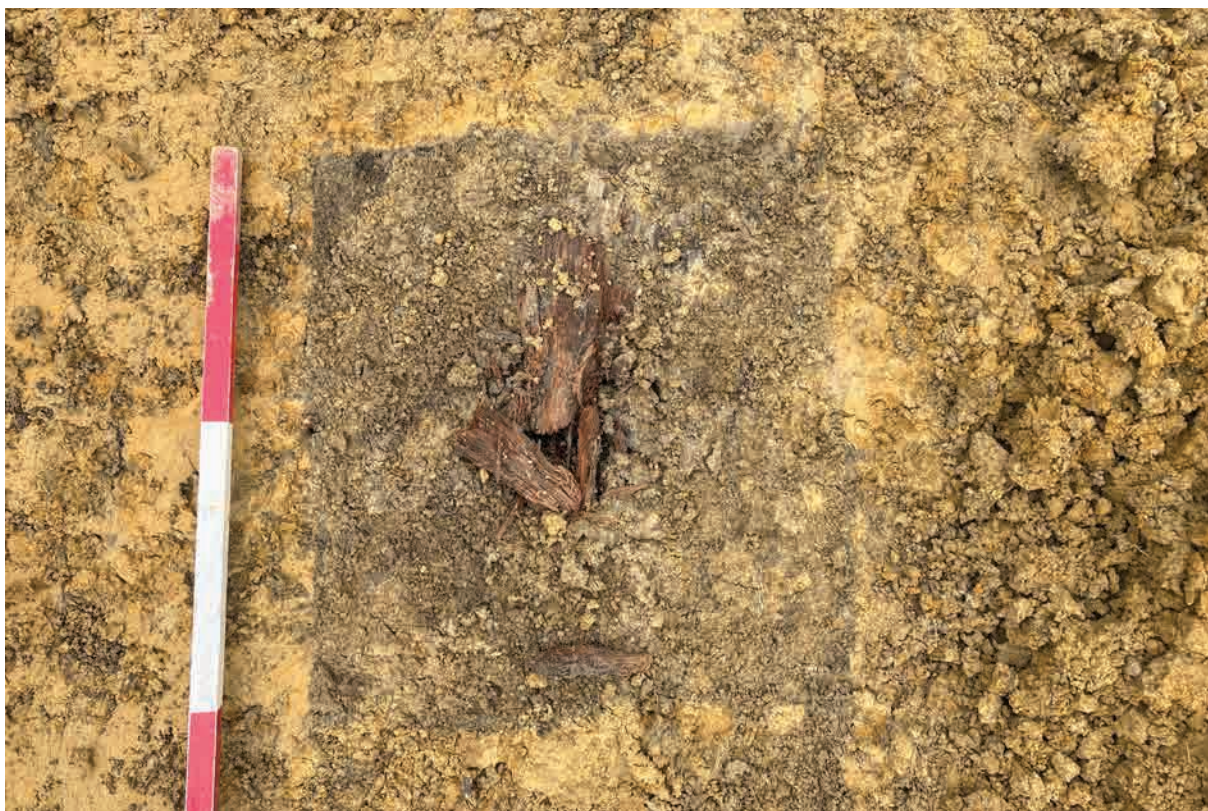
Figure 7. Example of a posthole with wood at Gate 1 on the Carrington Backbone project.

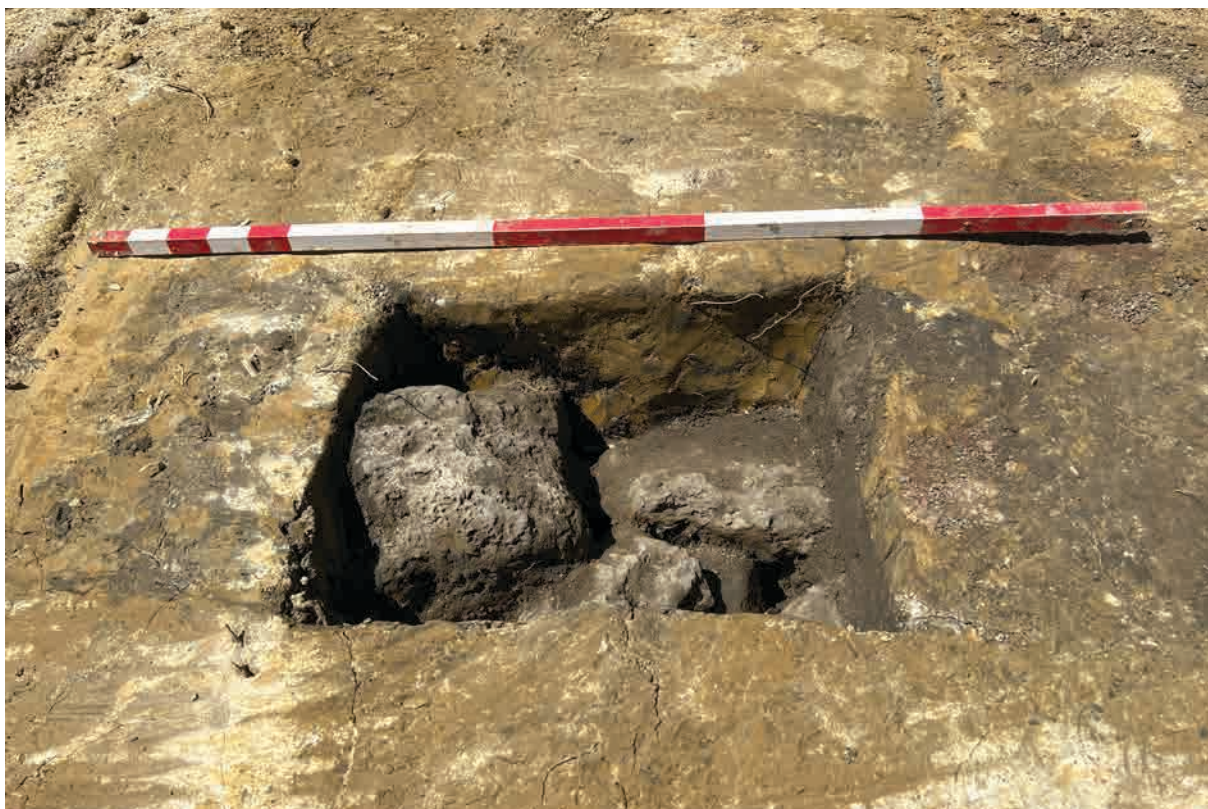
Figure 8. Excavated section of a stone lined drain near Gate 1 on the Carrington Backbone project.

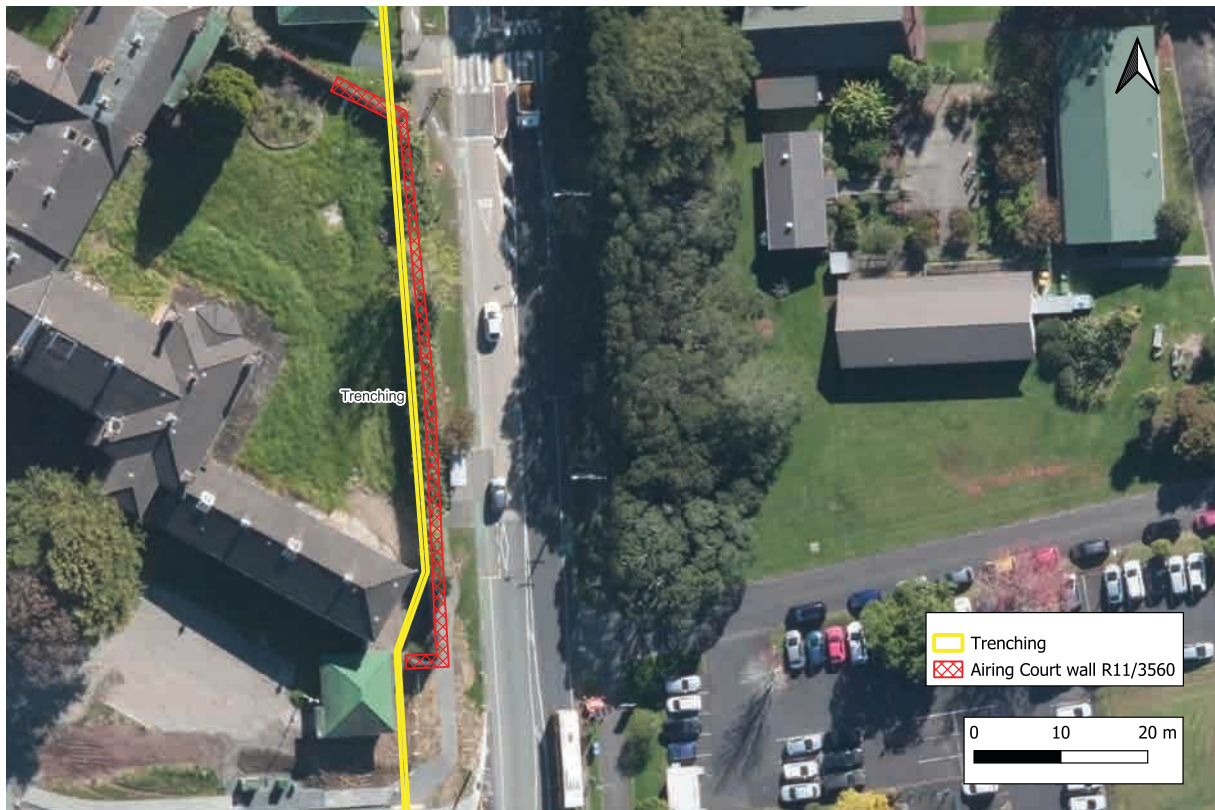
Figure 9. Map of the trenching along the Airing Court wall (R11/3560) during the Carrington Backbone project.

Trenching for services was also carried out running parallel to Carrington Road, including cutting under the Airing Court wall (R11/3560). This trench, measuring 4 m wide by 160 m long, showed that subsurface deposits vary considerably across the areas, ranging from topsoil directly over natural clay subsoils, to areas built up with older demolished material, including bricks dated to the 19th century, and areas with early 20th century services. The full trench was dug up to the base of the Airing Court wall, with a narrower cut drilled underneath the northern section of the wall itself, where it cut west towards the main hospital building (Figure 9). Trenching under the showed it to have relatively shallow foundations, reaching approximately 500 mm, with some broken brick mixed into the underlying clay fill (Figure 10 and Figure 11).

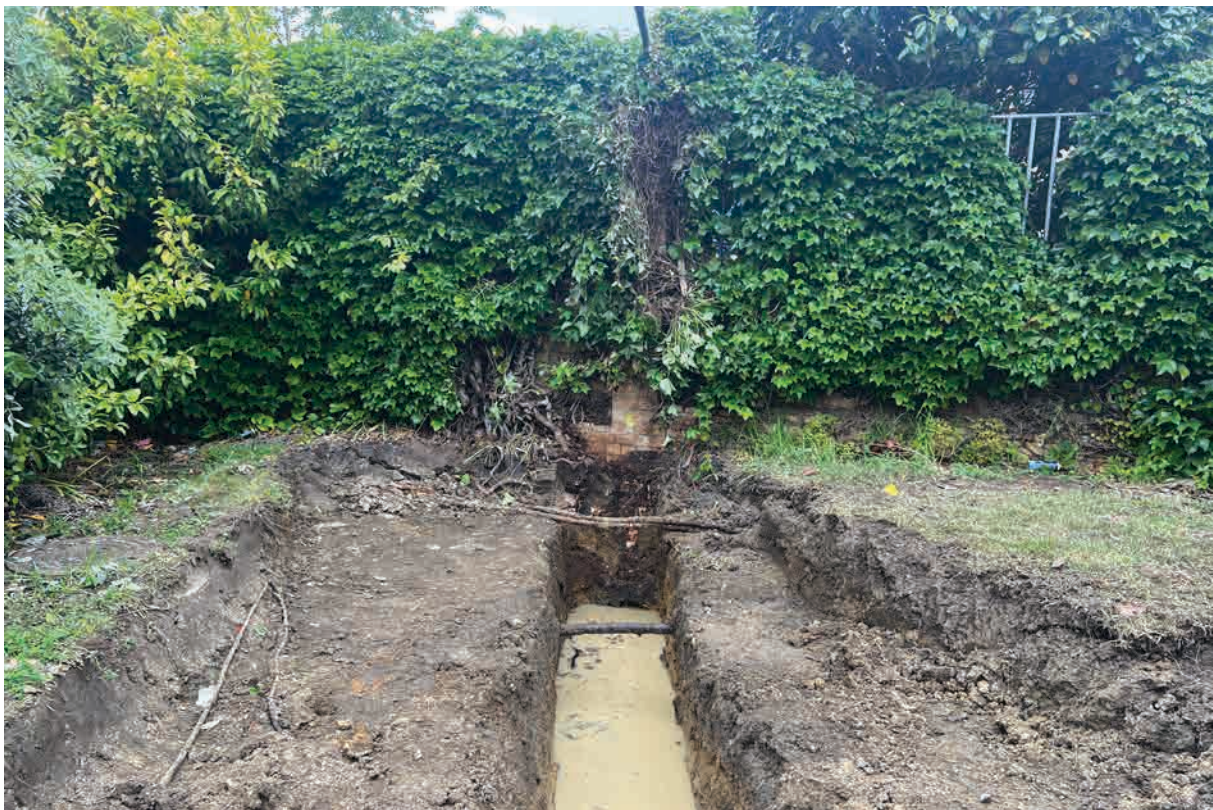
Figure 10. South facing view of the trench approaching the Airing Court wall (R11/3560).

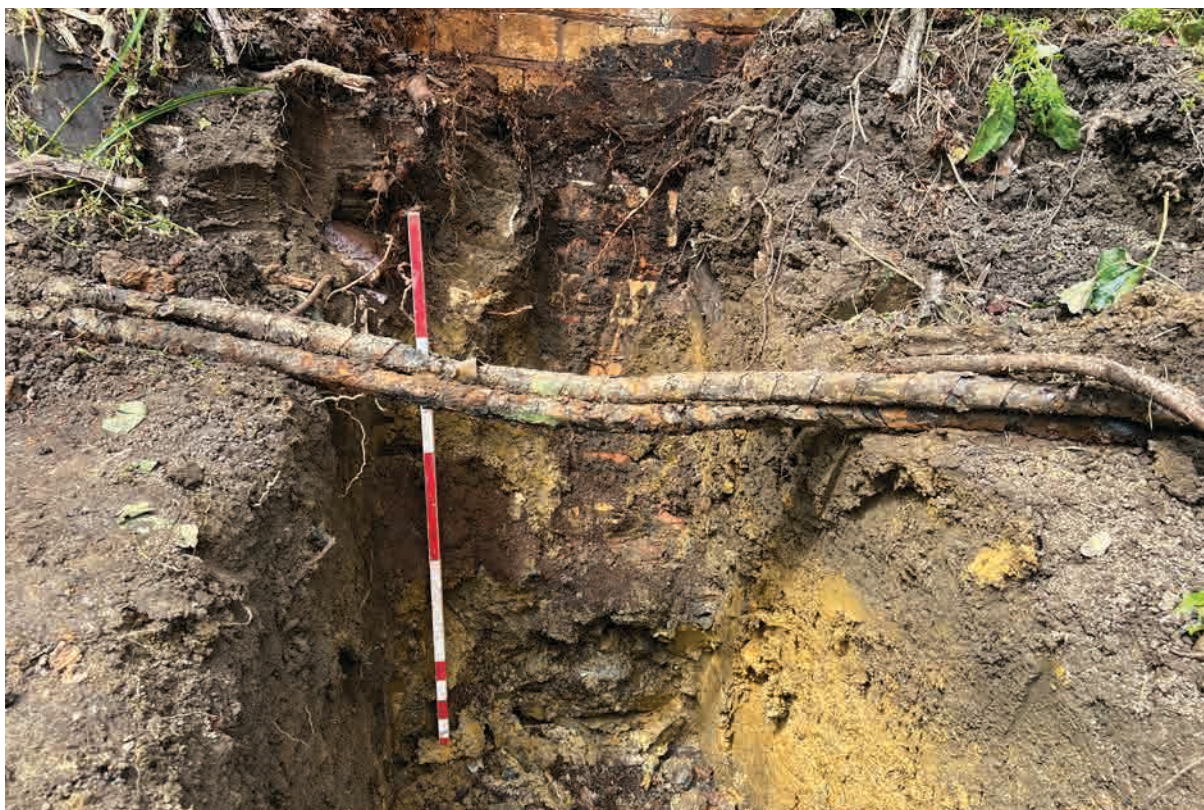
Figure 11. Close up view of trench at the base of the Airing Court wall (R11/3560).

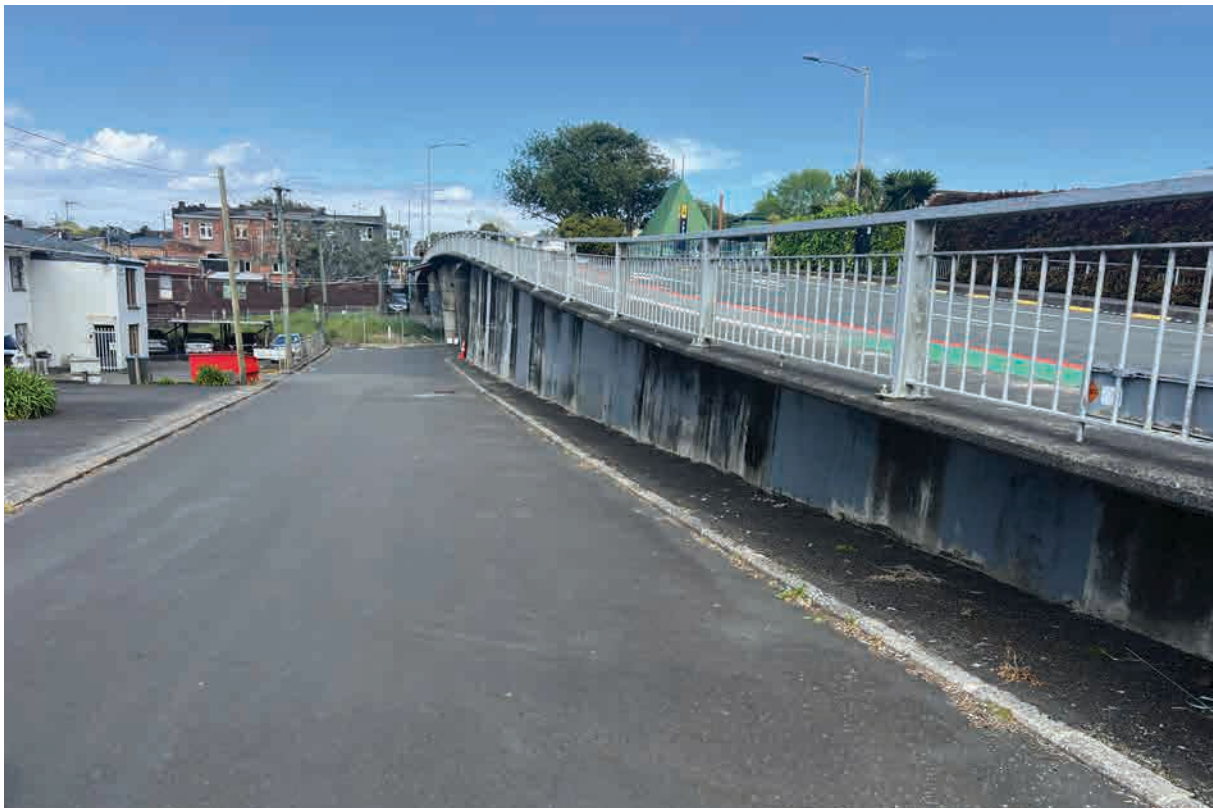
At the southernmost extent of the project, the proposed works run alongside the Mt Albert rail station overpass. The entire area is concreted, with limited visibility of the tracks (Figure 12).

Figure 12. Southeast facing view of the Mt Albert rail overpass.

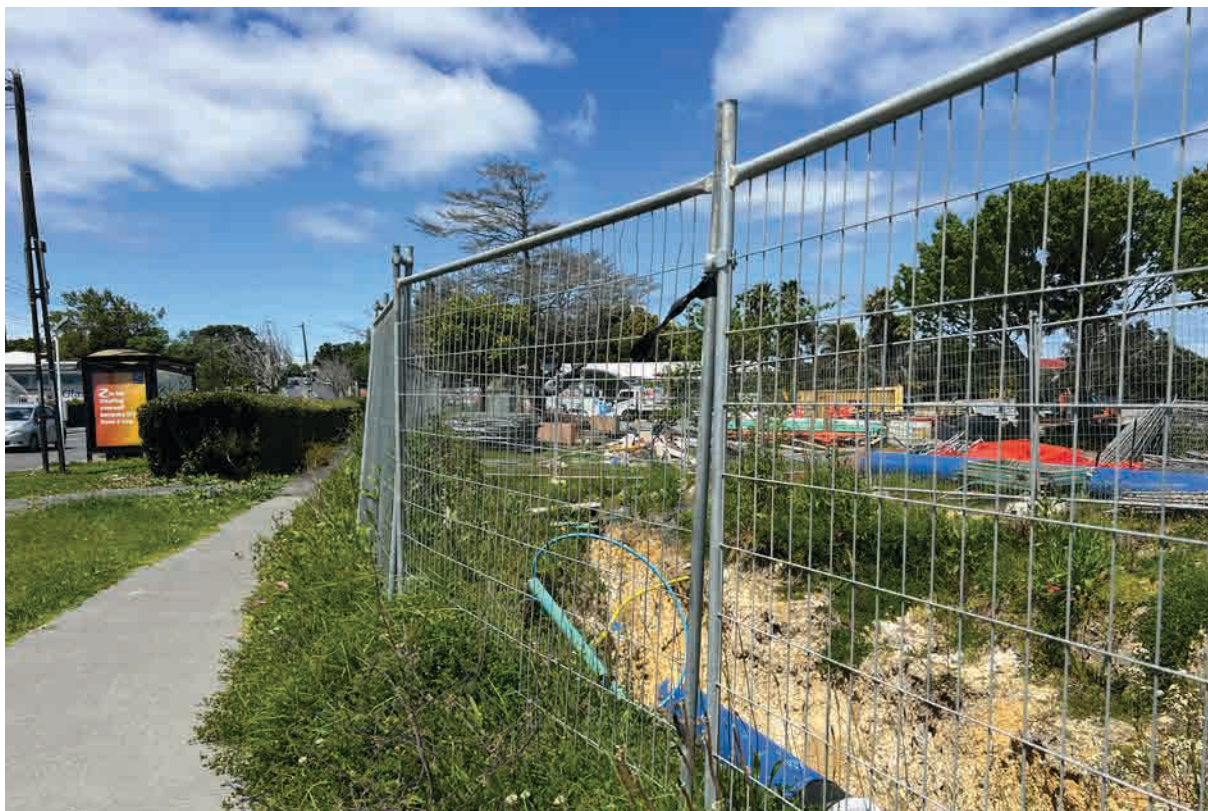
Figure 13. South facing view from Farm Road, along the former Carrington Hospital Farm.

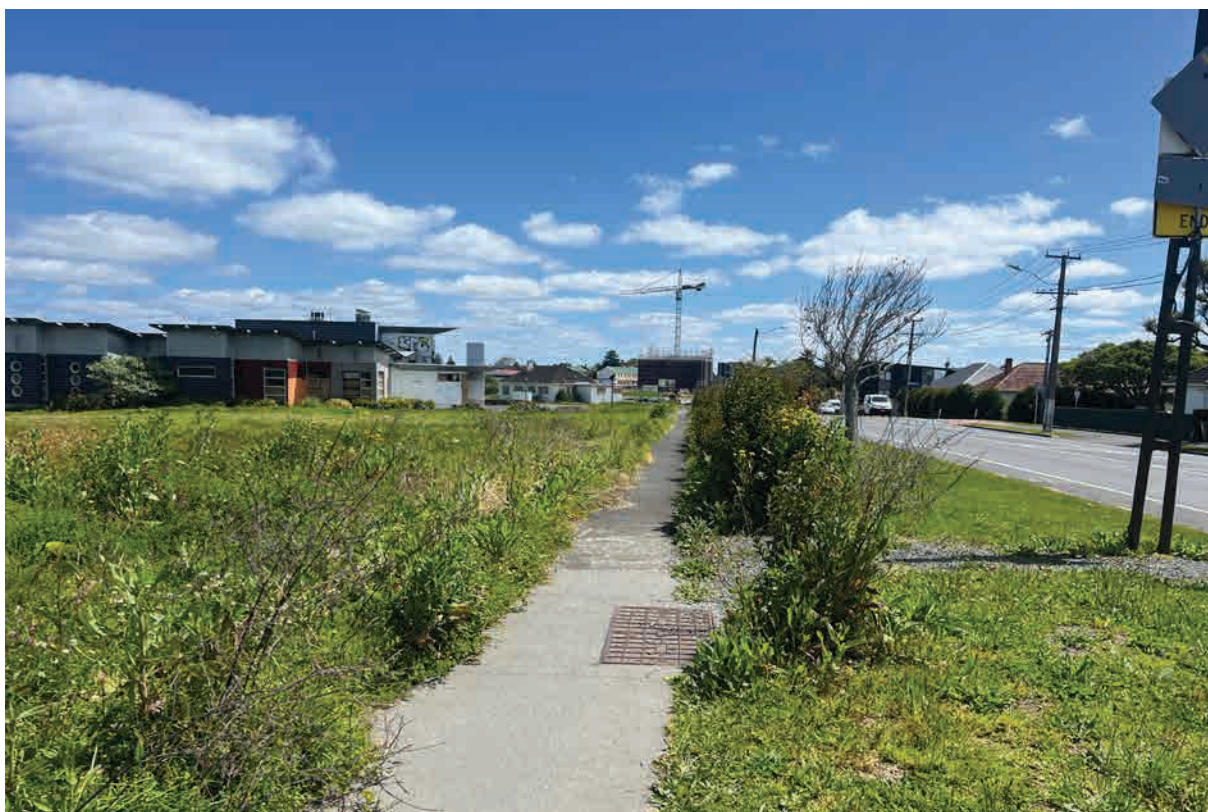
Figure 14. North facing view along the former Carrington Hospital Farm.

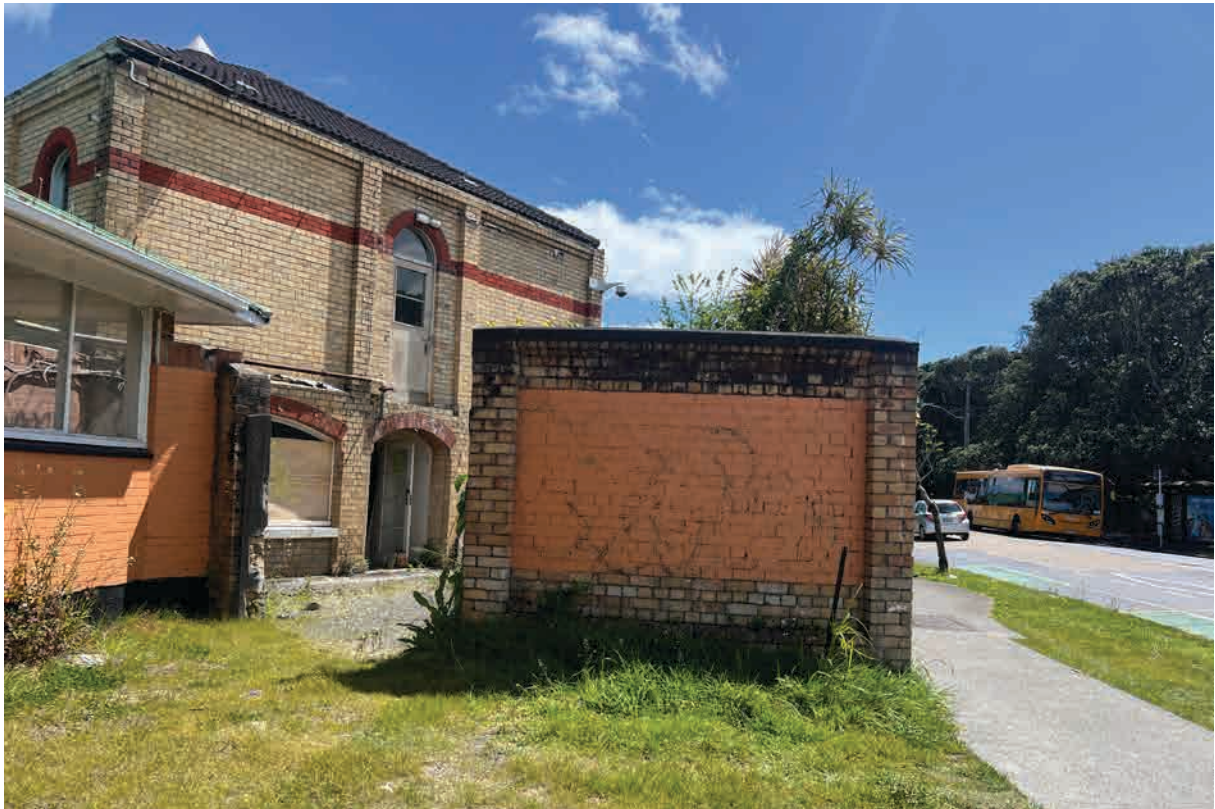
Figure 15. Southern end of Airing Court wall (R11/3560).

Condition	The Airing Court wall is currently largely overgrown with vines. However, the visible portions of the wall appear to be in good condition.
Rarity	The Airing Court wall is the last remaining full height brick wall associated with the hospital.
Context Information	The Airing Court wall is part of the wider context of the Oakley Creek Hospital. There is the potential for scientific information to be recovered by archaeological means if archaeological material is uncovered during works.
Amenity	The Airing Court wall is visible from the road and is one of the public facing portions of the Oakley Hospital. It has high Amenity value.
Cultural	Any potential subsurface historic deposits relate to the historic occupation of the property.

Prior to demolition of the Airing Court Wall (R11/3560), the structure will be recorded to a minimum standard HNZPT Level 2 (HNPZT 2018). Additional mitigation of effects to standing structures (Airing Court Wall), are largely addressed separately in the built heritage impact assessment prepared for this project (DPA Architects 2024), and in the requirements of the proposed conditions of consent. Potential mitigation includes the construction of a section of brick paving in the cycle lane, following the alignment of the Airing Court wall (R11/3560) and constructed using the wall's bricks. Interpretive panels could also be constructed, describing the history of the wall and its use, in the context of the wider history of the asylum.

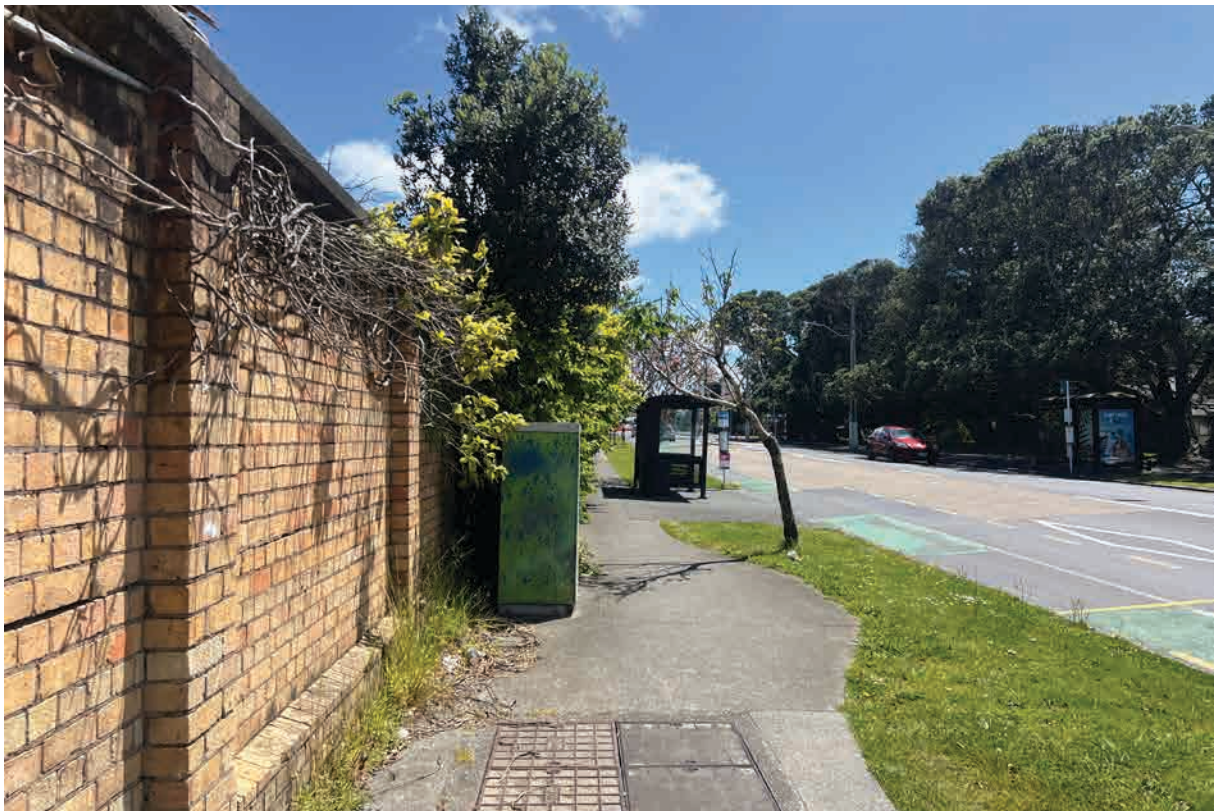
Figure 16. North facing view along the 19th century Airing Court wall (R11/3560).

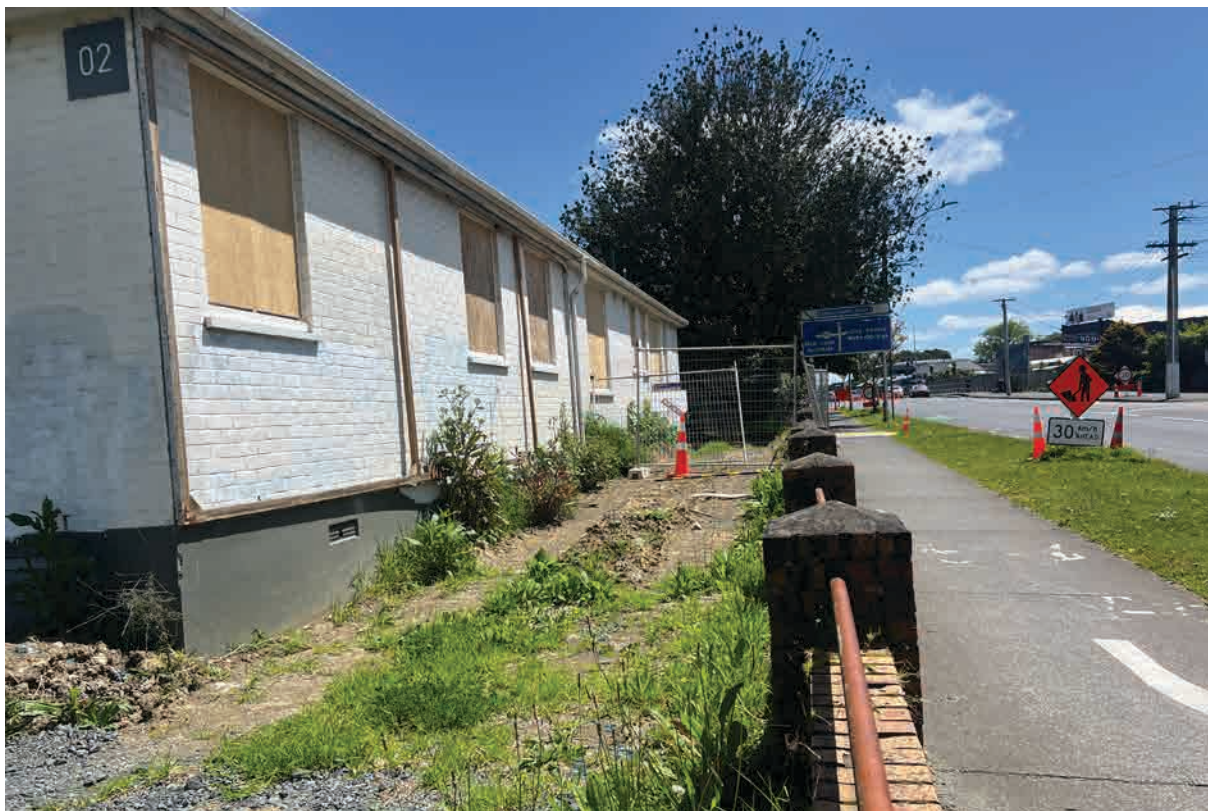
Further to the north, alongside the former Hospital Farm area, a footpath is surrounded by overgrown vegetation, with recent topsoil stripping in some areas due to other development projects. Where subsoils are visible they are largely clays fills, with evidence of older demolition materials mixed throughout. It is unclear where natural subsoils have been exposed, if at all (Figure 13 and Figure 14). Very little ground surface is visible due to berms, footpaths and ongoing construction. Where the proposed road upgrades will impact the brick walls related to Carrington Hospital Building 1, (Figure 15 and Figure 16), no additional archaeological material was visible. Sections of the walls, particularly the taller Airing Court wall (R11/3560), date to the 19th century and are therefore archaeological. The lower brick wall (Figure 17) is a more recent 20th century addition.

Figure 17. North facing view of 20th century wall running along the edge of the Building 1 (R11/3561).

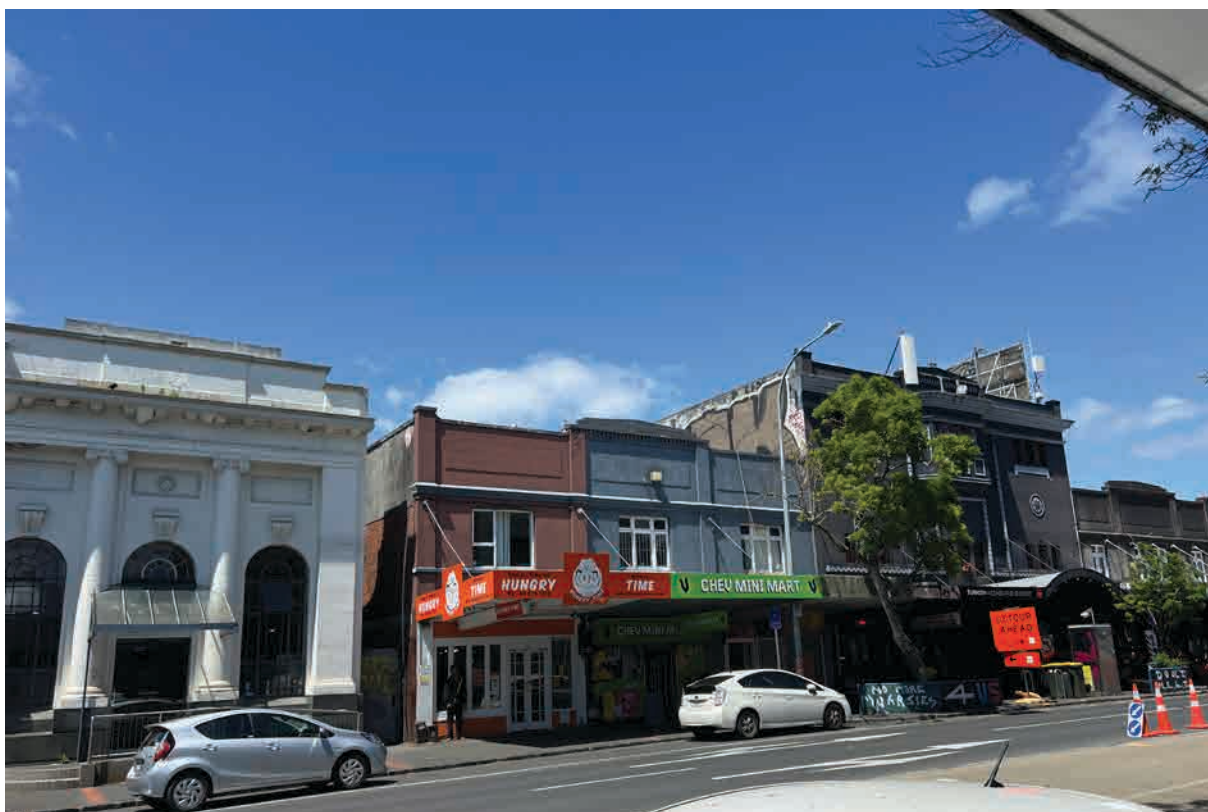
The northern most section of the works runs across a motorway overpass, extending to the intersection of Carrington Road and Great North Road. Although the proposed road upgrades extend to without 16 m of CHI item 22042 (Historic Structure at 1234 Great North Road), there is no evidence of archaeological material inside the works area (Figure 18).

Figure 18. Southeast facing view of CHI listed buildings on Great North Road.

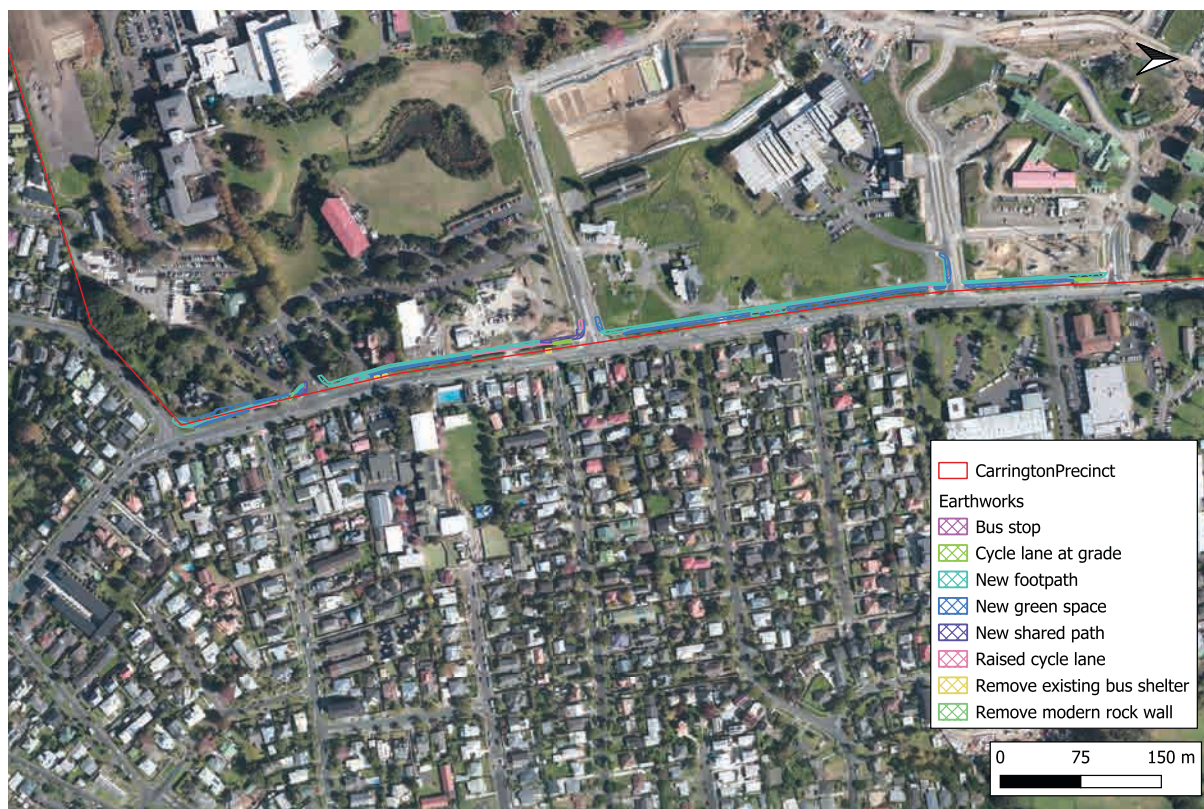
Figure 19. Earthworks proposed alongside and inside the former Carrington Hospital precinct / farm.

deposits, both pre-European Māori and 19th century, to be present where soils are unmodified, or where the ground has been built up. Proposed earthworks along Carrington Precinct will extent up to 7–8 m inside the precinct, and will reach depths of up to 4.1 m. There is therefore a risk potential to impact previously unrecorded subsurface archaeological deposits which may be present (Figure 19).

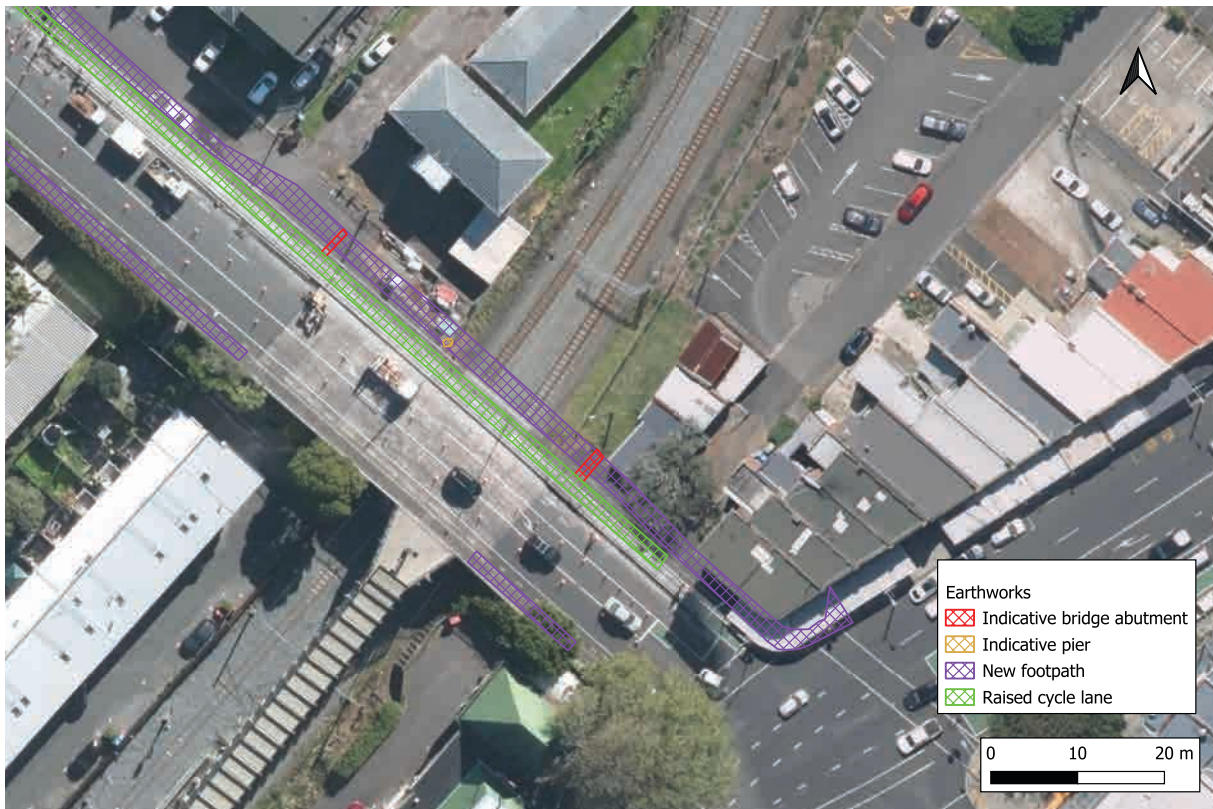
Figure 23. Works proposed near the Mt Albert Train Station.

The proposed works terminate alongside the Mt Albert Train station and overpass. The station itself is recorded as archaeological site R11/3319. The rail line is known to have been constructed in 1880. Station R11/3319 is recorded some 150 m west of the current overpass, with the existing station extending up to 50 m from the overpass. The proposed works in this area include construction of an extension of the existing overpass, to accommodate a cycle lane, and new footpath. The extension will be constructed on the eastern side to the existing overpass, away from R11/3319. Construction will require the installation of two 1 m diameter columns to support the addition, which will also be attached to the existing overpass (Figure 23). There is therefore a low risk that archaeological deposits related to the early operations of the Mt Albert railway line and station may be impacted.

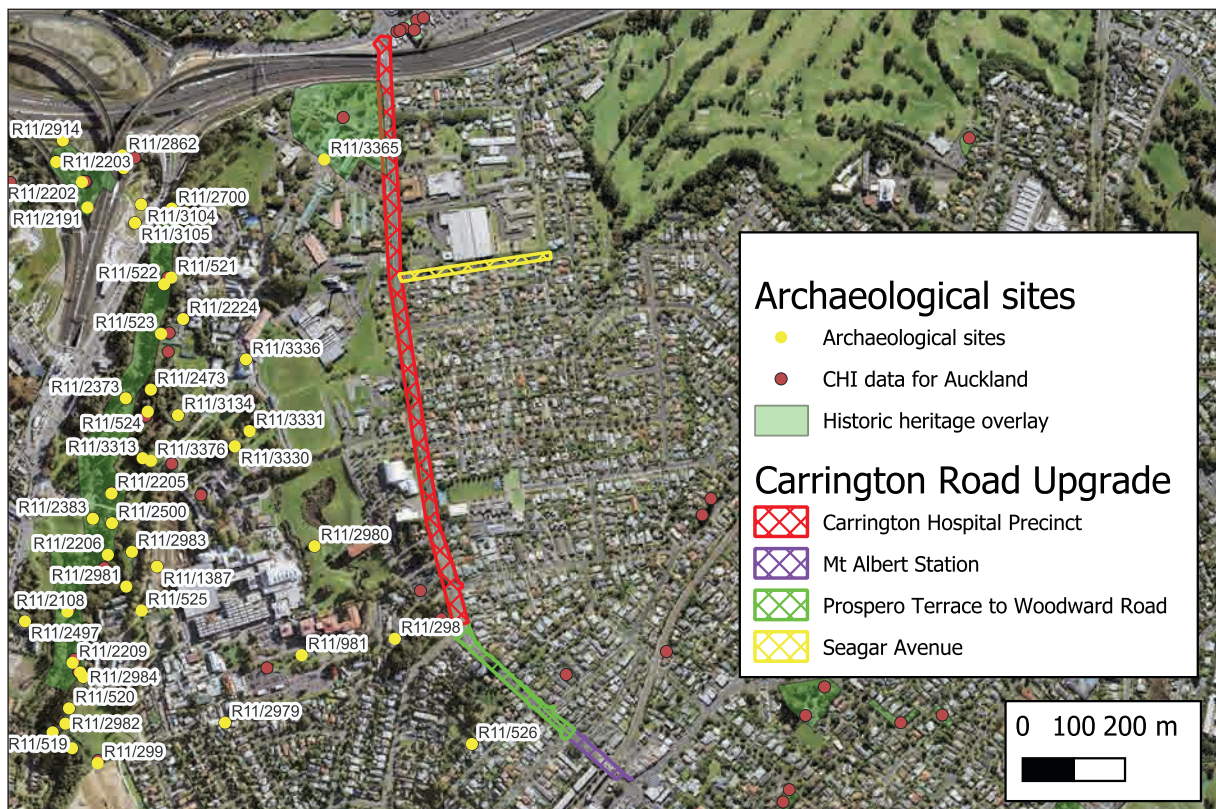
Figure 24. Locations of the areas described in assessment of effects.

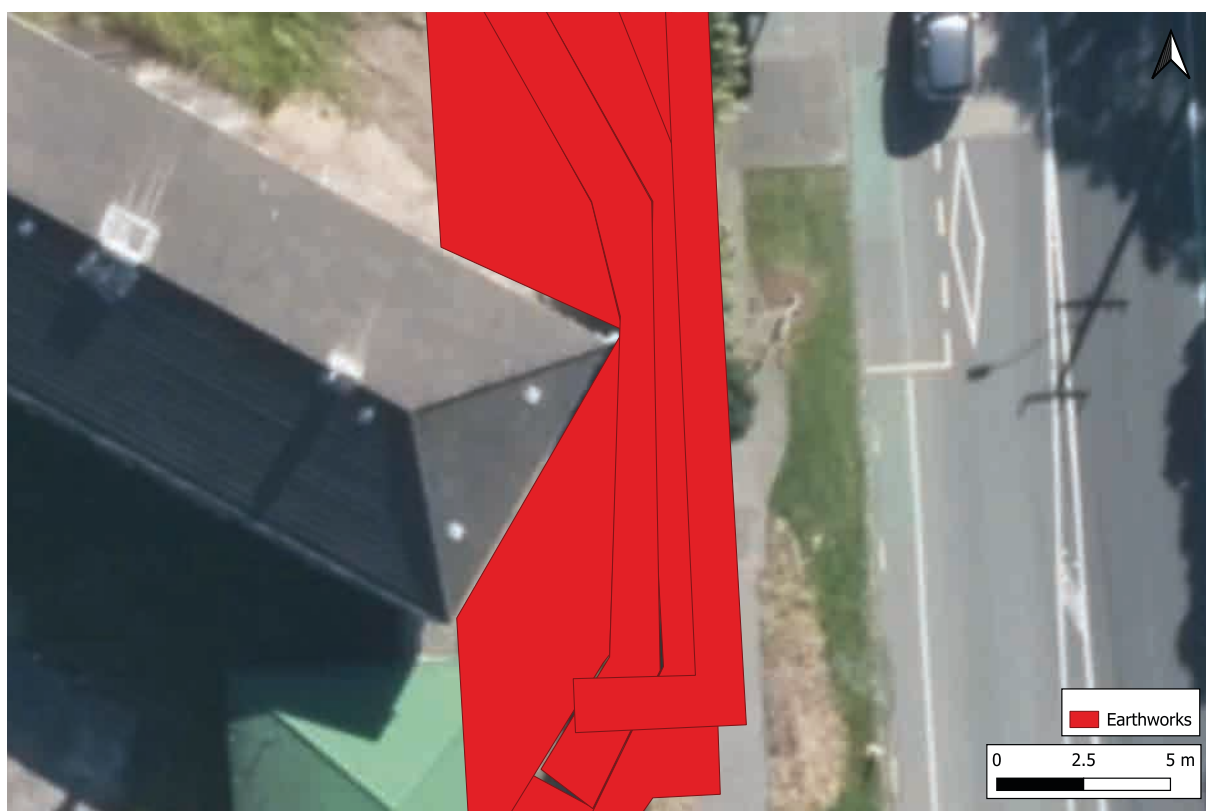
Road widening is proposed inside the scheduled extent of Carrington Hospital Main building, for both raised and at grade cycle lanes, new footpaths, new shared paths, and new green spaces, as well as a new bus stop. Road widening works will extend along the length of the scheduled hospital extent, approximately 185 m, extend up to up to 8 m inside the Carrington Hospital site, and will generally reach depths of 1.3 m. Proposed road widening will narrow down near the corner of Gate 1 to avoid impacting the Carrington Main building (Figure 20 and Figure 26).

Figure 26. Localised narrowing of the project to avoid damaging the Carrington Hospital Main Building.
