# Contaminated Land Assessment

Carrington Road Improvements Project

Prepared for Auckland Transport  
Prepared by Beca Limited

22 November 2024

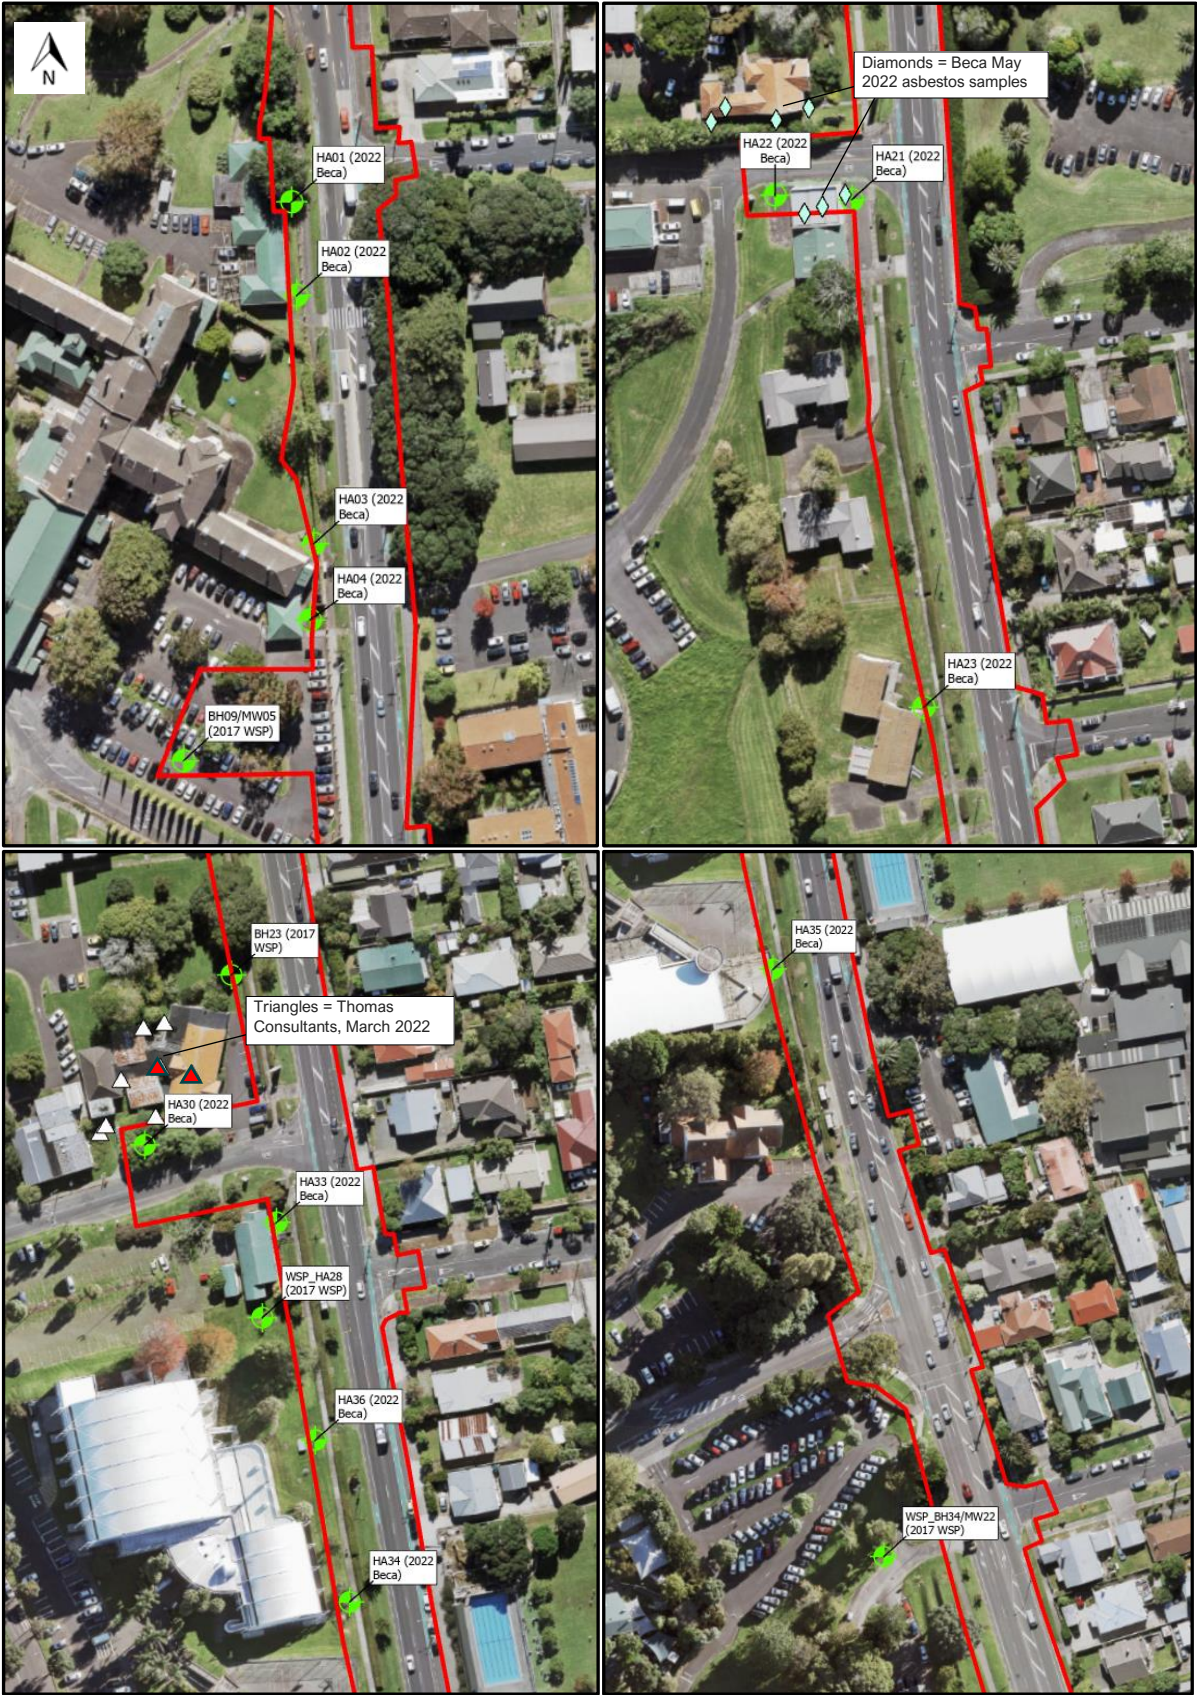
Figure 4: Previous onsite / adjacent to site soil sampling locations (base image source: Auckland GIS viewer)

Soil samples were collected from 31 locations (shown in Figure 4 below) and submitted for laboratory analysis for contaminants of concern based on the HAIL activity identified within the corresponding reports. Contaminants of concern analysed for included heavy metals (arsenic, cadmium, chromium, copper, lead, mercury, nickel, zinc), asbestos, organochlorine pesticides (OCP), organophosphorus pesticides (OPP), herbicides, phenols, polycyclic aromatic hydrocarbons (PAH), total petroleum hydrocarbons (TPH), polychlorinated biphenyls (PCBs), and benzene, toluene, ethylbenzene, and xylenes (BTEX).

Analyte concentrations from soil samples on or adjacent to the site (Figure 4) are summarised below and a summary screening table provided as Appendix C. The samples were screened against NESCS recreational soil contaminant standards and AUP(OP) permitted activity soil acceptance criteria.

- HA02 0.1m below ground level (bgl) and 0.3m bgl returned lead concentrations of 270mg/kg and 300mg/kg respectively, exceeding the AUP(OP) permitted activity soil acceptance criteria of 250mg/kg.

- Asbestos was detected in two soil samples (represented by the red triangles) within the Thomas Consultant Investigation (presence / absence asbestos analysis completed). These sample locations were 5-10m from the proposed site works and within the footprint of a removed building. Thomas Consultants prepared a Remediation Methodology for the contaminated soils. Confirmation to whether these remedial works were undertaken has not been provided.

- All remaining sample locations returned analyte concentrations below the NESCS recreational soil contaminant standard and AUP(OP) permitted activity soil acceptance criteria. Some samples returned analyte concentrations which exceeded the expected naturally occurring soil background ranges.
