To: Liam Winter
From: James Botting
Copy: Mandy McDavitt
Subject: Carrington Road Improvements Project - Check of Groundwater Permitted Activity Status

Date: 20 February 2025
Our Ref: 3230635-776096487-5127

Preliminary Geotechnical Appraisal Report

Carrington Road Improvements Detailed Business Case
3 March 2023

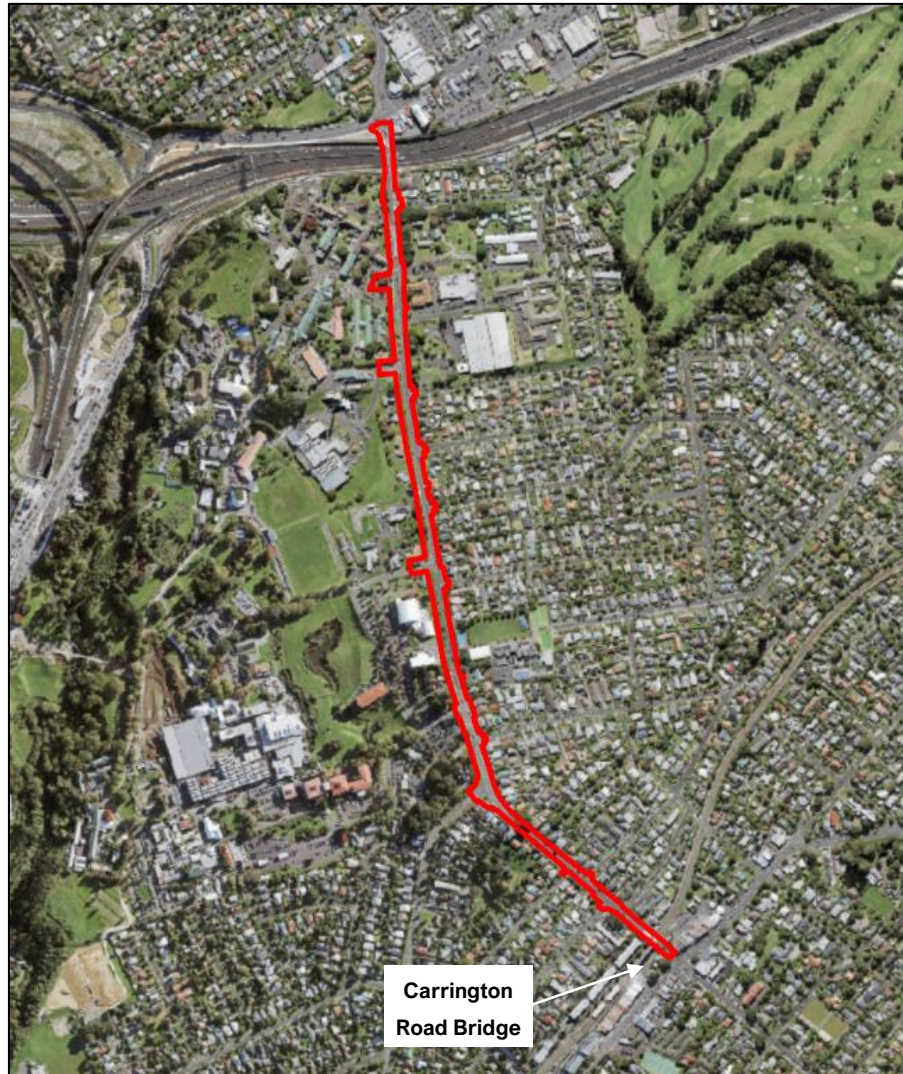
Figure 1: Carrington Road Improvement Project Extent (in red). (Base image source: Auckland Council GeoMaps)

Auckland Transport (AT) intends to upgrade Carrington Road into a multi-modal urban road corridor which will comprise the widening of the existing Carrington Road Corridor and improvements or construction of various associated features such as bus lanes, cycle lanes and footpaths. The extent of Carrington Road is shown in Figure 1.

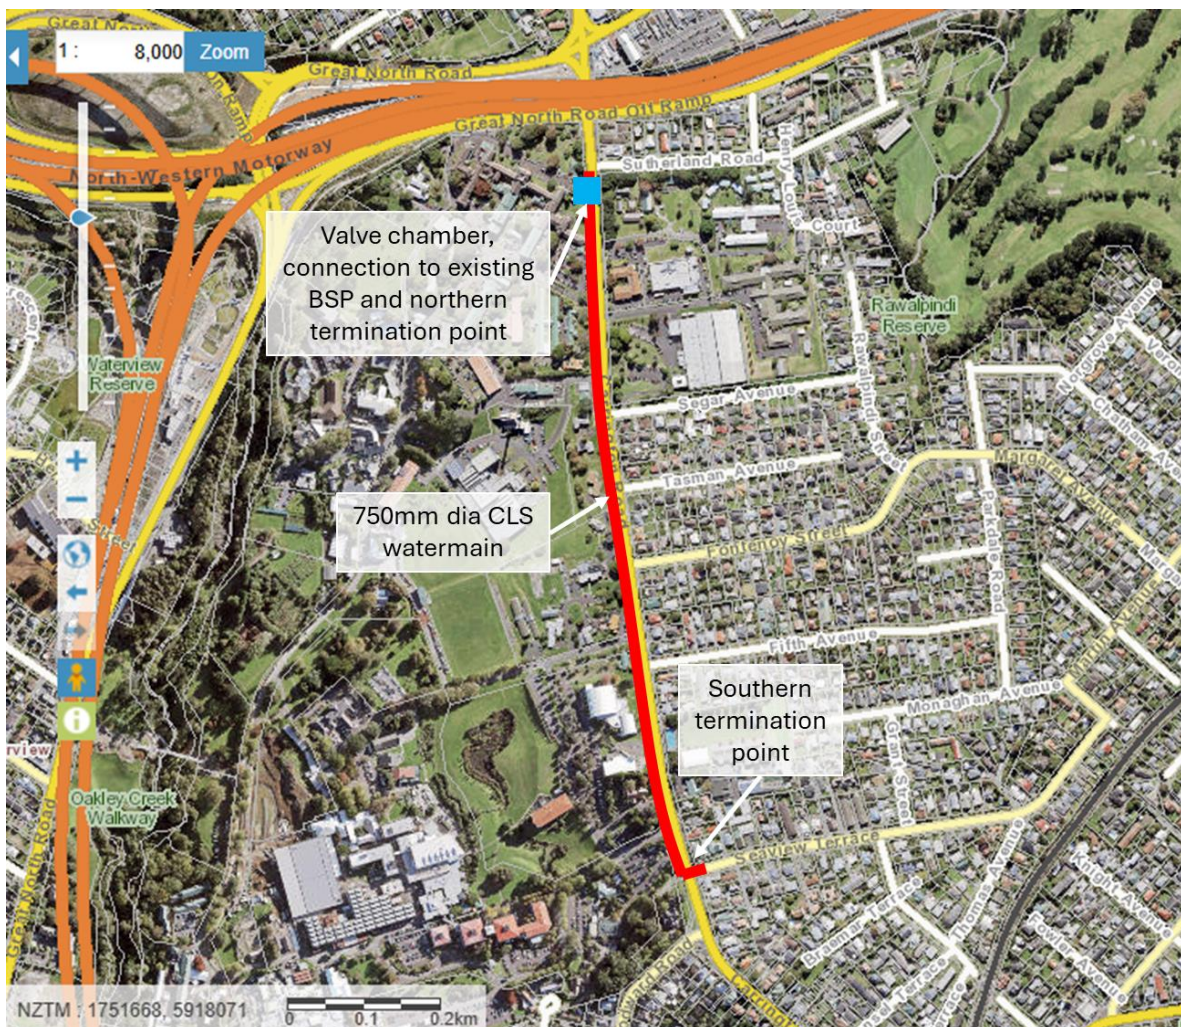
Figure 3: Sketch showing extent of Point Chevalier Watermain No.2

In conjunction, Watercare Services Limited (Watercare) has proposed the Point Chevalier Watermain No. 2 Project (the Watermain) along Carrington Road. The Watermain is a Ø750mm concrete-lined steel (CLS) pipeline approximately 1km in length between Seaview Terrace and Sutherland Road, and forms part of a wider scheme to improve supply, maintain levels of service, and provide resilience to both the Point Chevalier and Khyber water supply zones. The design and planning for the Watermain has been expedited to realise efficiencies with the CRIP, and to enable the projects to be constructed concurrently. The Watermain extent is shown in Figure 3.

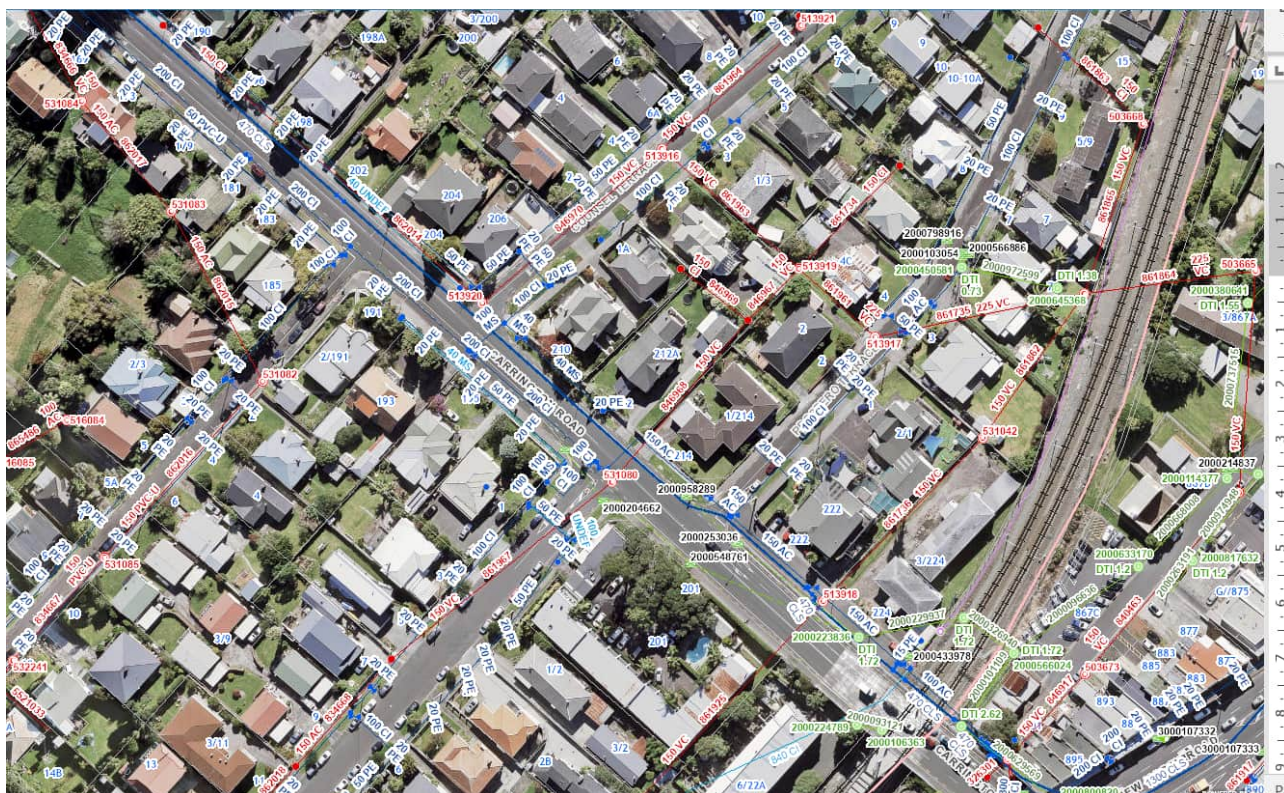
Figure 7. Example map of buried utilities within the corridor (Auckland Council, 2023b)

A review of the existing utility plans for the corridor has identified that the corridor is heavily constrained with buried water supply, wastewater, stormwater and electrical assets. An example of this is shown below in Table 7 for the section of the corridor immediately north of the North Auckland Railway.

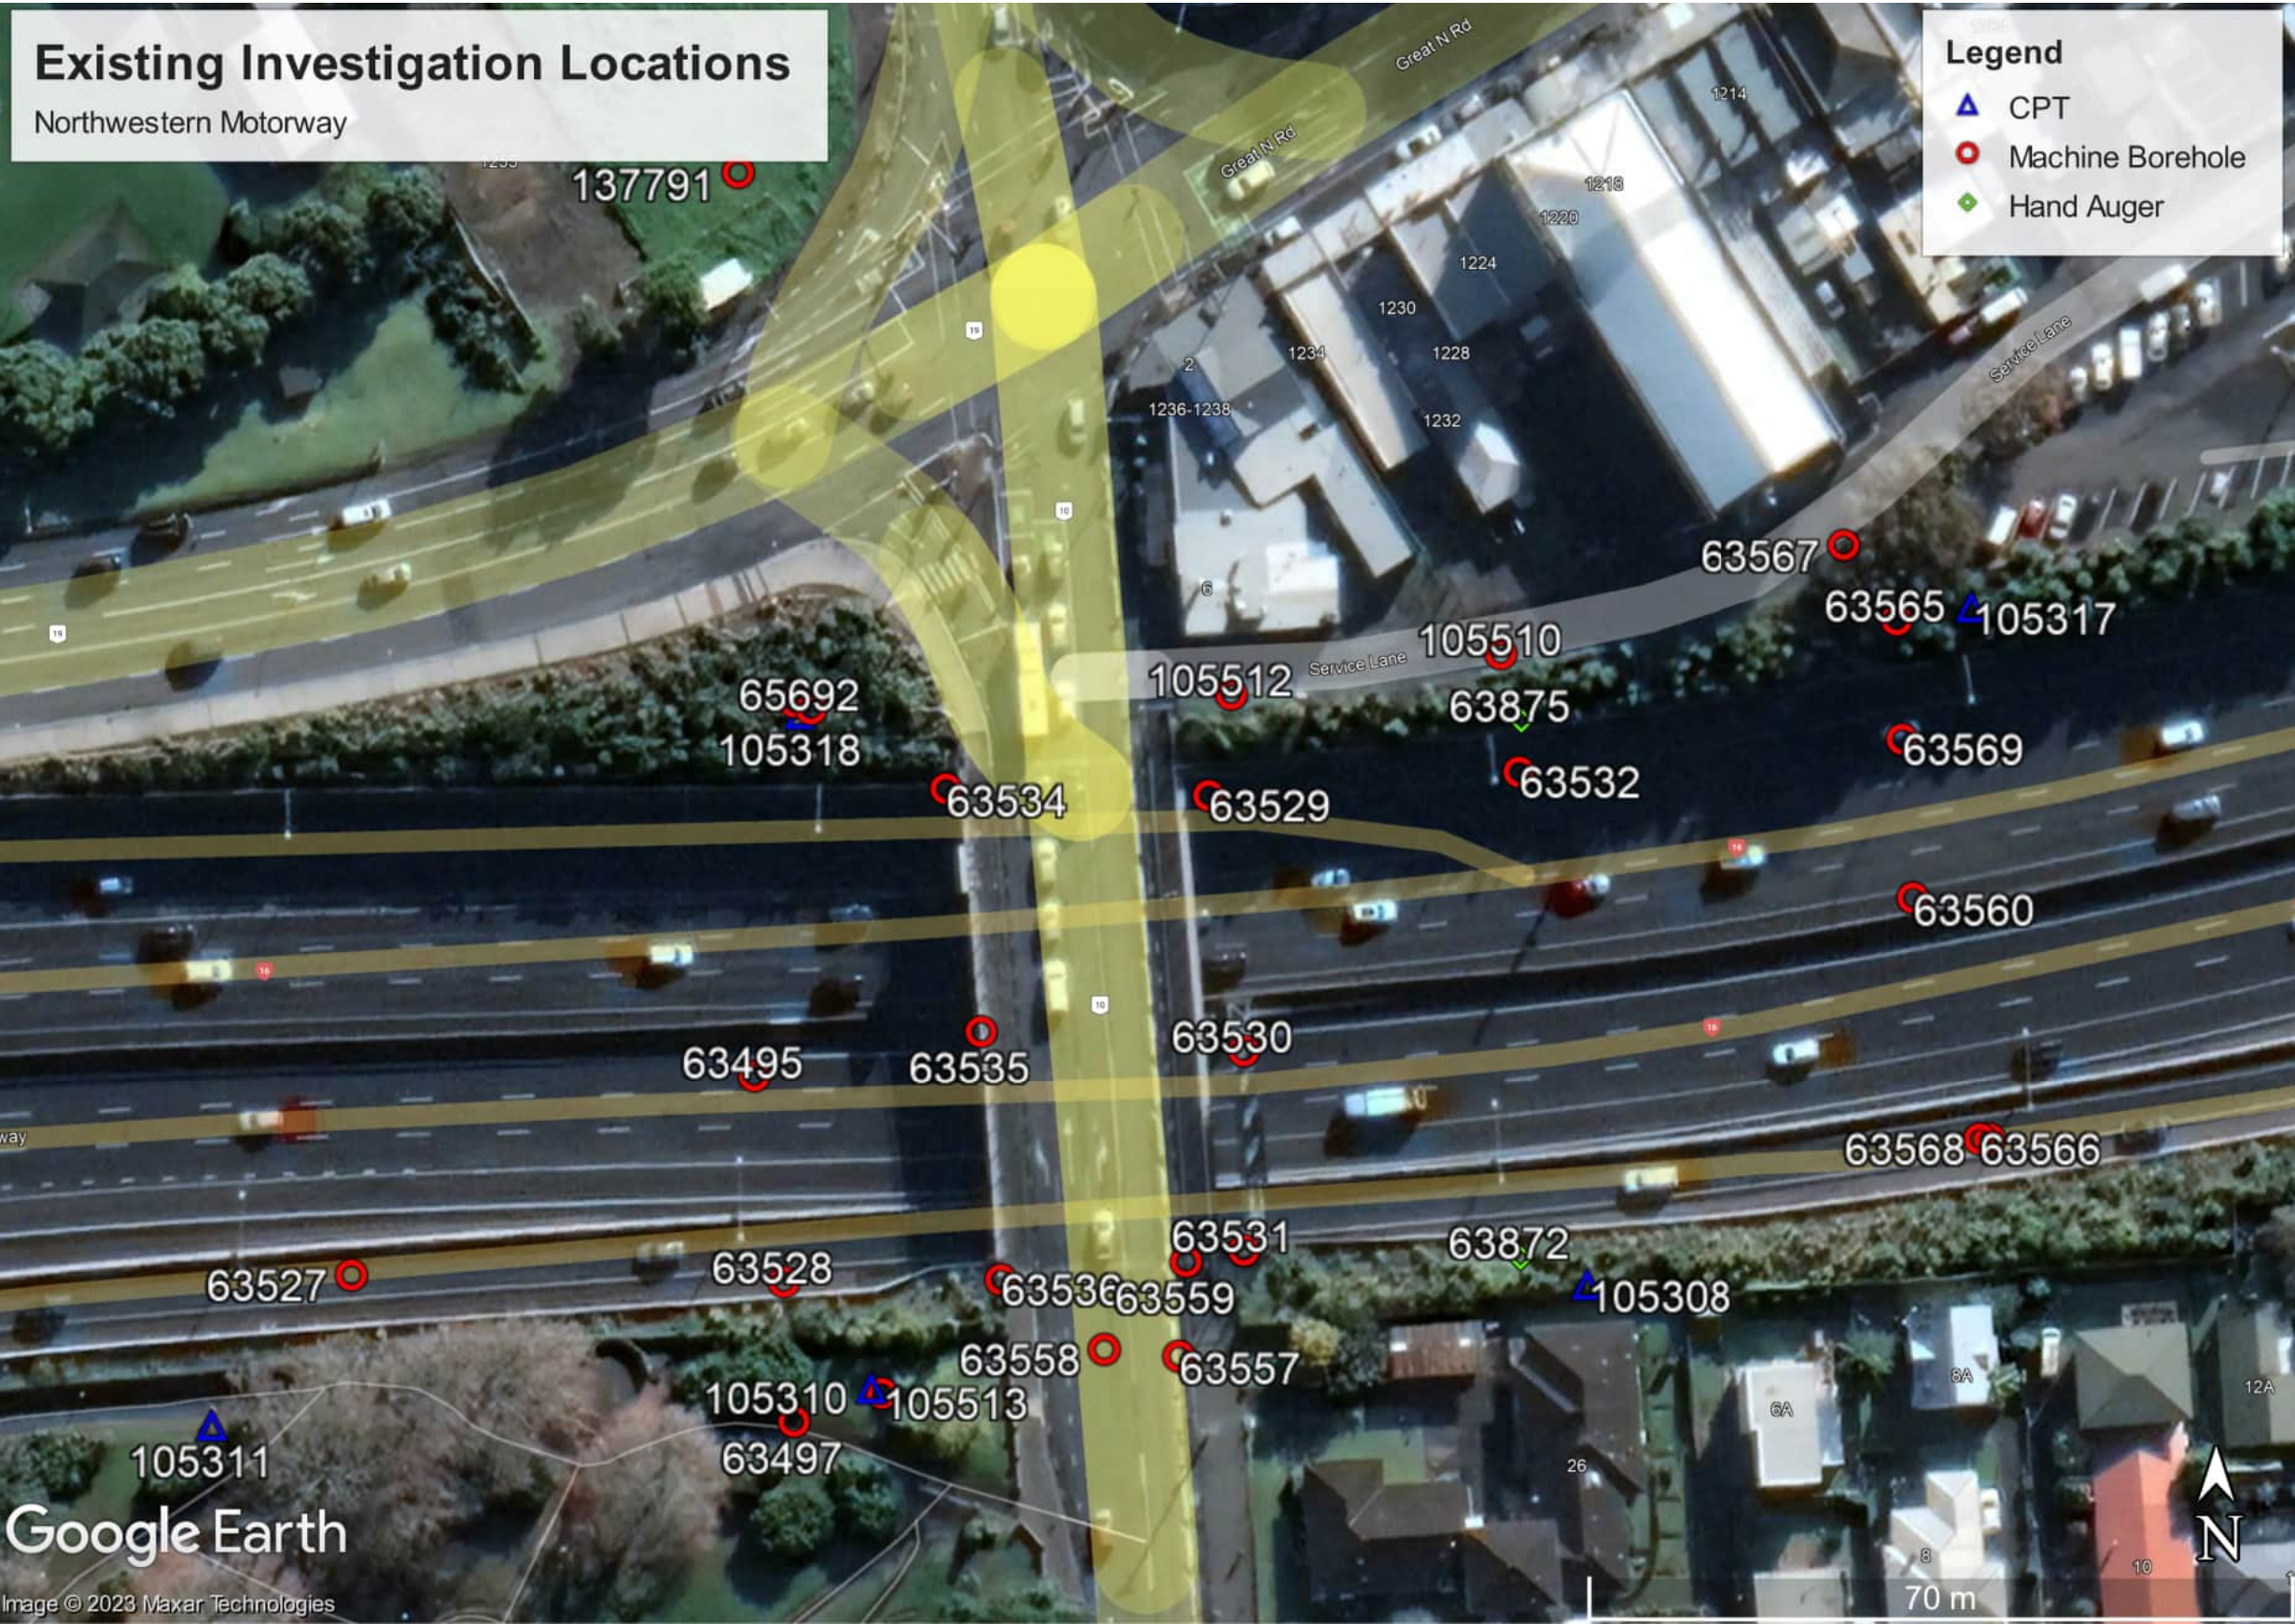
Figure C-2. Existing Investigation Locations (Northwestern Motorway)

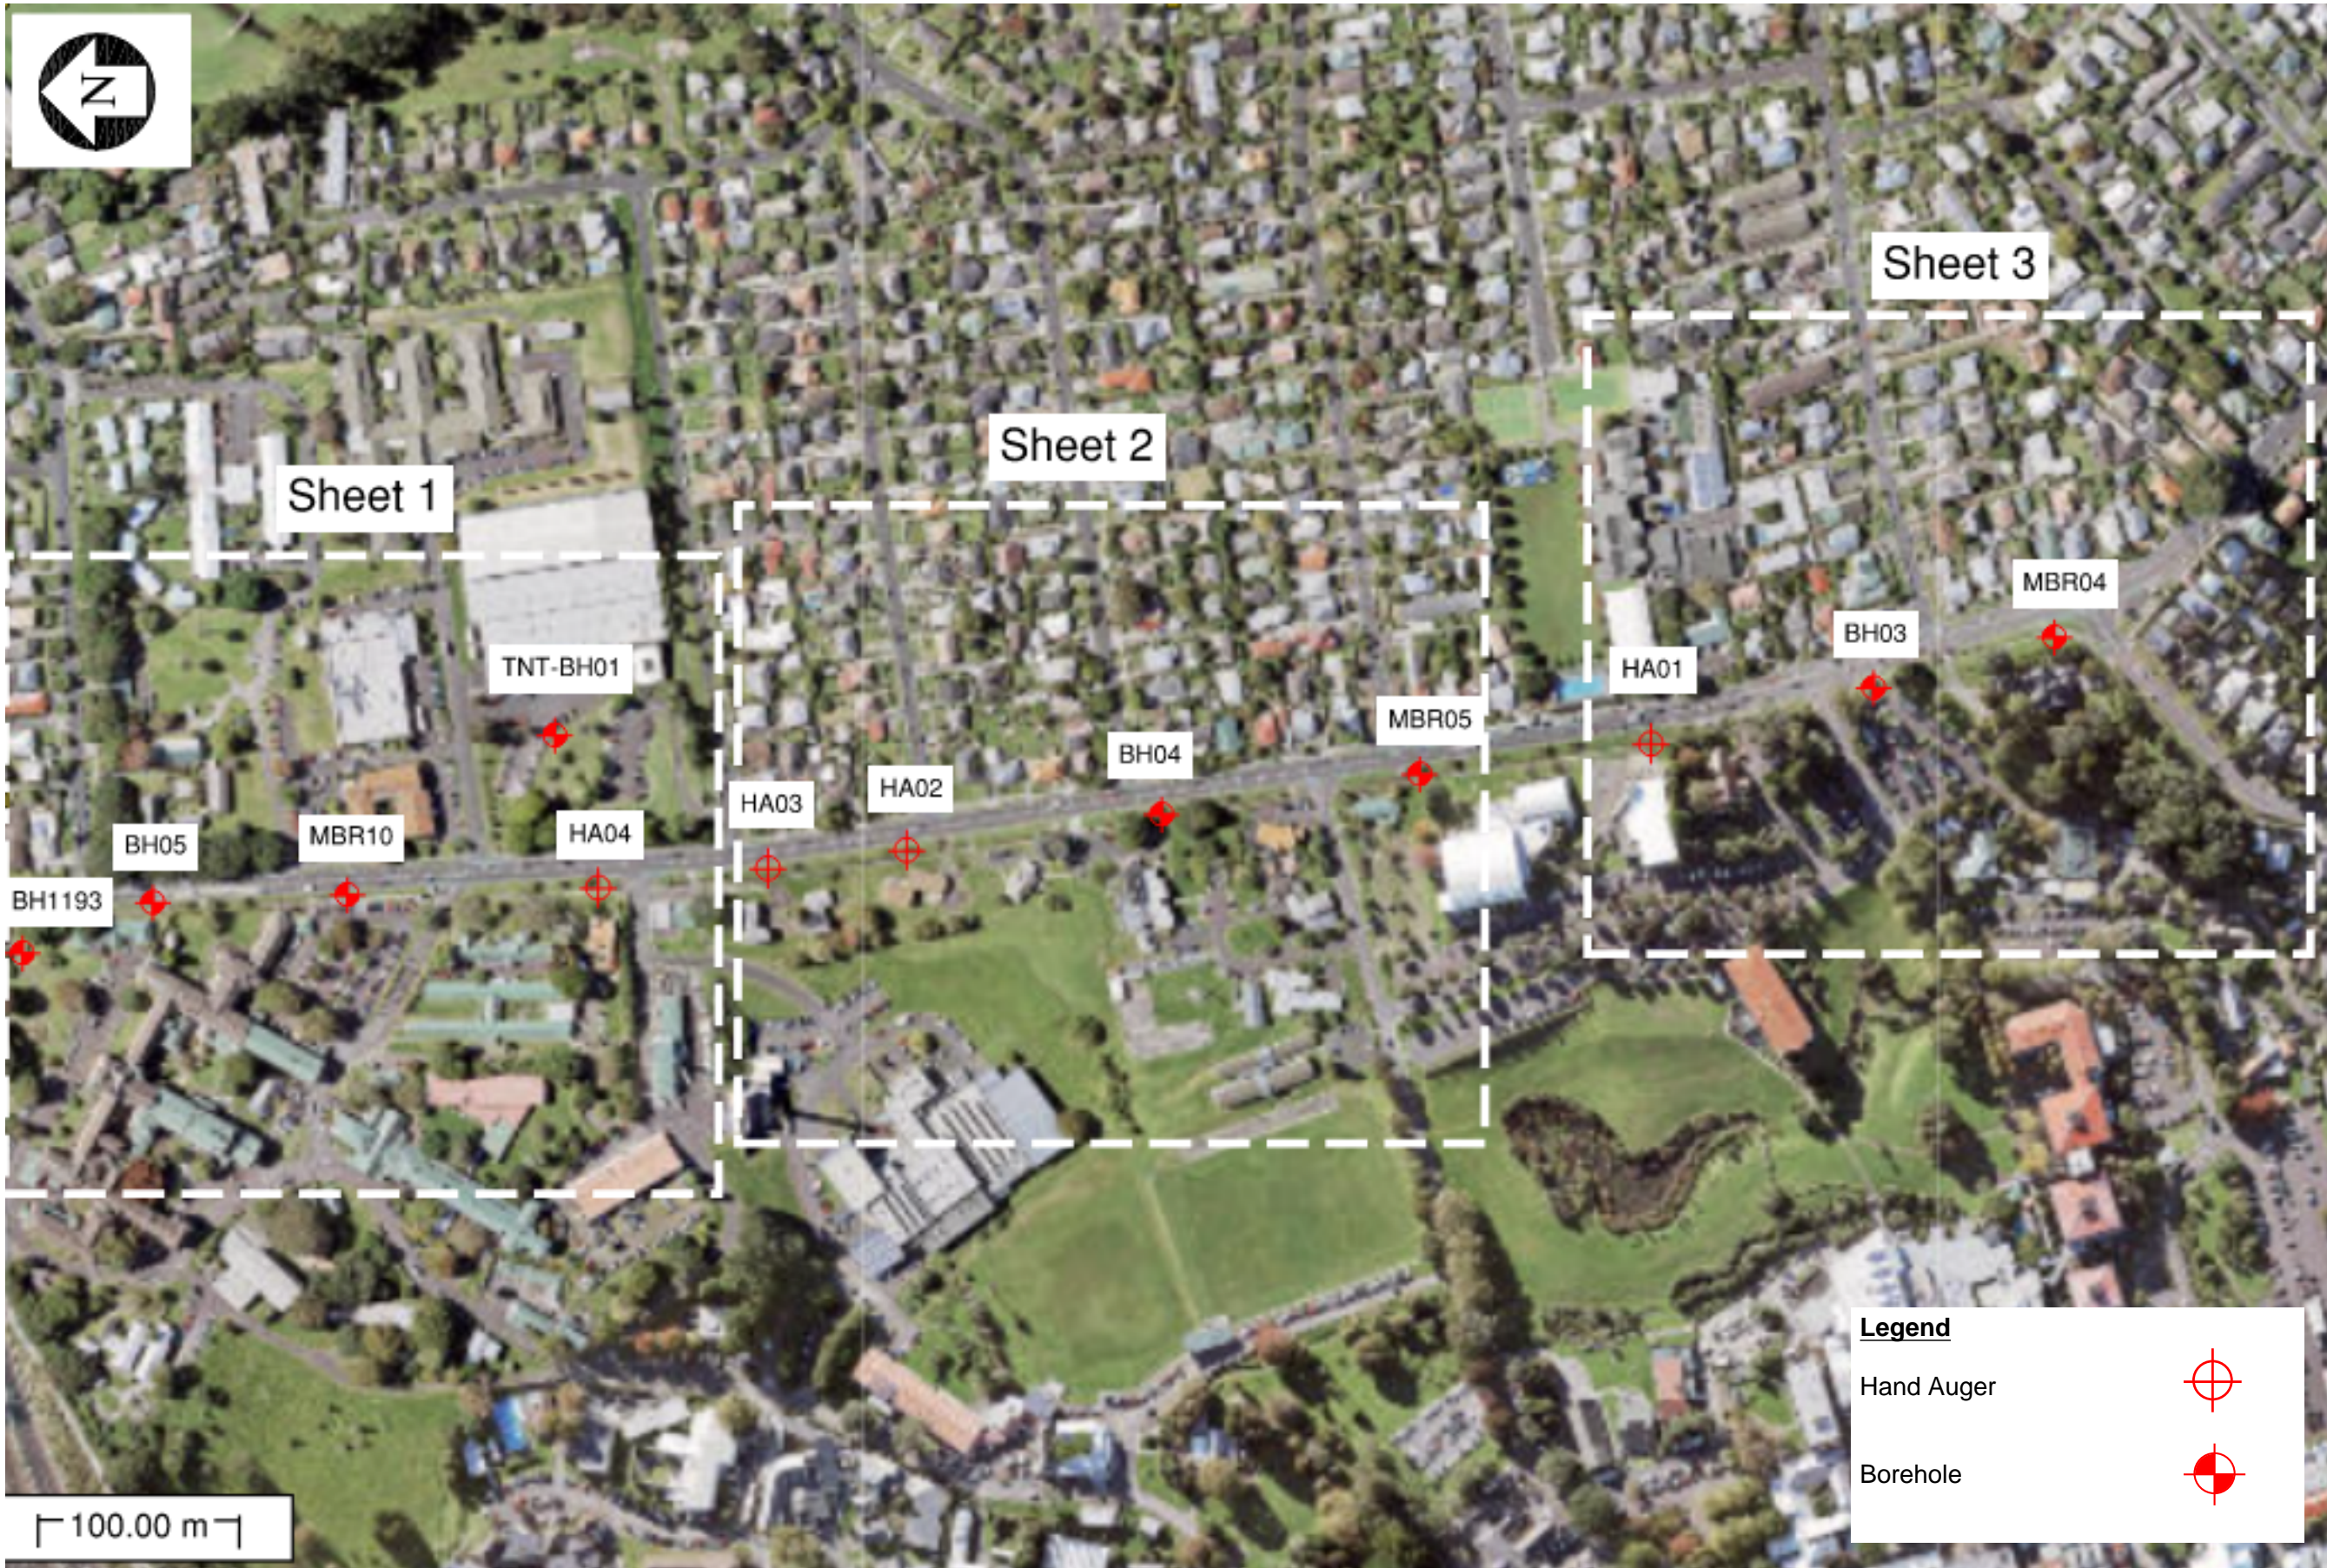
| | Client WATERCARE | Project POINT CHEVALIER WATERMAIN NO.2 | Title SITE INVESTIGATION PLAN | Discipline GEOTECHNICAL Drawing No. Revision |
