Unless otherwise noted, the CRIP and Watermain projects are referred to collectively in this letter as 'the Project'. The Project extent is shown in Figure 1 and a full Project Description can be found in Section 3 of the Assessment of Effects on the Environment (AEE) report.

# Carrington Road Improvements Project

## Technical Memorandum

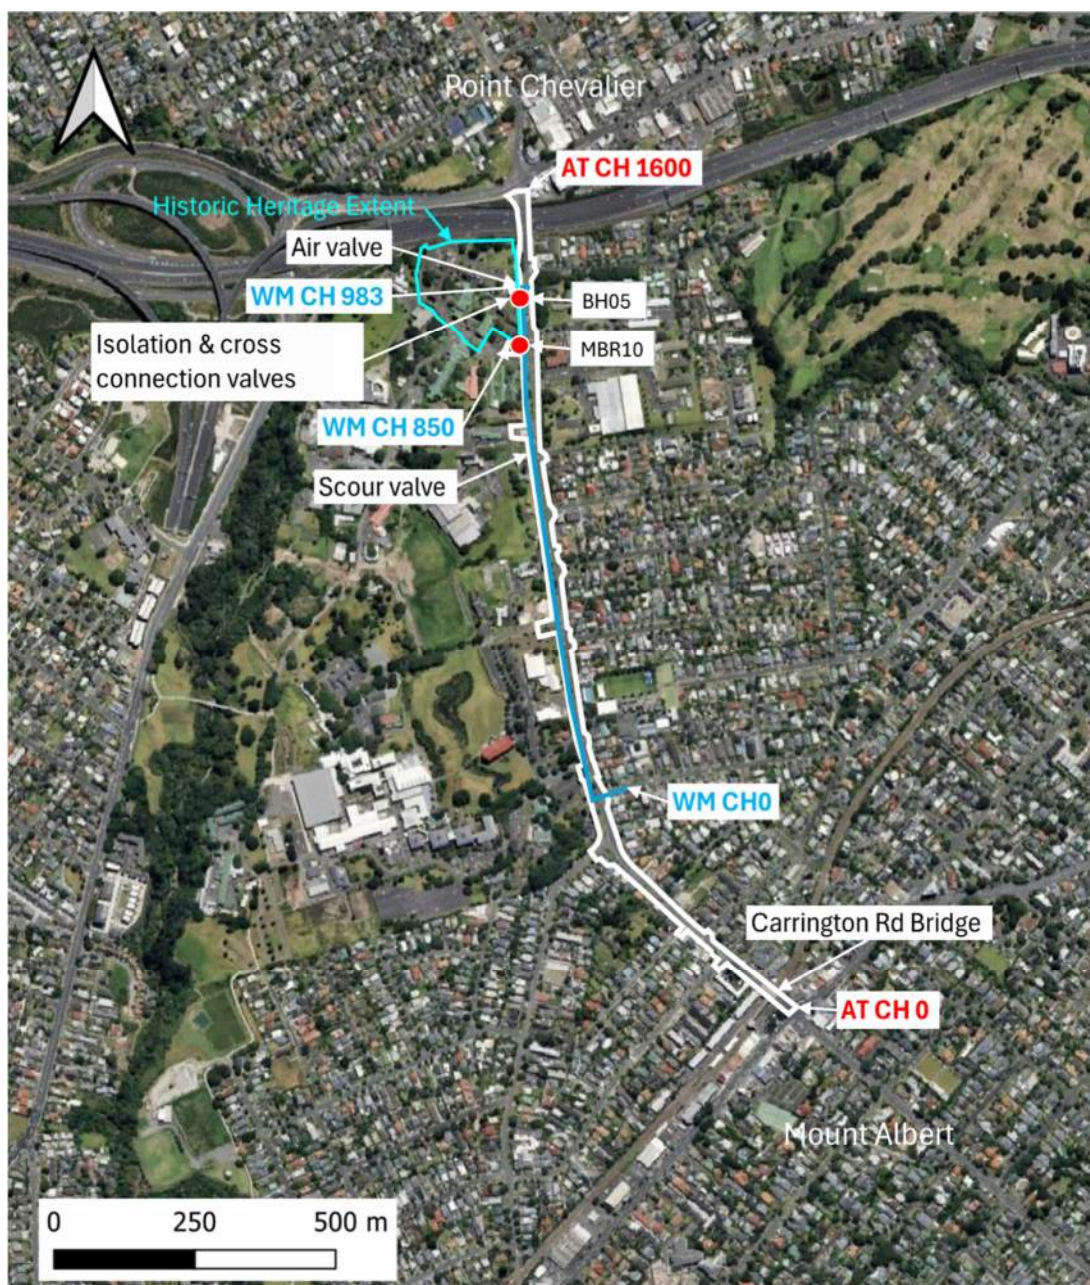
Figure 1: Carrington Road Improvement Project Extent (in white) and Point Chevalier Watermain No 2. Extent in blue. Historic heritage extent (Historic Oakley Hospital) outlined in cyan.

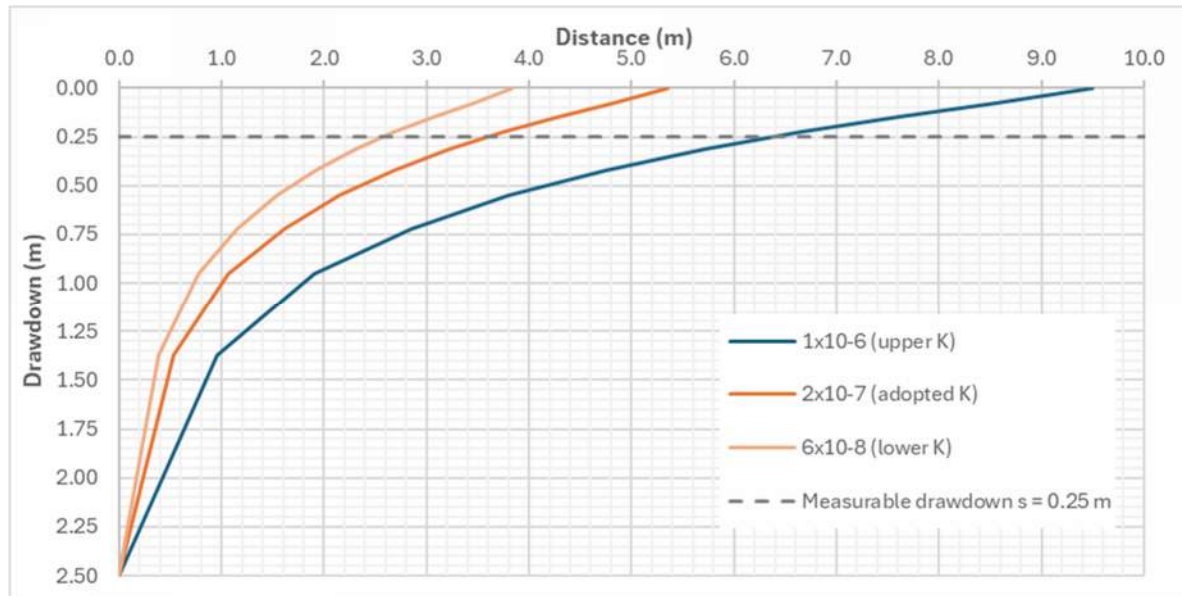
Figure 3: Sichert-derived drawdown cones for DN4000 isolation valve chamber excavation (the upper and lower K values are also shown as plausible upper and lower bounds of permeability).

Drawdown extent is based on the equation originally proposed by Sichardt (1931) which considers steady state (permanent) drawdown irrespective of time, based on permeability and required drawdown at an equivalent

“well”. The magnitude of drawdown at distance is based on a normalised drawdown cone; the derived drawdown cone for the key isolation valve chamber excavation using the upper, lower and nominal case for hydraulic conductivity is shown in Figure 3.

Subsequent versions of CIRIA (C750) have more explicitly noted that the Sichert equation is intended to derive a radius of influence ( $R_0$ ) for assessing inflows. The assessment of inflows for an equivalent well may not be particularly sensitive to  $R_0$  (which is a log function in most equations), but the assessment of drawdown effects will be sensitive.

In our experience, the assessment of  $R_0$  is sensitive to assumed hydraulic conductivity e.g., a plausible increase in hydraulic conductivity by a factor of 5 would increase the drawdown extents noted above by ~176%.

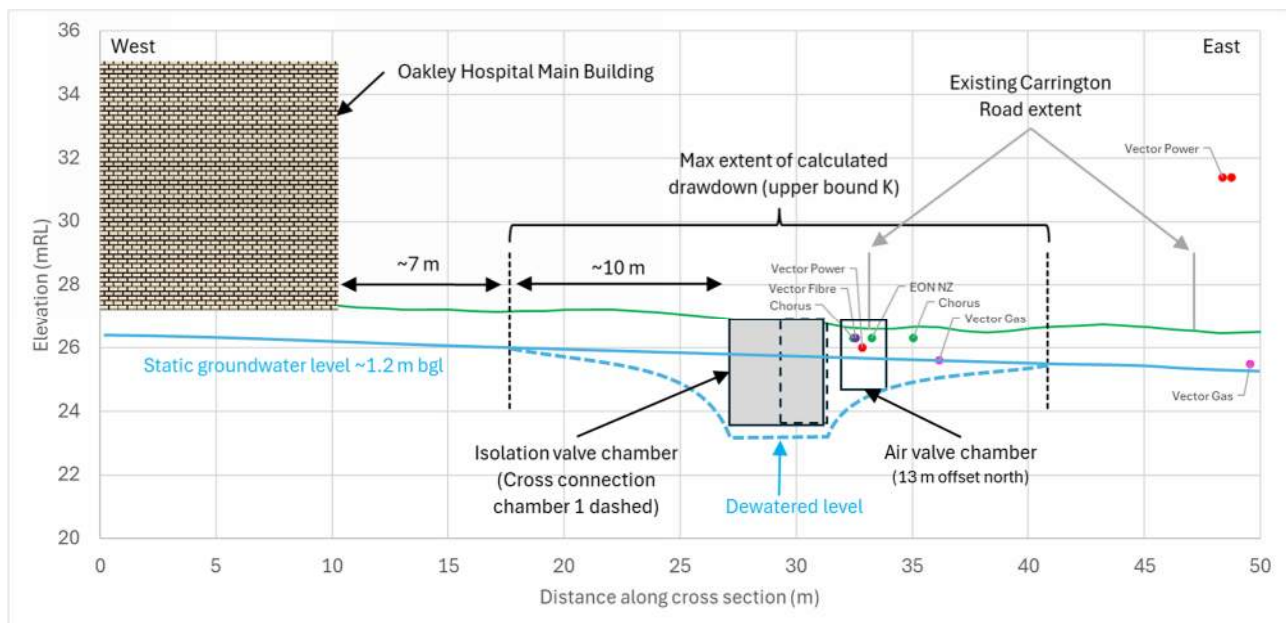
Figure 4: Cross section through Isolation valve chamber excavation perpendicular to Carrington Road alignment showing maximum calculated extent of drawdown in relation to existing services.

All of the services above will be diverted or replaced during the course of the works.

There are no other known public services in proximity to the works not already specified in Section 6.2 and those within the maximum extent of drawdown are scheduled to be diverted or replaced.

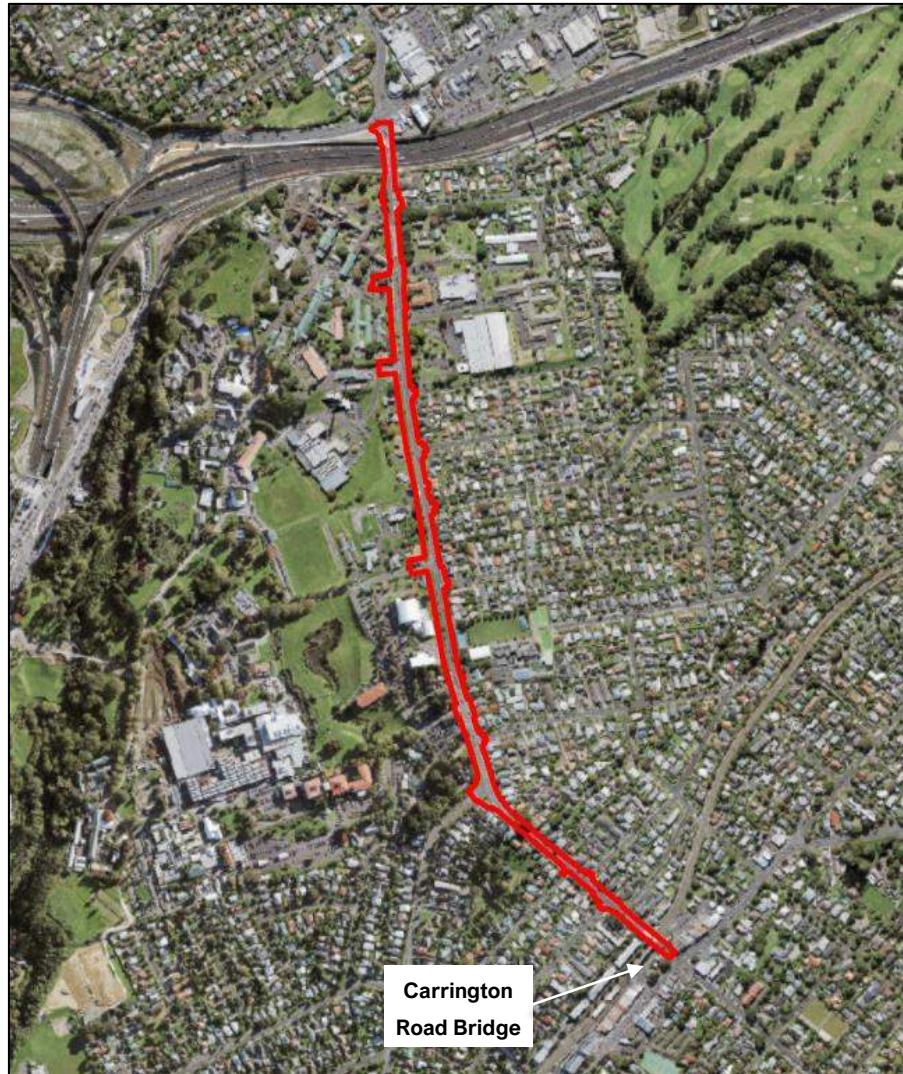
Figure 1: Carrington Road Improvement Project Extent (in red). (Base image source: Auckland Council GeoMaps)

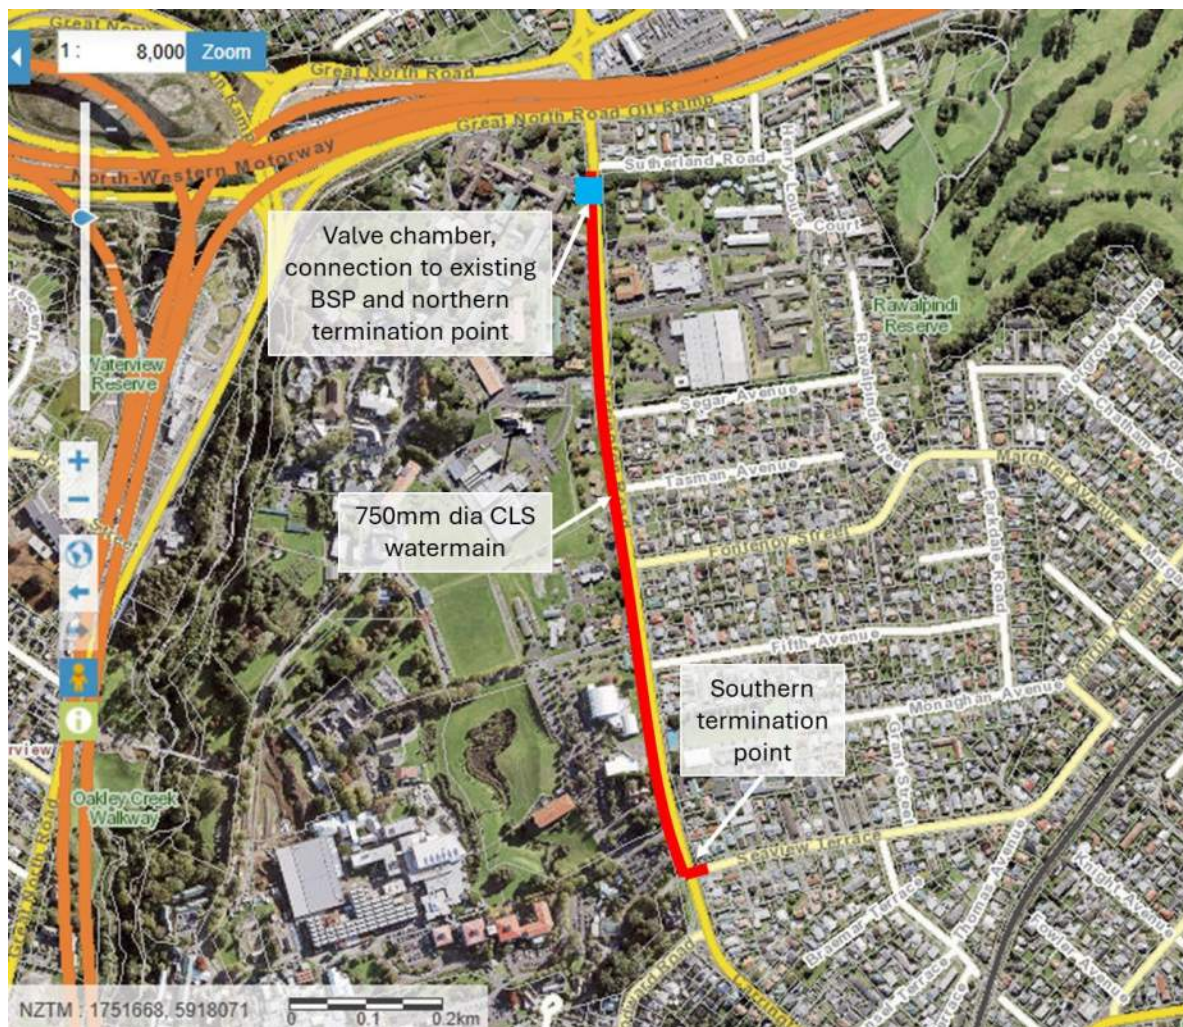
Figure 3: Sketch showing extent of Point Chevalier Watermain No.2

- **Watermain No 2** – installation of a new 750mm diameter pipeline along the western side of Carrington Road requiring 2.5-3 m excavation to avoid utility conflicts.

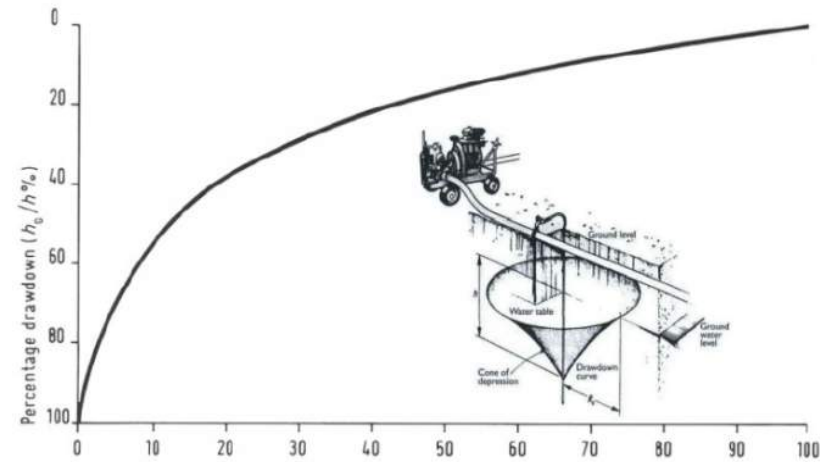
CIRIA R113, Figure 13: Normalised drawdown cone relative to centre of cone of depression

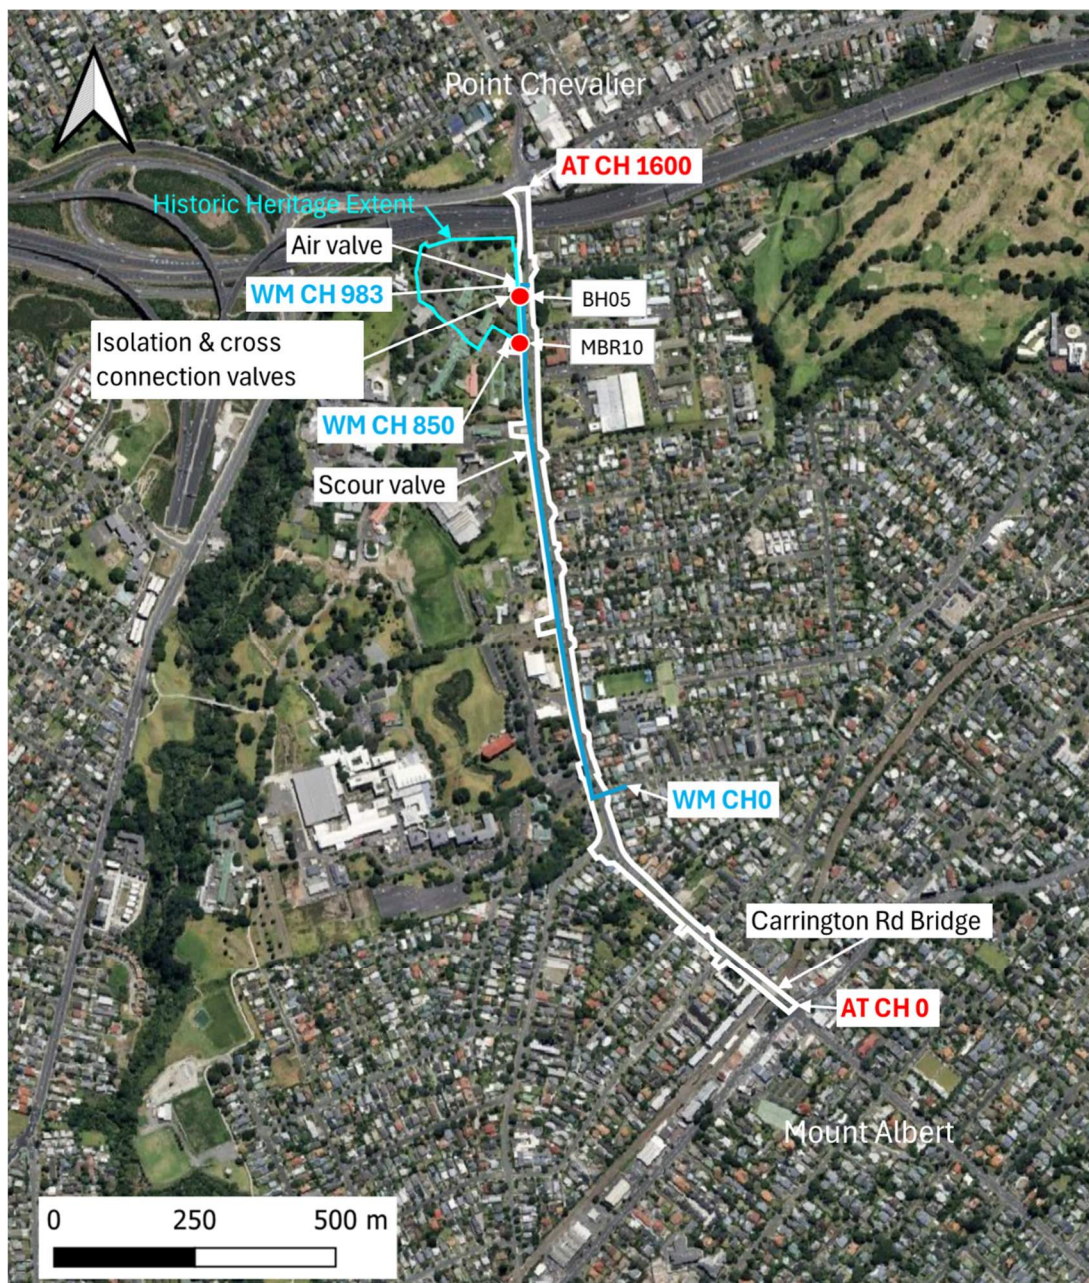
Figure 1: Carrington Road Improvement Project Extent (in white) and Point Chevalier Watermain No 2. Extent in blue. Historic heritage extent (Historic Oakley Hospital) outlined in cyan.

Unless otherwise noted, the CRIP and Watermain projects are referred to collectively in this plan as 'the Project'. The Project extent is shown in Figure 1.

The wider Project extent is shown in Figure 1. The focus of this GMCP is on works associated with installation of the air valve chamber and associated cross-connection and isolation valve chamber (Figure 2).
