CARRINGTON ROAD IMPROVEMENTS PROJECT

HERITAGE INTERPRETATION AND MITIGATION

RESOURCE CONSENT INFORMATION PACK
JULY 2025

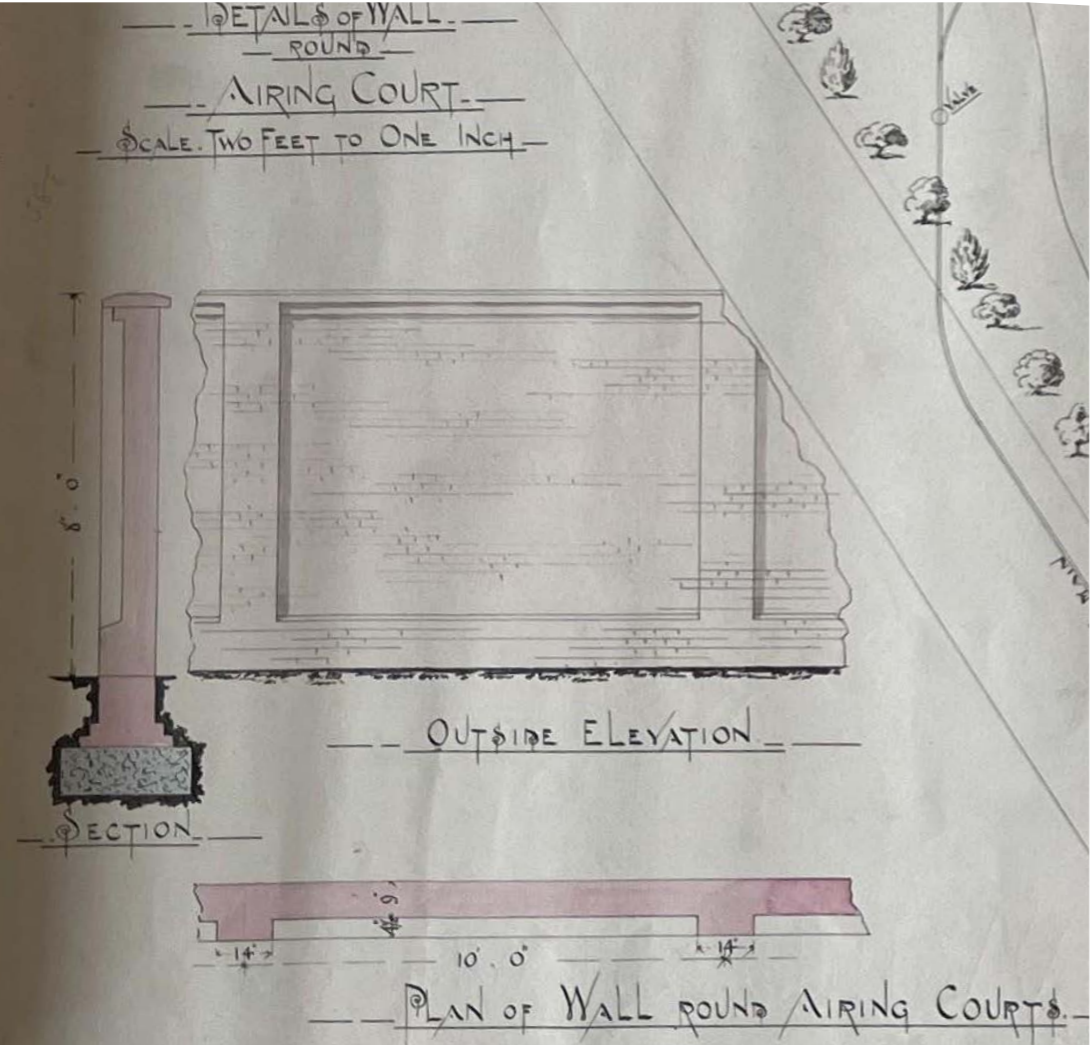
AN OUTSIDE ELEVATION OF THE WALL BY CHARLES BEATSON

- Constructed approximately 1887 in conjunction with adjacent building to form airing court to a minimum height of 8' (2440mm)
- The existing wall features English Bond rectangular panels divided by regularly spaced pilasters at 10' (3050mm) centres that terminate in an angled stringcourse surmounting a base three bricks high or greater. The top of the wall has a cement plastered brick cap
- Constructed from locally sourced clay bricks, with average dimensions of 8-9" (~210-220mm) long x 4" (~105mm) wide x 3" (~75mm) high. Existing mortar is red-brown and may be an early cement/lime mix mortar
- Site measurements indicate wall thickness varies slightly from design drawings at 320mm at the pilasters, probably due to variances in the brick dimensions from the design specification
- Ties into a lower brick wall (~1200mm) which returns to meet the heritage building and completes courtyard

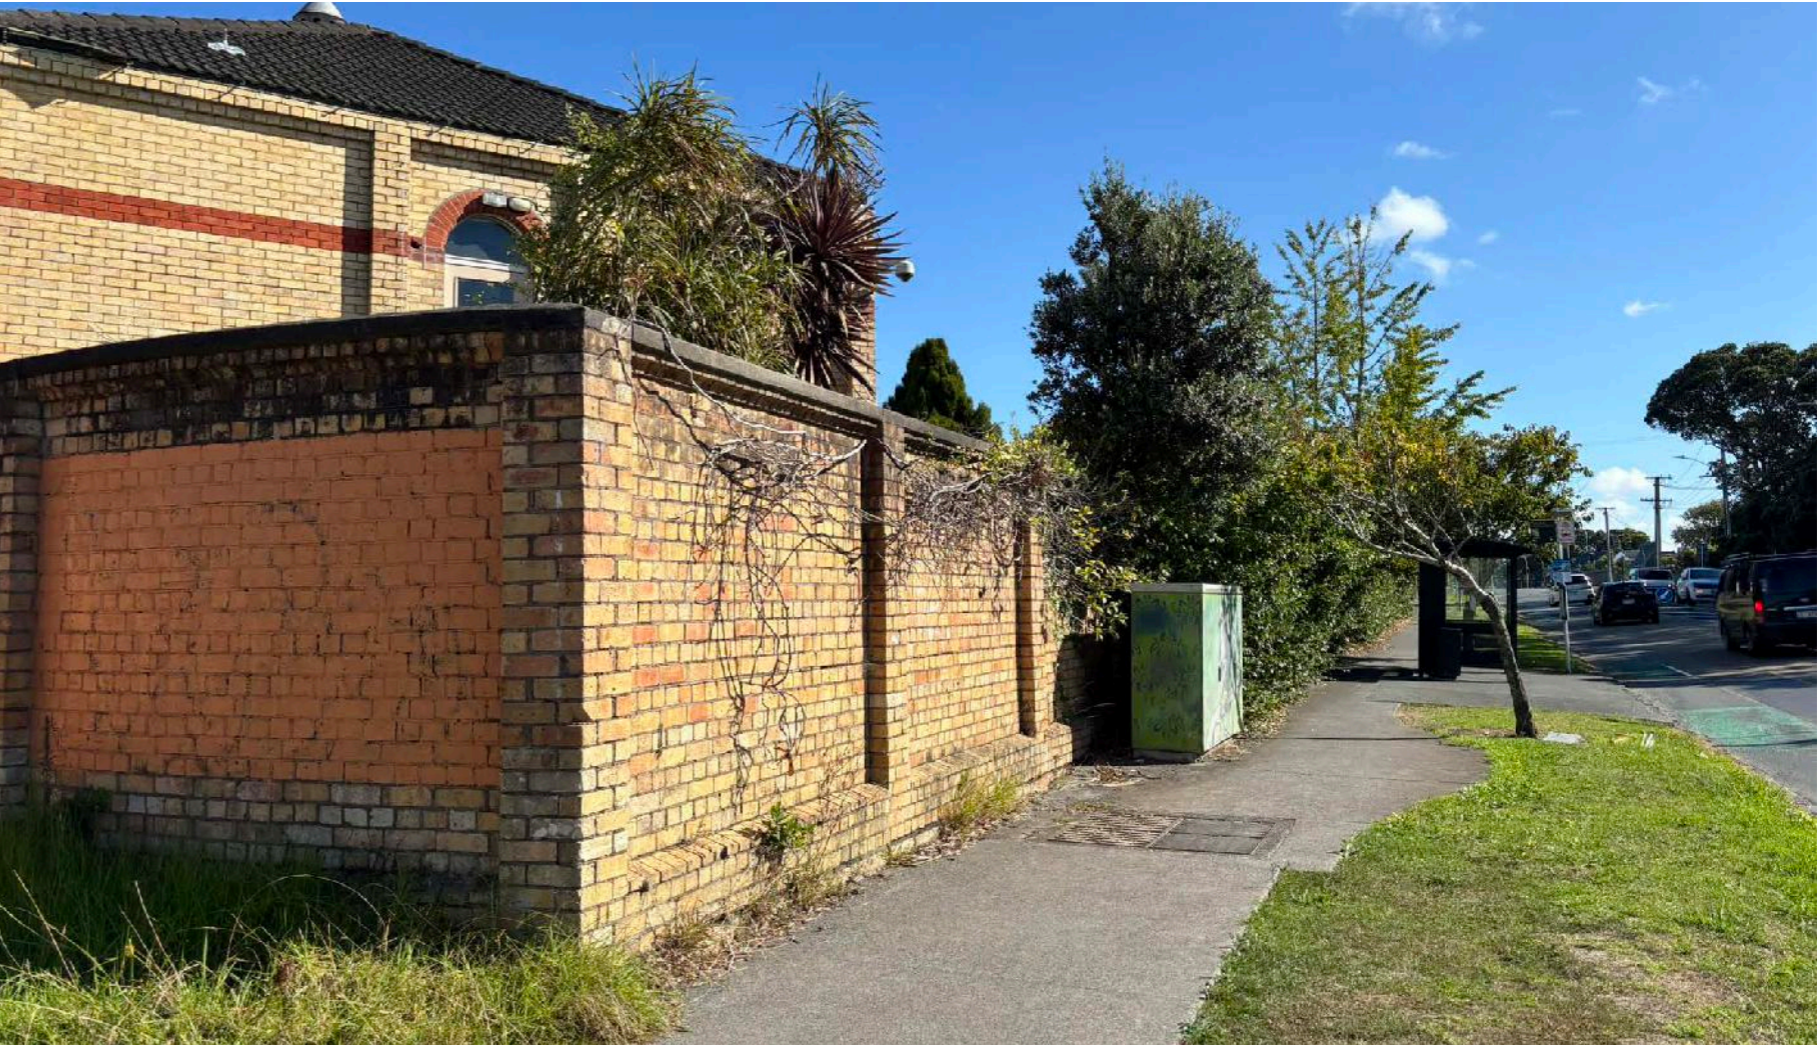
BRICK WALL CONDITION 2024, SHOWING RECTANGULAR INSET PANELS, PILASTERS
RENDERED CAPPING AND VARIABLE HEIGHT WALL BASE

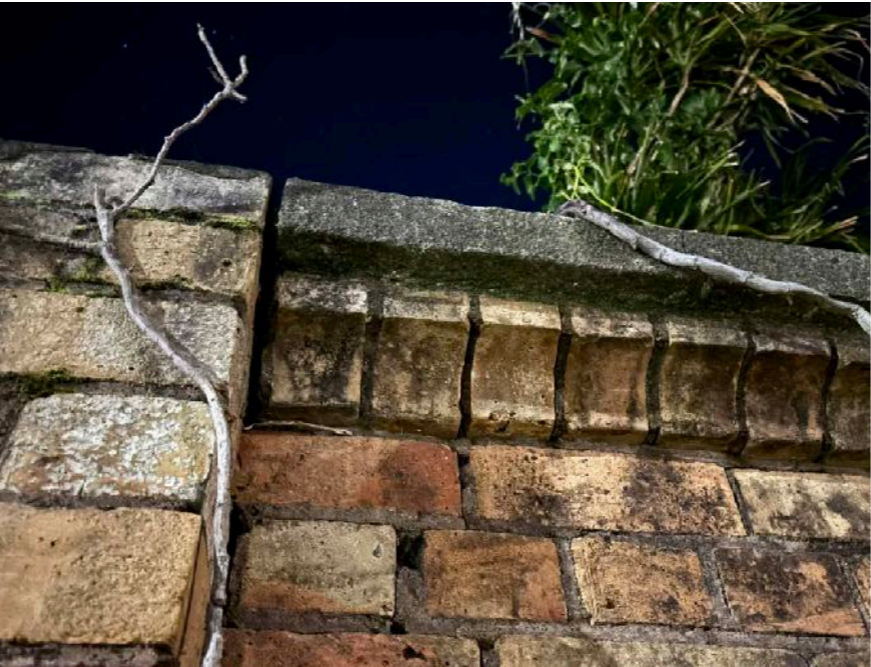
BRICK COVING COURSE AT TOP OF WALL PANELS

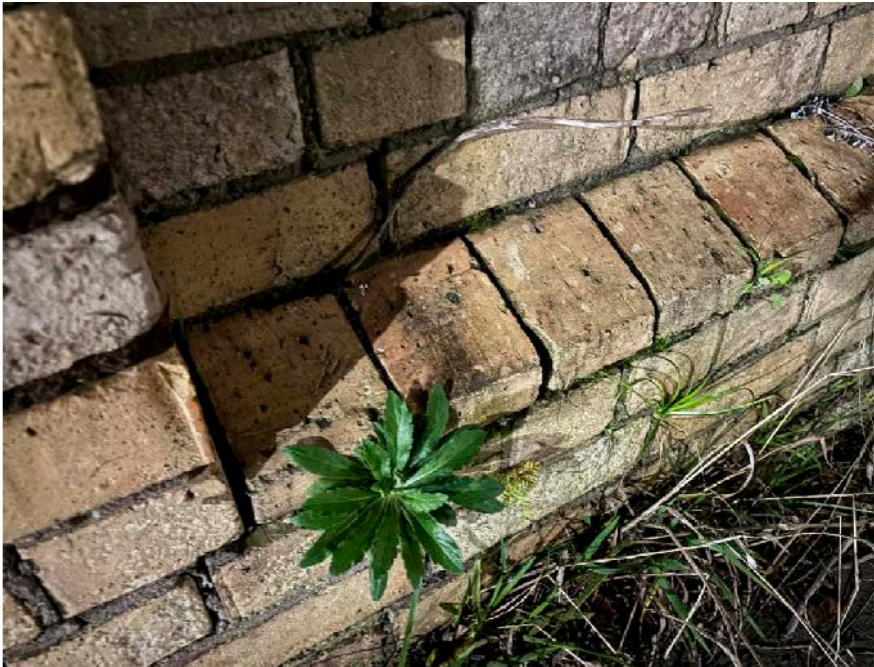
ANGLED BRICK STRING COURSE AT BASE OF WALL PANELS

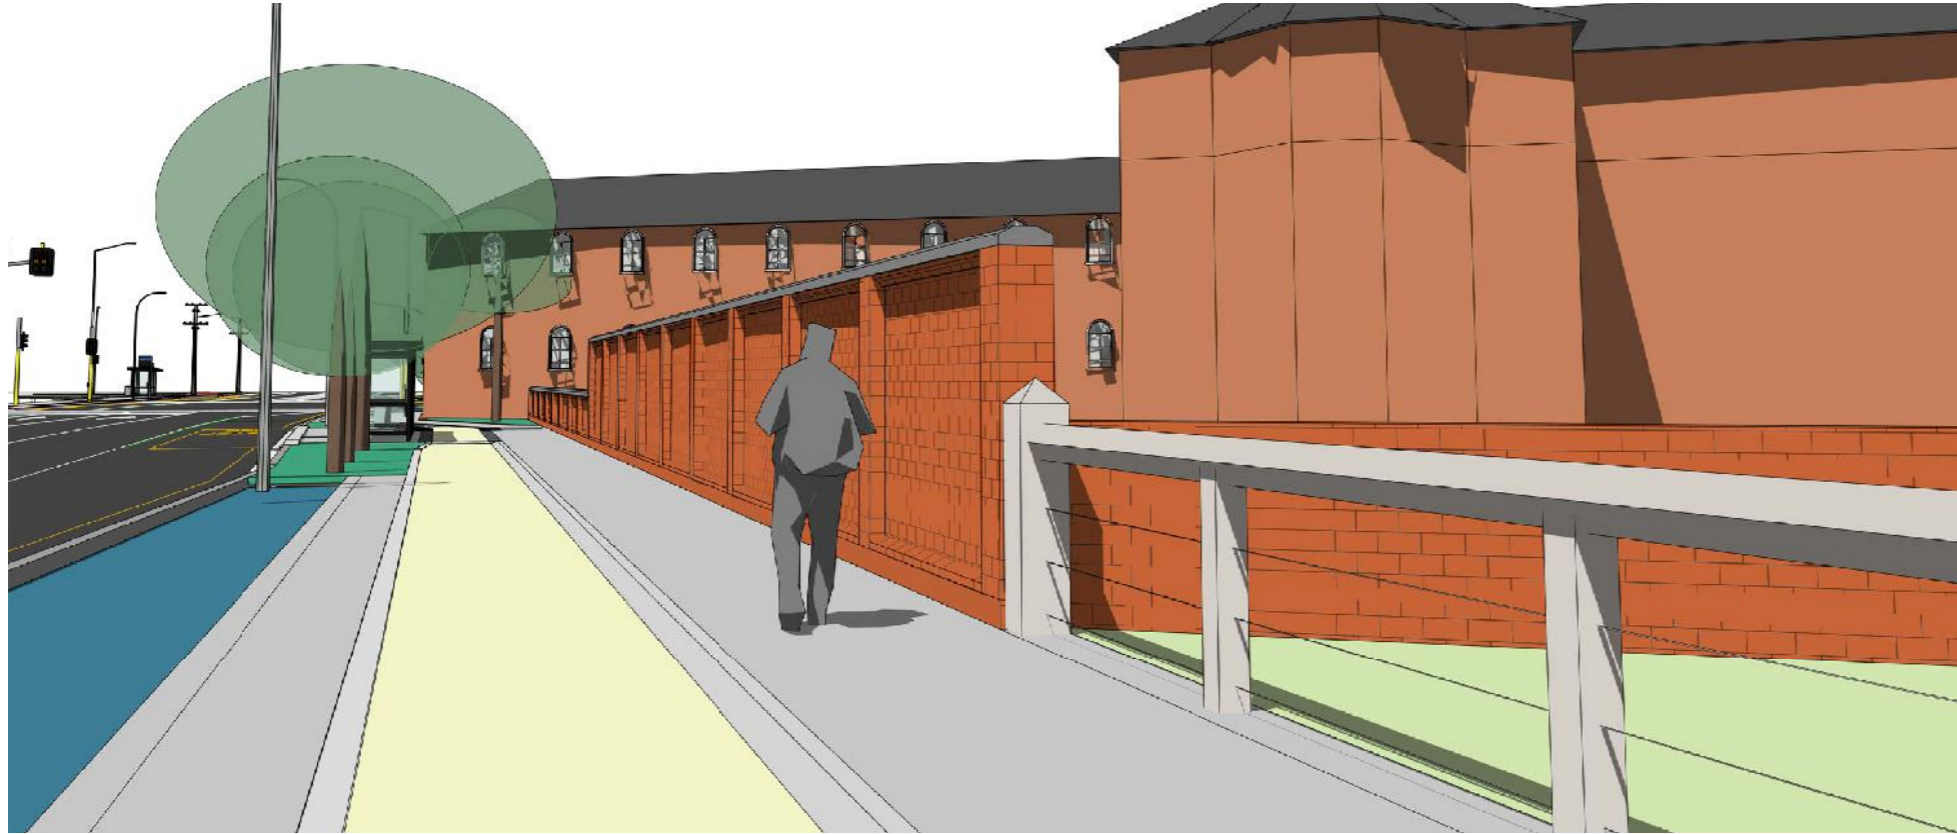
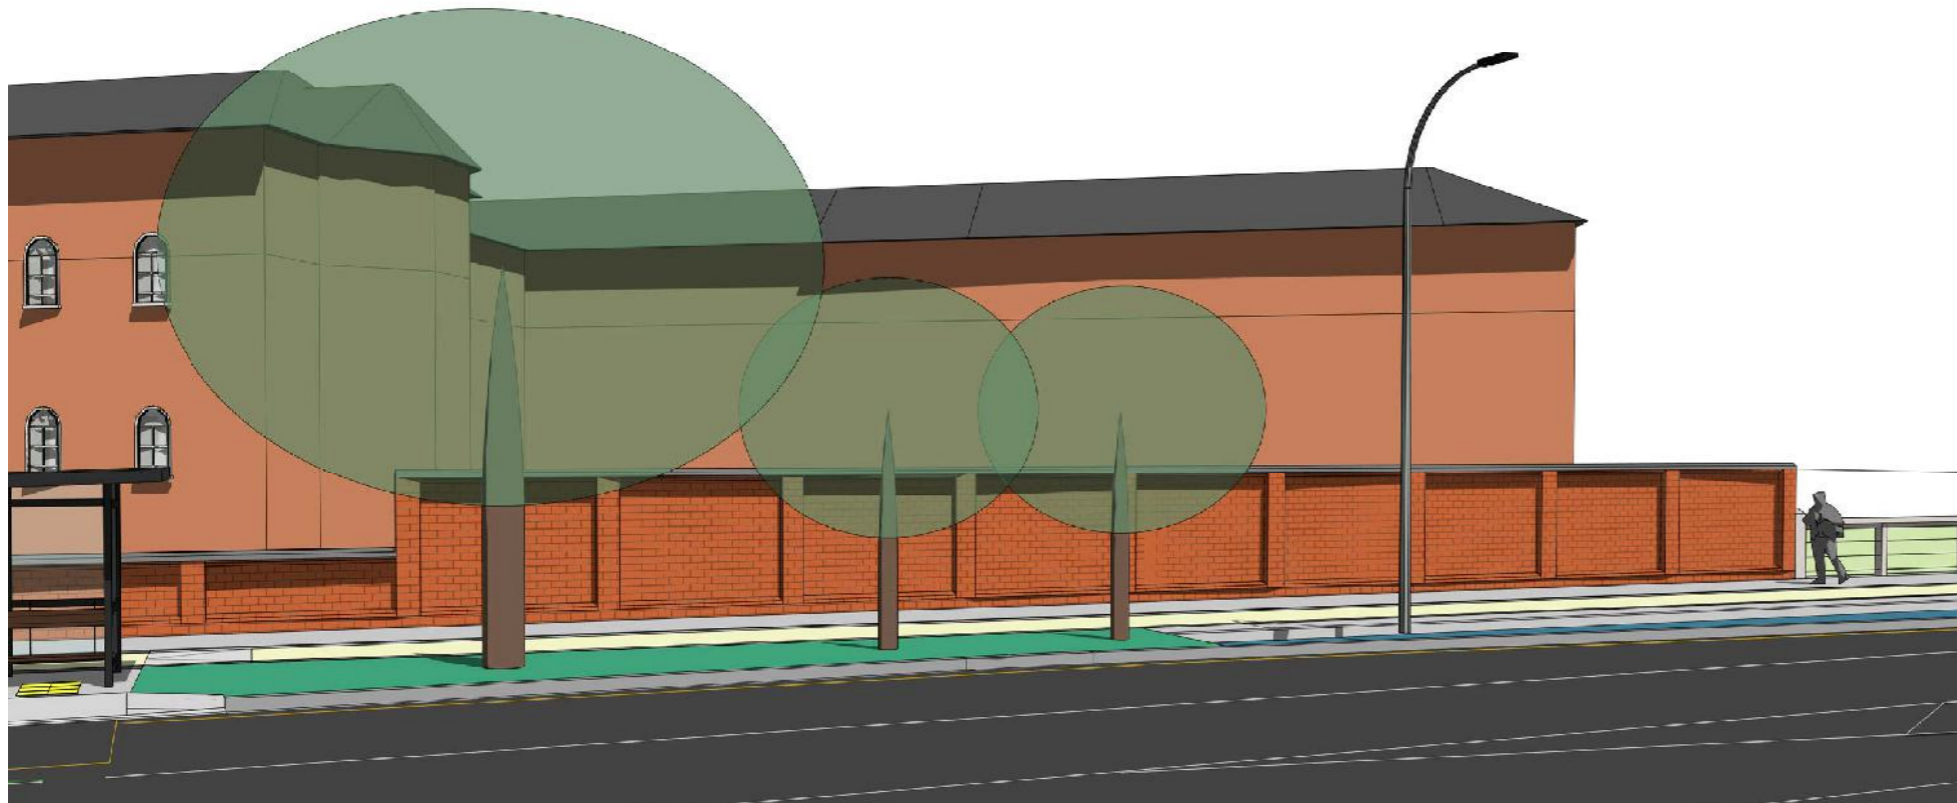
HERITAGE BOUNDARY WALL REPLICA - HNZ OPTION

Brick reclaimed from heritage wall is reused for a lower 1250mm height wall (1250mm) and a taller 2440mm high wall as per Heritage New Zealand - Pouhere Taonga recommendation

- The existing wall return within private land is constructed at a lower height of approximately 1250mm, with additional height added via metal railings. The taller wall section requested by HNZ will not be tying into an equal height wall, making for an unusual transition

- Occupies up to 350mm of valuable space in the road reserve above ground which must be taken from the berm, cycleway or footpath widths
- Footings occupy 2000mm of space below ground in cross section, limiting space for underground services within the constrained road corridor

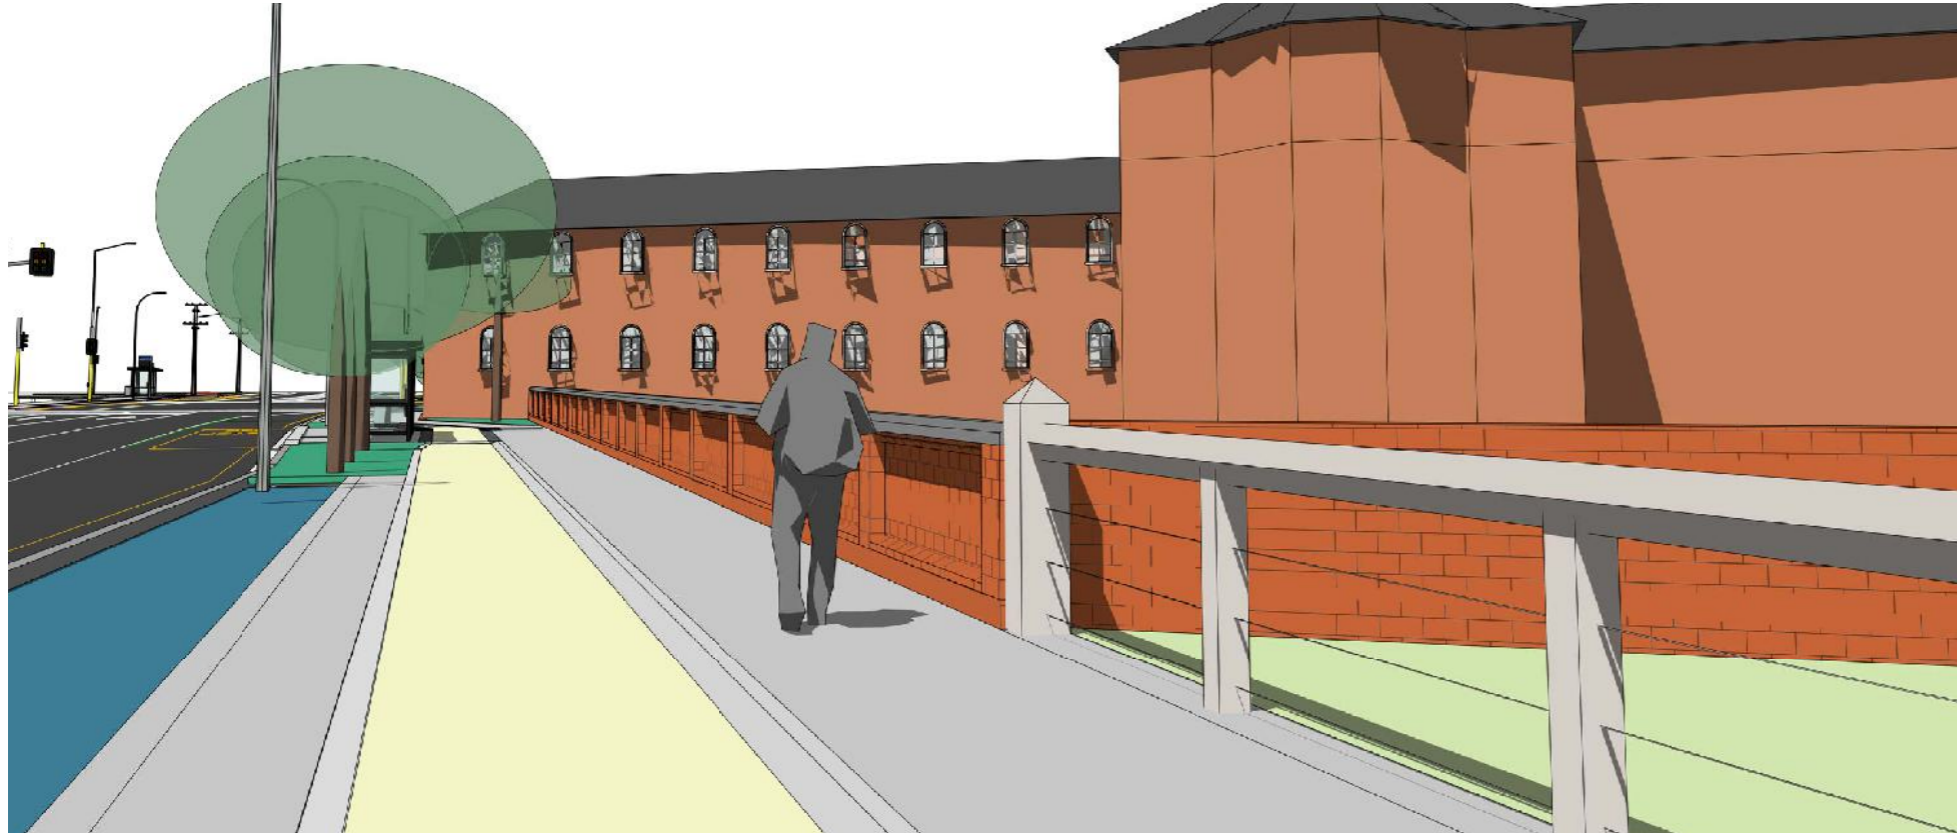
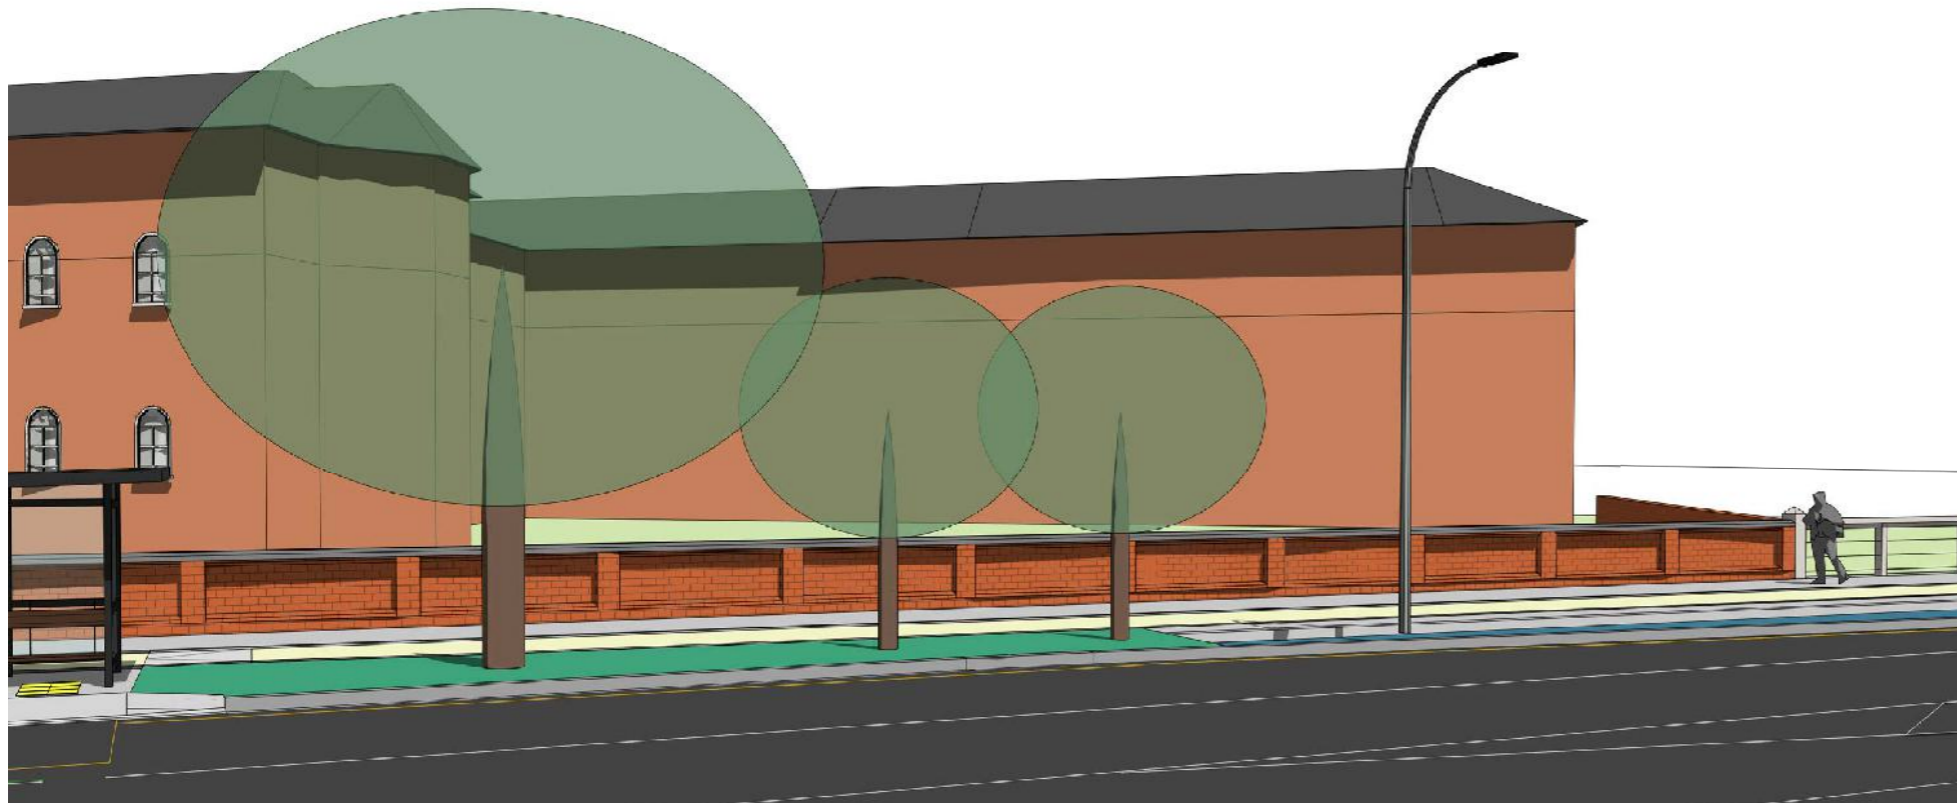
HERITAGE BOUNDARY WALL REPLICA - PREFERRED OPTION (BASED ON KNOWN SPATIAL CONSTRAINTS)

Brick reclaimed from heritage wall is reused for a lower height wall (1250mm) to tie into the existing wall return in private land.

- Direct and understandable interpretation of lost heritage wall feature via recreation of key wall design elements, but at lower height
- Provides edge treatment to courtyard space
- Permits use of brick in a way that replicates the original use and purpose
- Lower height preserves views to the heritage building, and provides a better pedestrian user experience
- More feasible due to smaller footings and reduced footprint in road corridor, reducing impact on underground service pipe and duct alignments.
- Interpretative signage can be incorporated into top of wall

- Occupies up to 350mm of valuable space in the road reserve above ground which must be taken from the berm, cycleway or footpath widths
- Footings occupy approximately 1000mm of space below ground in cross section, limiting space for underground services within the constrained road corridor
- Construction dependant on sufficient brick being salvaged from wall, and a skilled contractor
- Graffiti protection coatings will be required

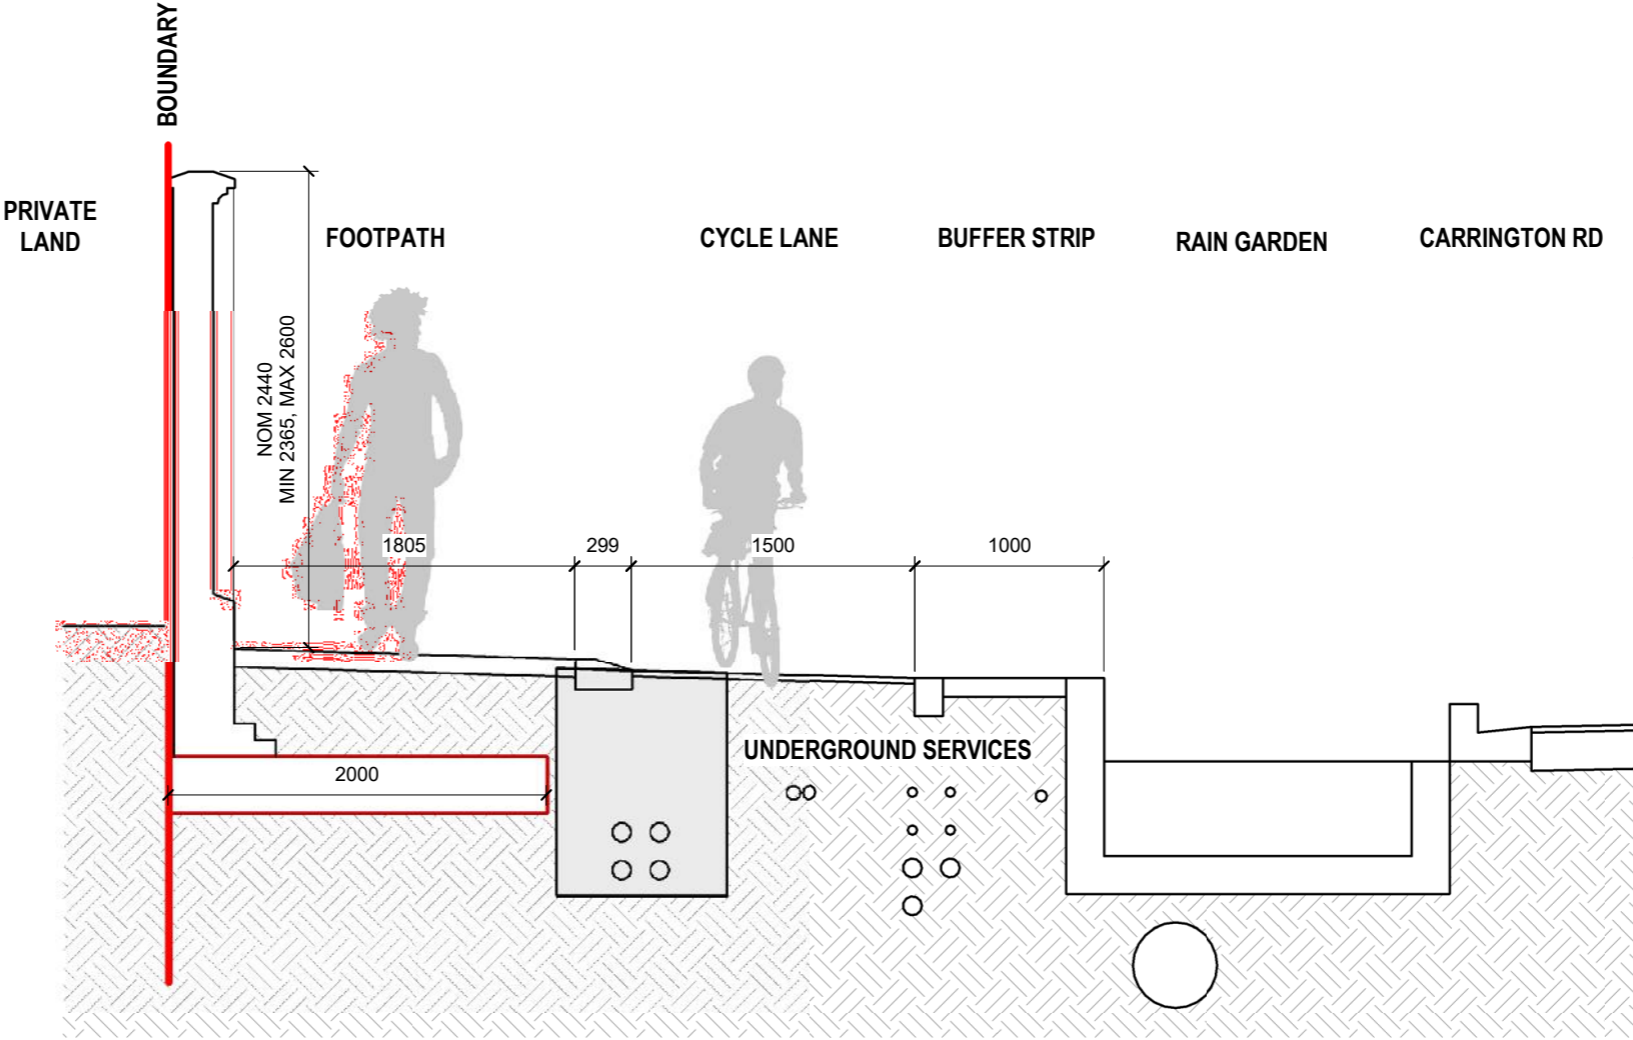
SECTION - HNZ BRICK WALL IN CONTEXT - 1:40

- Pilaster Footing width compromises space available for 450mm diameter trunk water main, gas main, power cables and comms ducts
- Water main would need to be placed under rain garden structure, which is non-compliant with Watercare requirements
- Comms ducts and chambers would clash with separator strip between footpath and cycle lane, compromising safety for vision impaired pedestrians

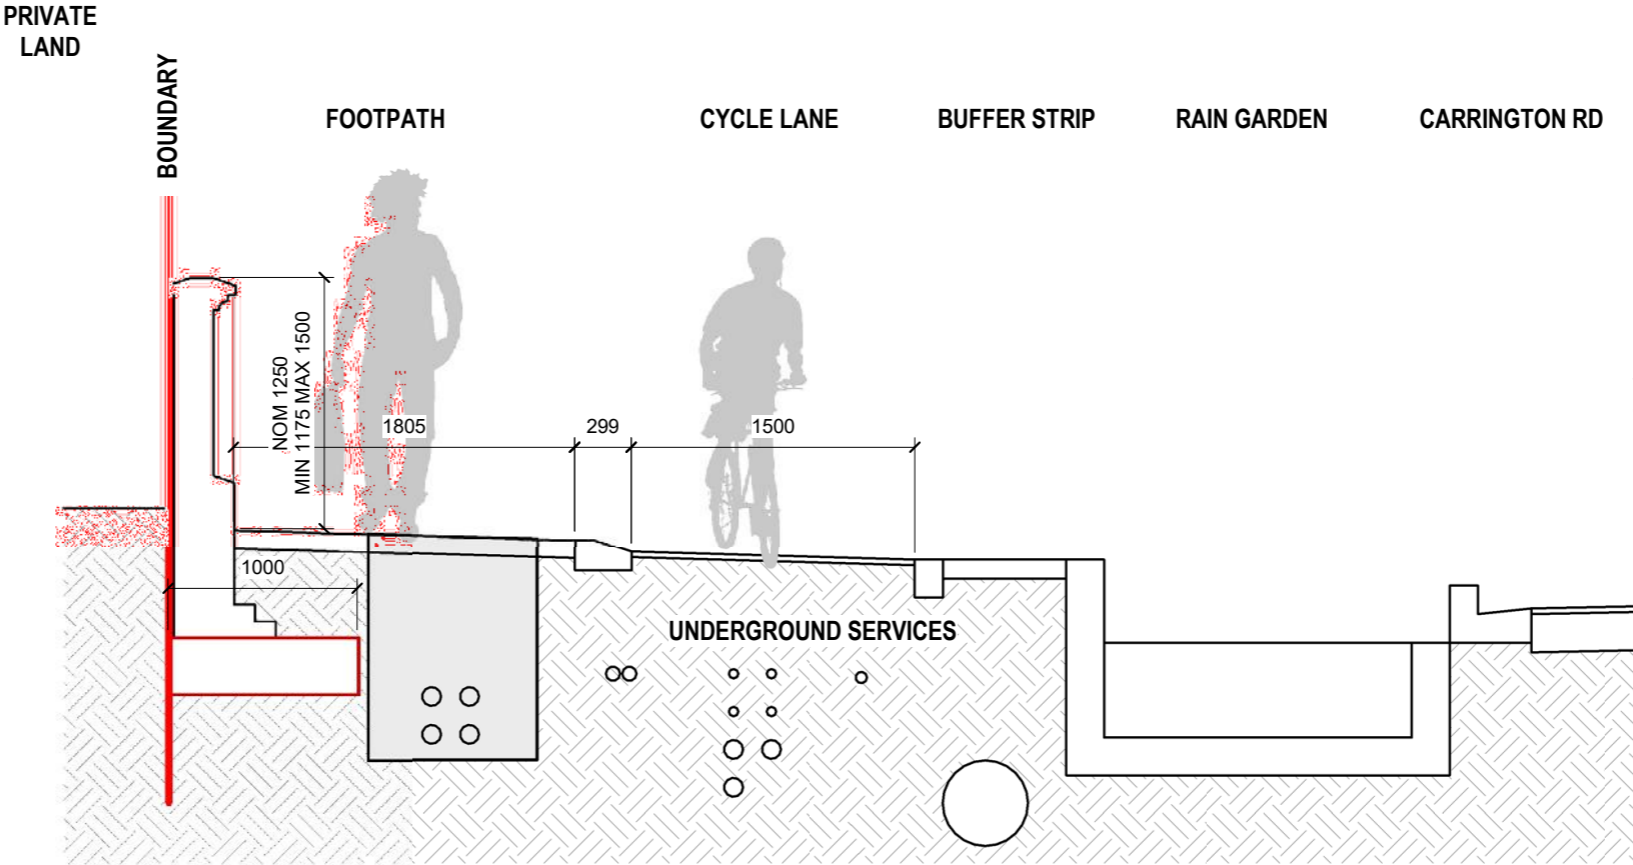
SECTION - LOWER BRICK WALL IN CONTEXT - 1:40

- Preferred option due to ability to integrate services in compliant and safe manner
- Comms chambers sit fully within footpath, reducing risks of a clash with the separator, or a requirement for a custom footing design for the wall
- Water main can remain outside of the rain garden footprint, making long term servicing and maintenance viable, and reducing risk of damage during rain garden renewal

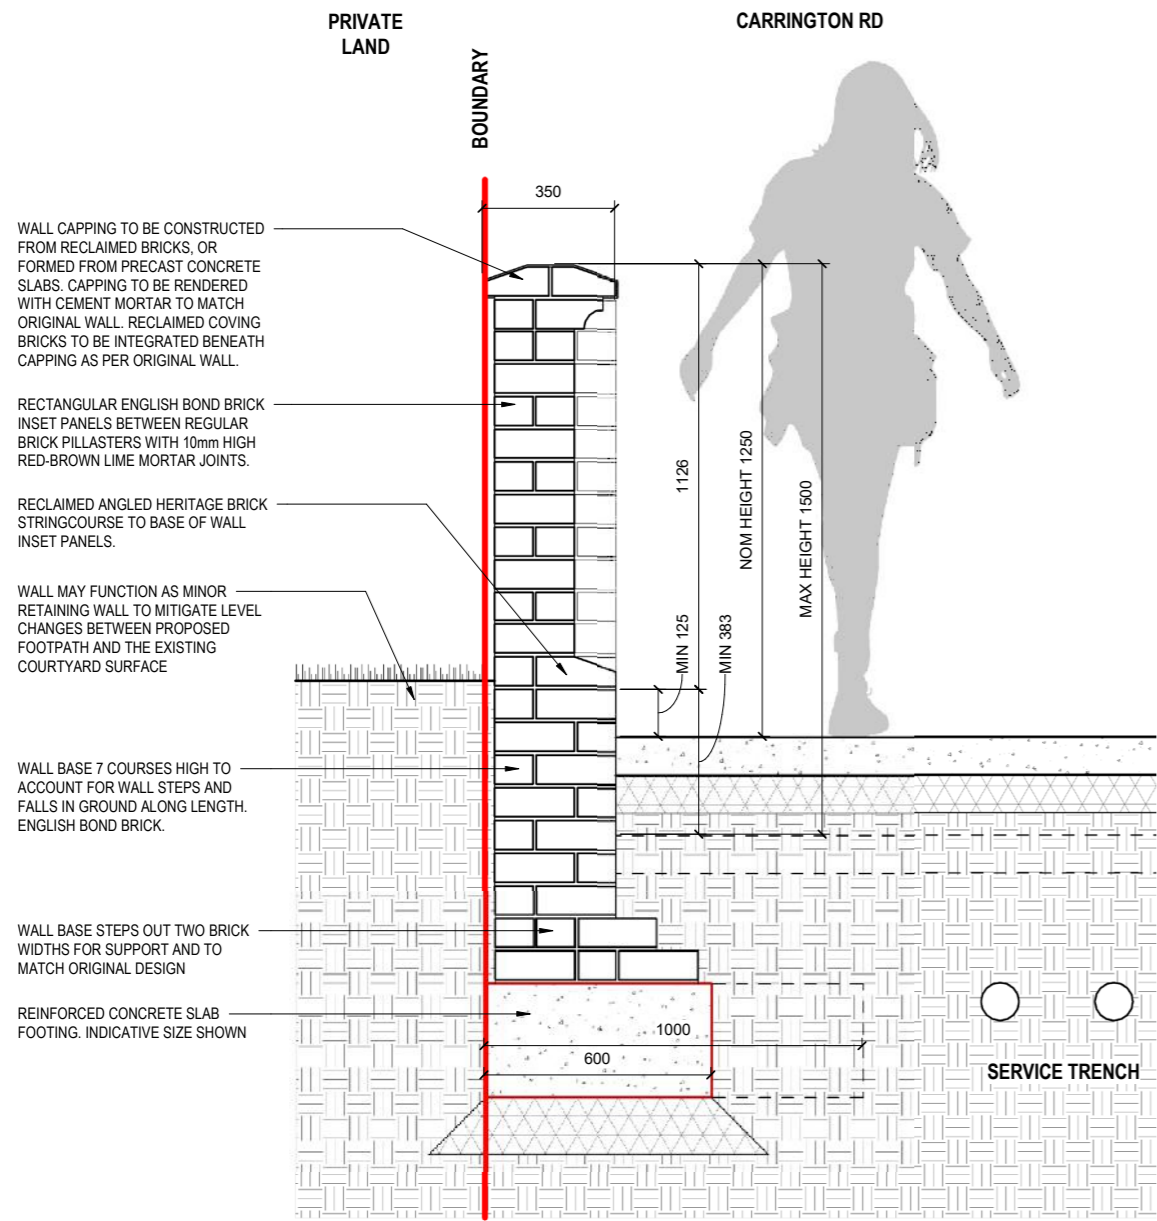
TYPICAL SECTION 1:20

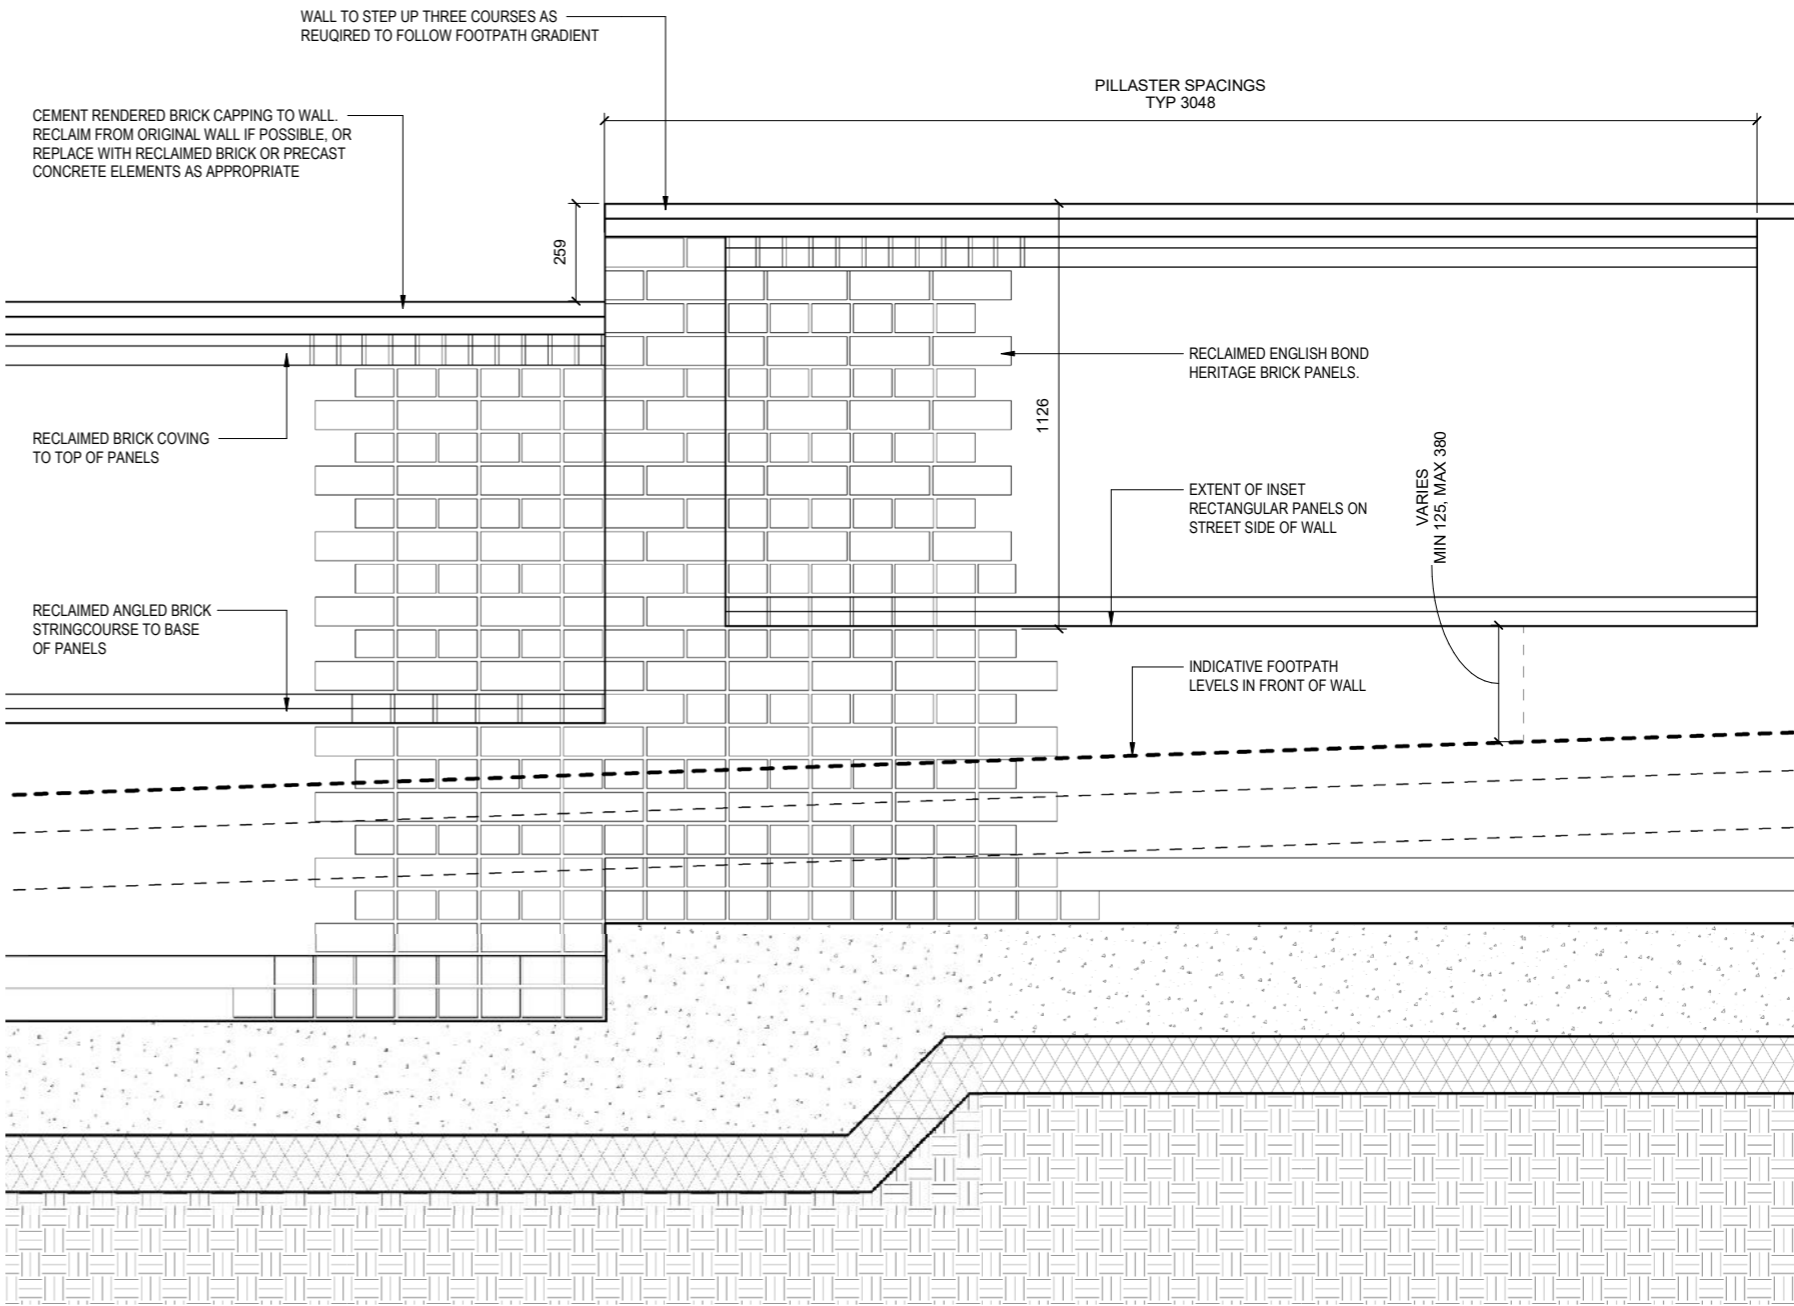
TYPICAL ELEVATION 1:20

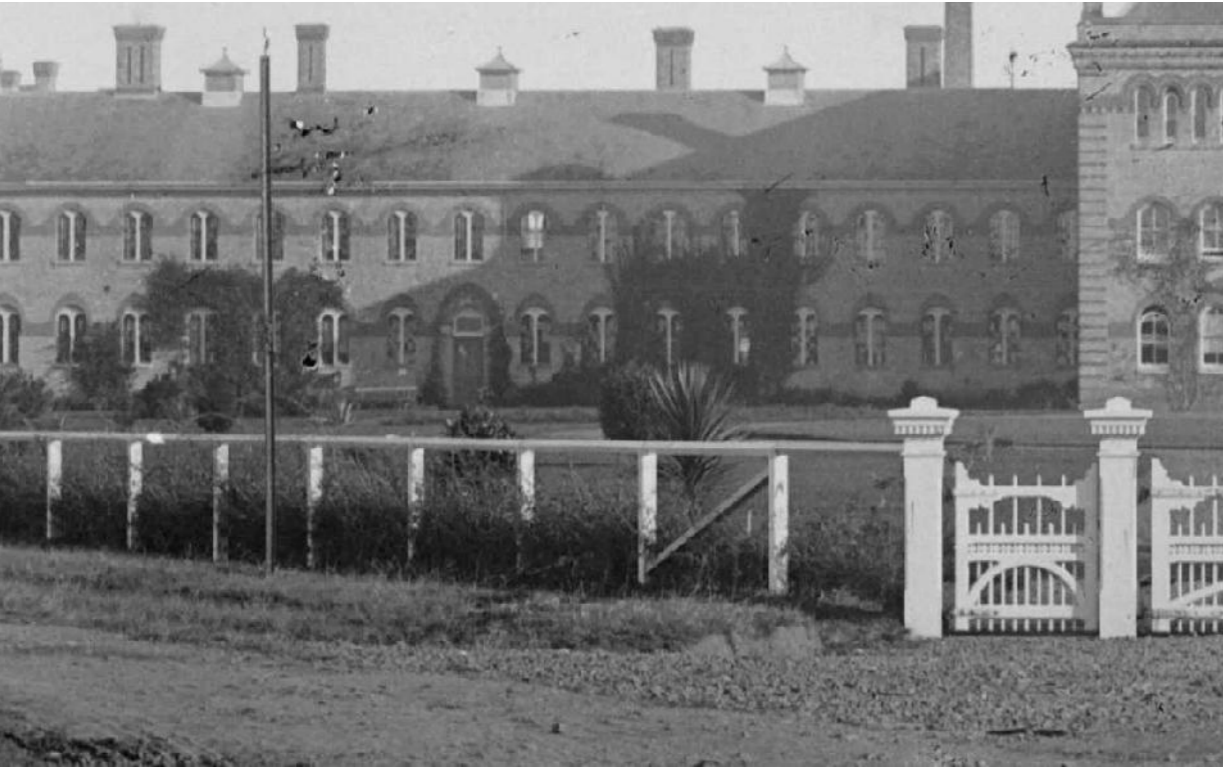
DETAIL VIEW OF BOUNDARY FENCE, SHOWING TIMBER POSTS, RAILS, WIRES AND HEDGING

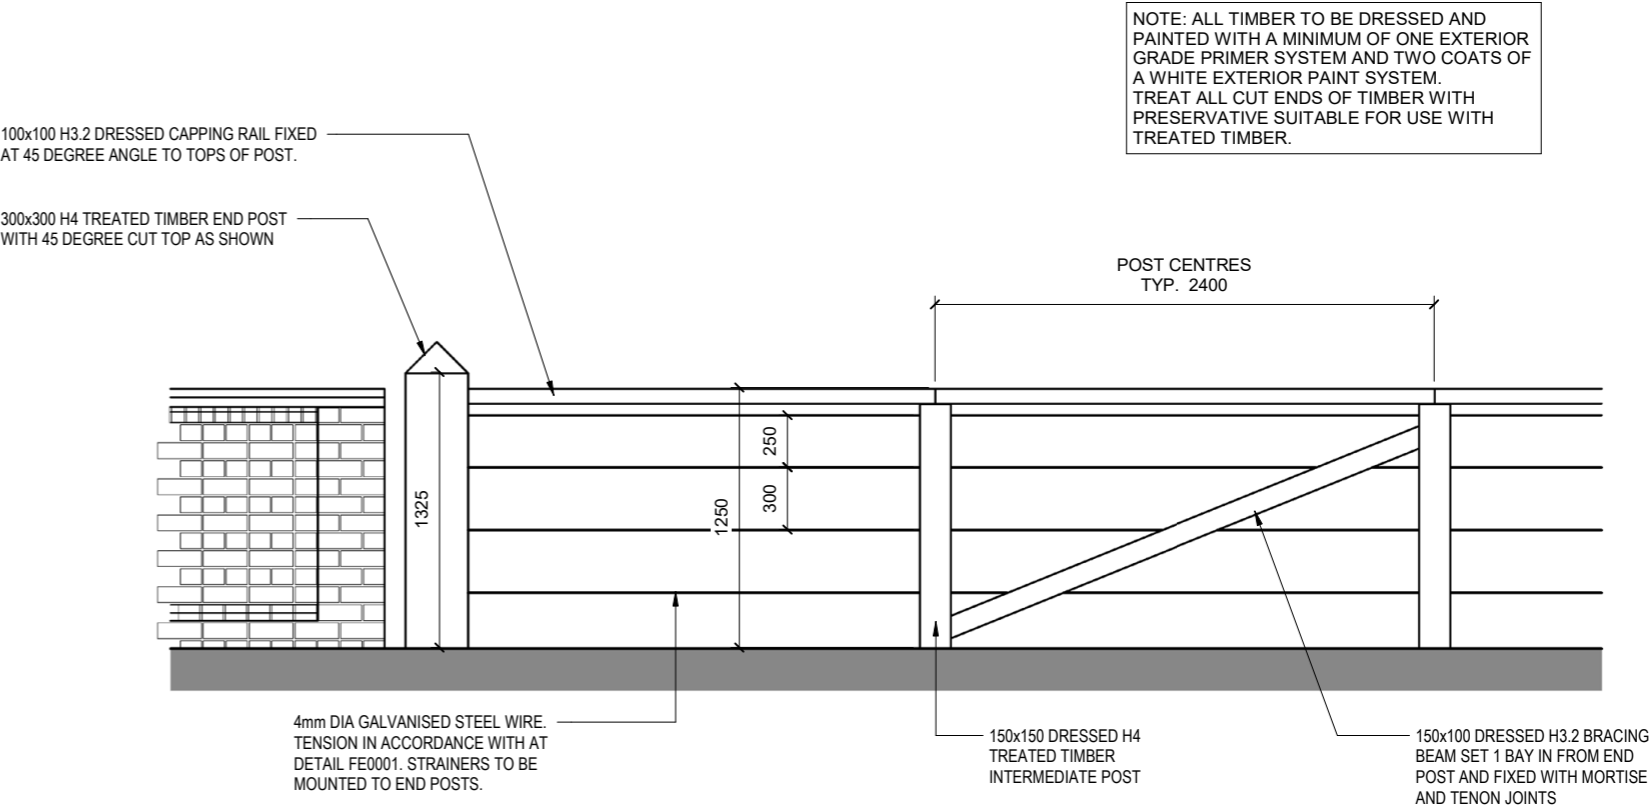
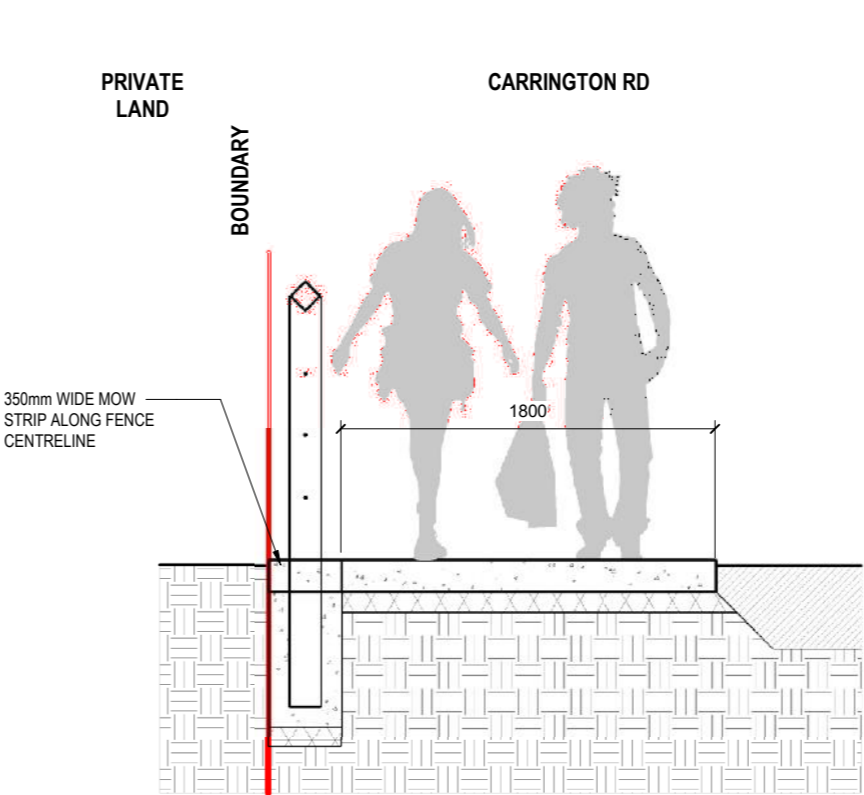
PROPOSED REPLICA FENCE

- Height estimated from photos and heritage designs & set to match heritage wall reconstruction
- Height strikes a balance between security and visibility
- Solid timber end posts anchor fence and permit the fitting of gates if required in future
- Braces utilised to support wire tensioning
- Wires discourage access under the fence and additional wires may be added for higher security design
- Top rail design resists sagging and discourages jumping the fence
- Fence located in road reserve to ensure AT ownership
- AT has primary responsibility for maintenance & control of appearance
- Footpath alignment adjusted as required to accommodate fence
