CARRINGTON ROAD IMPROVEMENTS PROJECT

HERITAGE INTERPRETATION AND MITIGATION

RESOURCE CONSENT INFORMATION PACK
JULY 2025

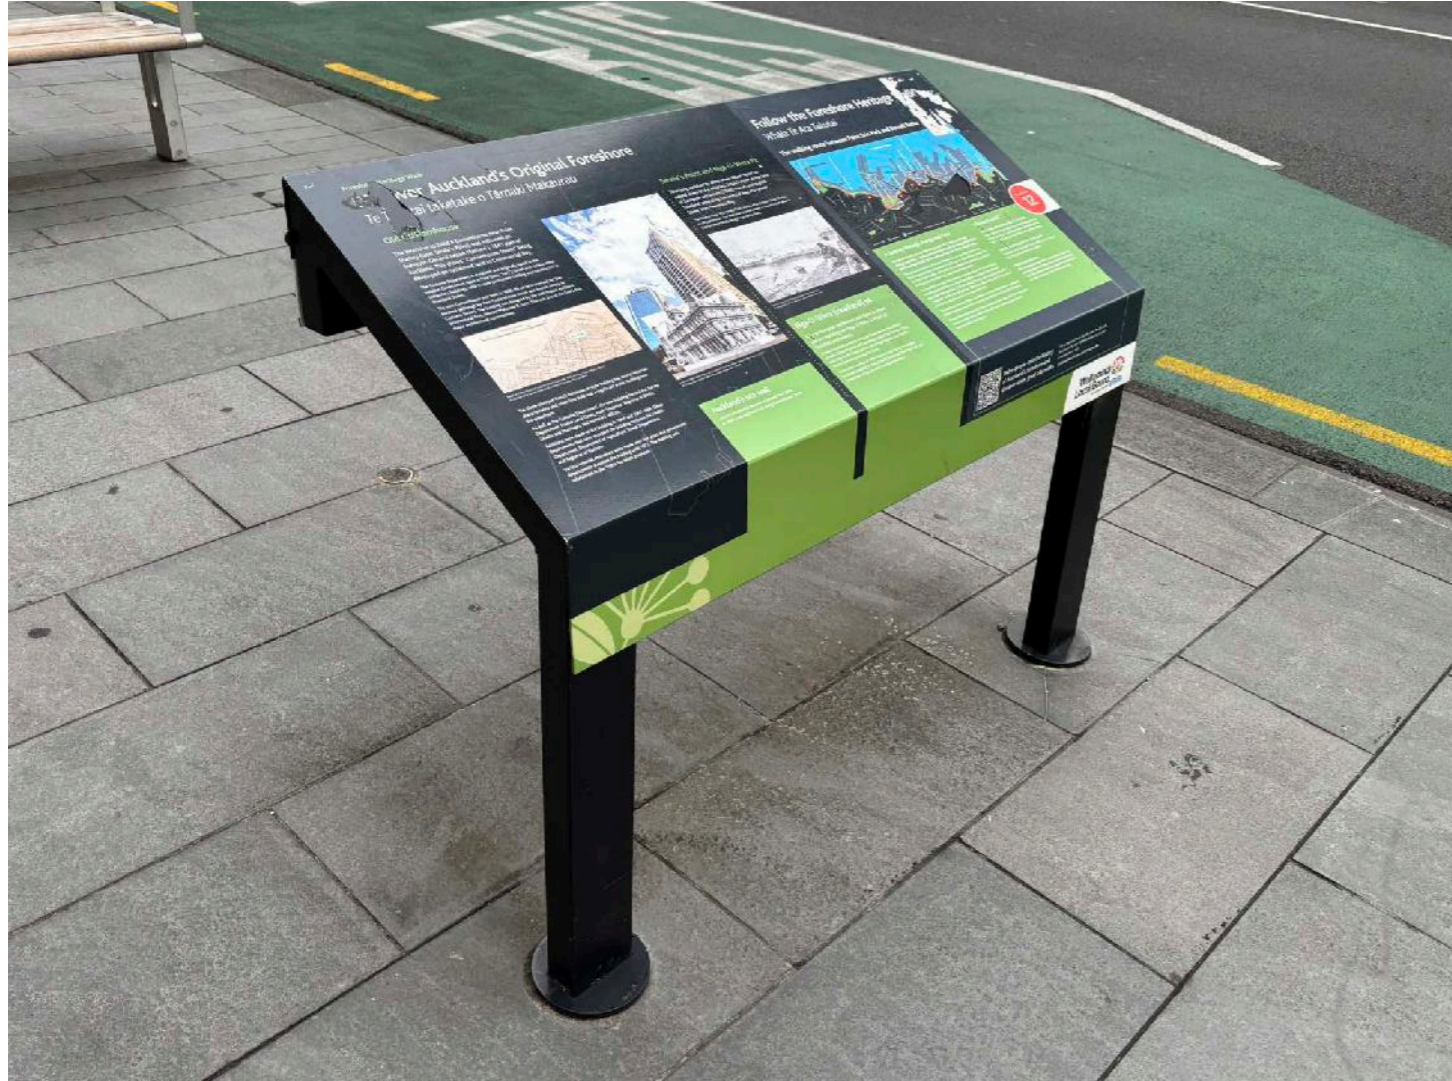
HERITAGE INTERPRETATION PANELS

A heritage panel may be designed in collaboration with Auckland Council and Heritage New Zealand - Pouhere Taonga to tell the story of the Oakley Hospital Building, and its subsequent life as a Unitec campus. This could be a small plaque or a larger interpretation sign fixed to the top or side of the wall near to the bus stop to maximise visibility.

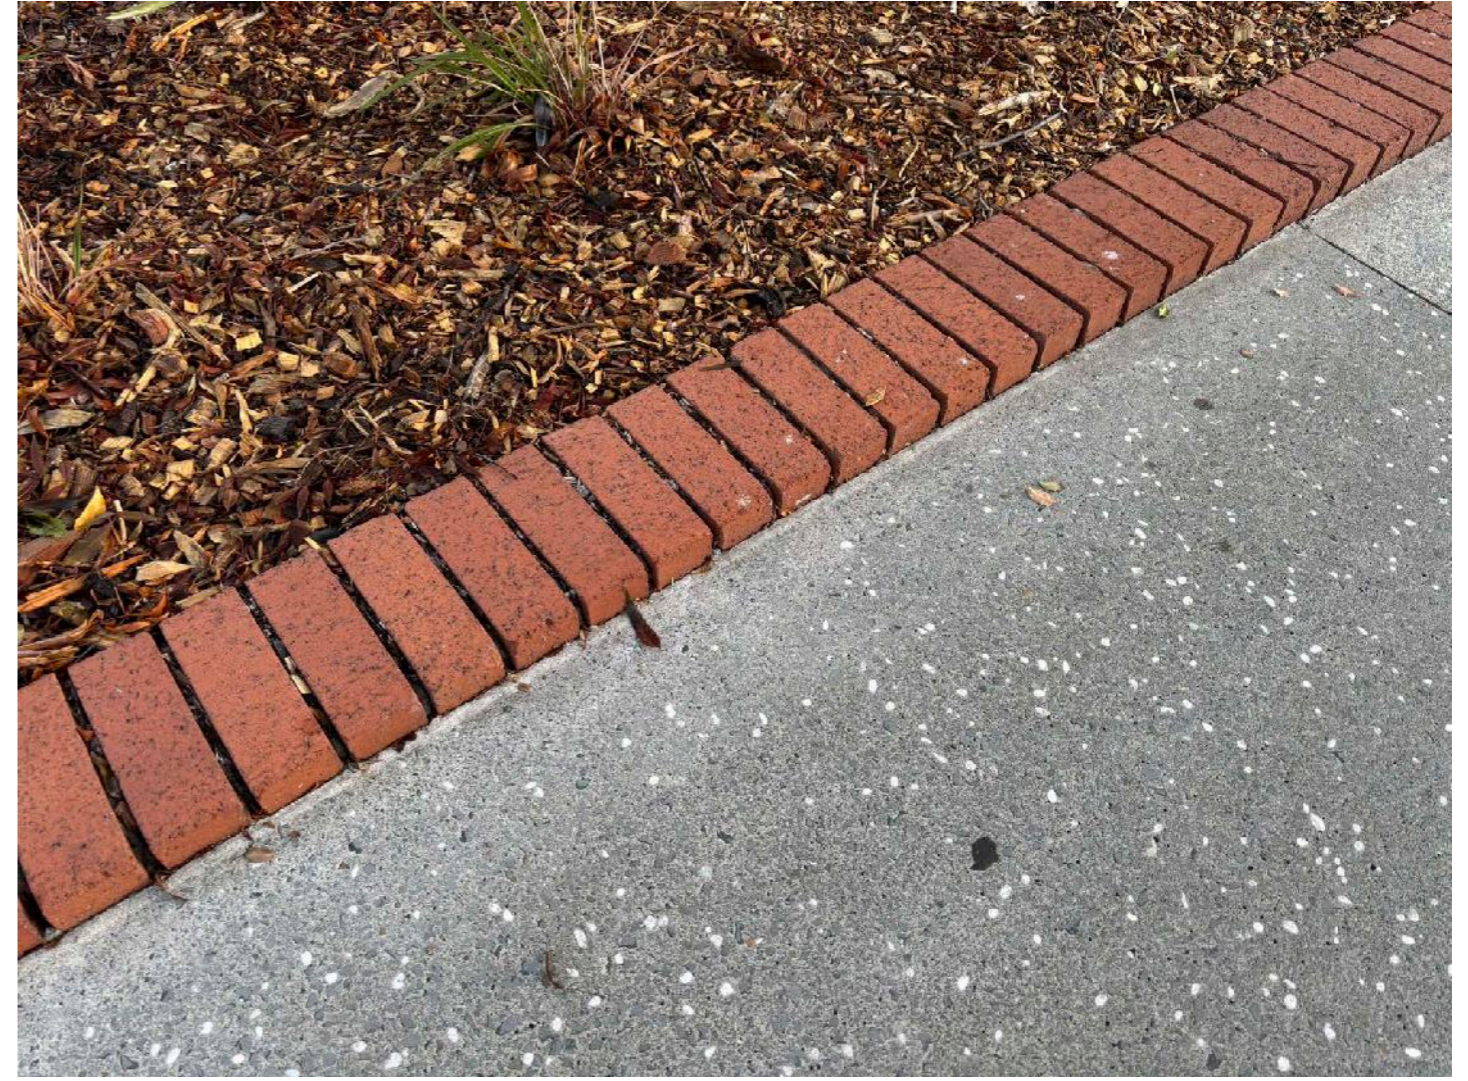
BRICK EDGING / MINOR WALLS

Bricks may be reused to form brick edging to garden beds to retain mulch / soil. This example is found in the New Lynn Town Centre
