# SH16 Safety Improvements Stage 2 - Preliminary Site Investigation (Contaminated Land)

Prepared for Waka Kotahi NZ Transport Agency - Auckland Prepared by Beca Limited

25 October 2022

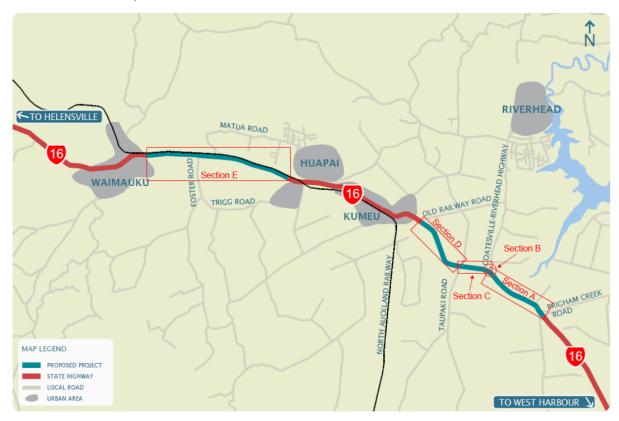
Figure 1: The SH16 Brigham Creek to Waimauku Project area.

The corridor is divided into two stages comprising five sections, as highlighted in Figure 1 below:

- Section A: Brigham Creek roundabout through to Coatesville-Riverhead Highway intersection;
- Section B: Coatesville-Riverhead Highway intersection;
- **Section C**: Coatesville-Riverhead Highway intersection through to Taupaki Road / Old North Rd intersection;
- **Section D**: Taupaki Road / Old North Road intersection through to the posted speed limit change (80km/h and 60km/h) east of Old Railway Road intersection, Kumeū; and

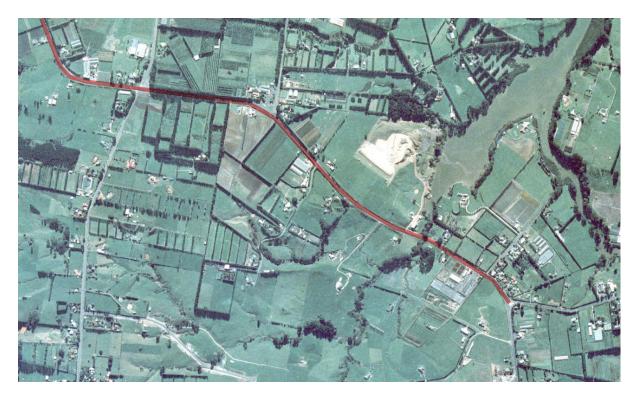
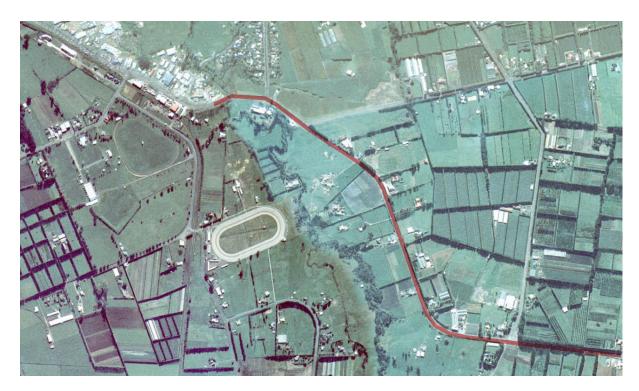
1999 – Auckland Council GIS Viewer

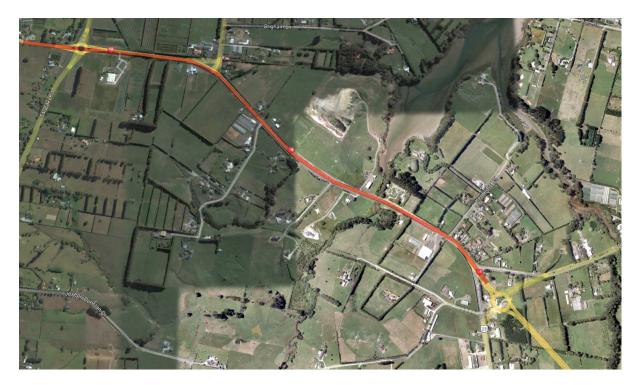
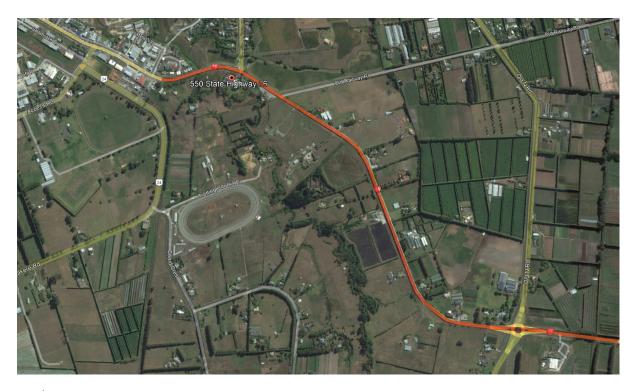
April 2010

2010-2011	<ul> <li>Development on the Brigham Creek roundabout has commenced and appears to be almost, if not complete.</li> <li>The location where the soil disturbance was occurring in 1999 appears to be subject to landfilling activities. Several trucks are present, alongside industrial moving equipment.</li> </ul>

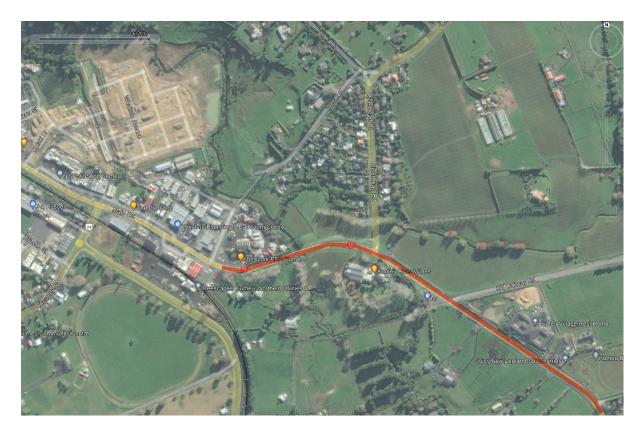
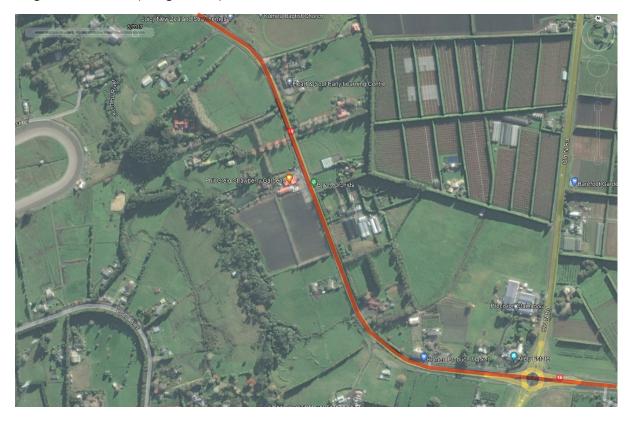
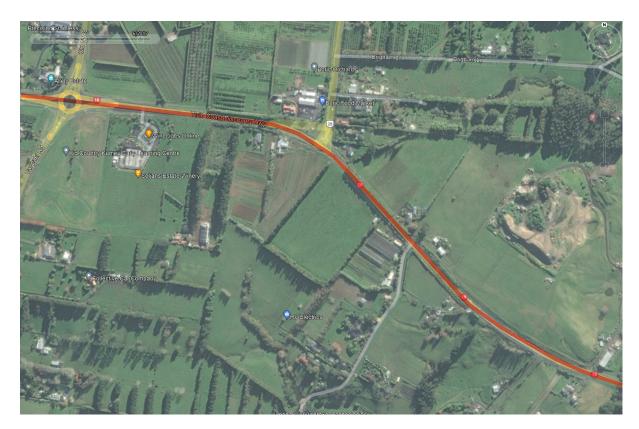
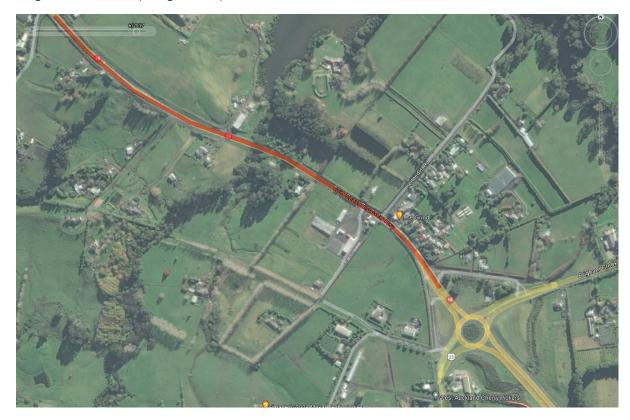
Stage 2 – June 2017 (Google Earth)

2017	<ul> <li>Development on the Brigham Creek roundabout has been completed.</li> <li>No further changes of significance are noted within the project area.</li> </ul>
2020 (Stage 2 reviewed only)	No further changes of significance are noted within the project area. All existing land uses appear the same as previously observed.
2022 (Stage 2 reviewed only	No further changes of significance are noted within the project area. All existing land uses appear the same as previously observed.

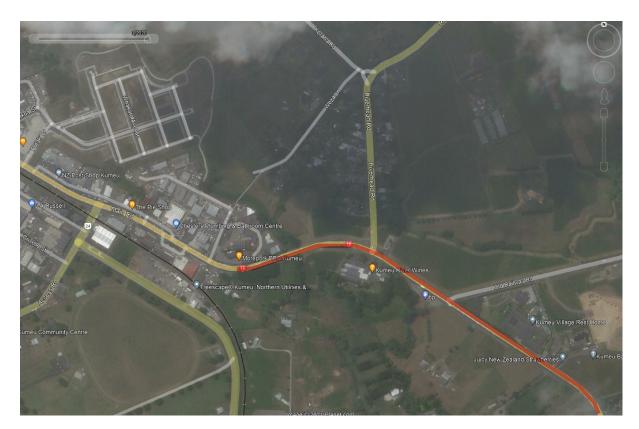
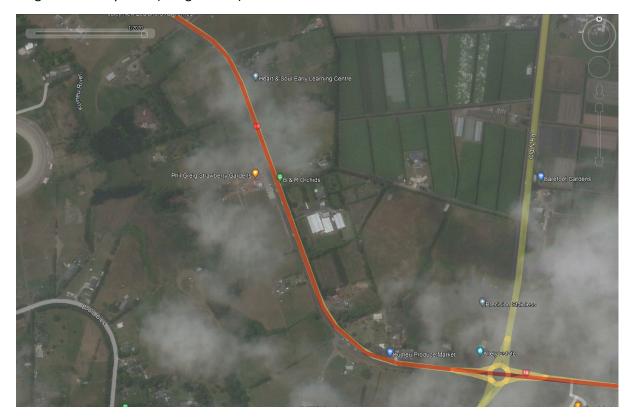
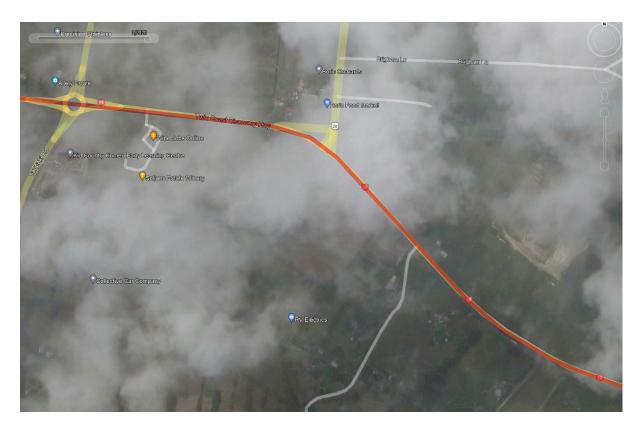
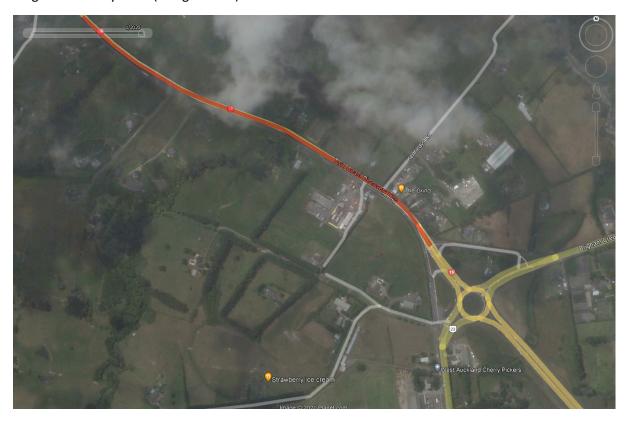
Stage 2 – January 2020 (Google Earth)
