# **SH16 IMPROVEMENTS, STAGE 2 BRIGHAM CREEK TO KUMEŪ: ARCHAEOLOGICAL ASSESSMENT**

Prepared for Beca Ltd

September 2022 (Updated from February 2022)

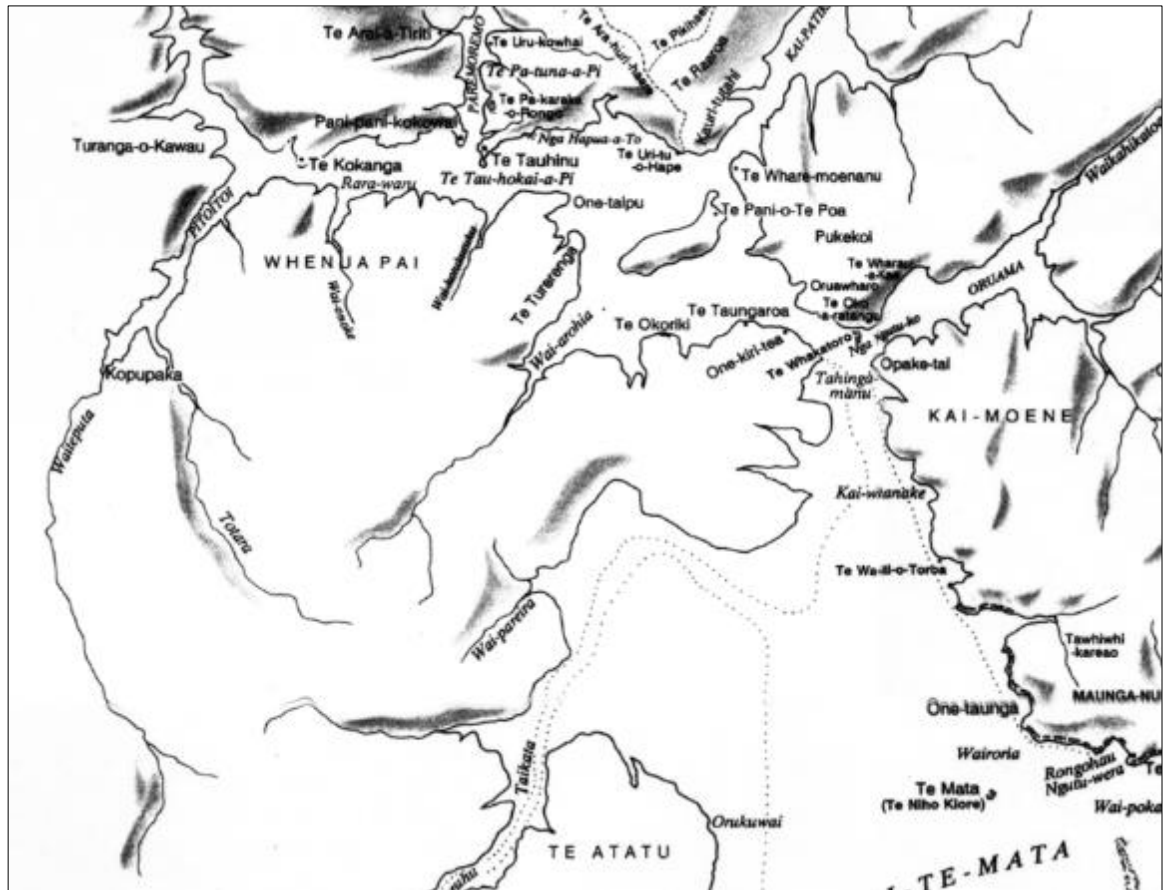
**Figure 3. Map showing Māori place names in the Brigham Creek/Whenuapai area (Kelly and Surridge 1990)**

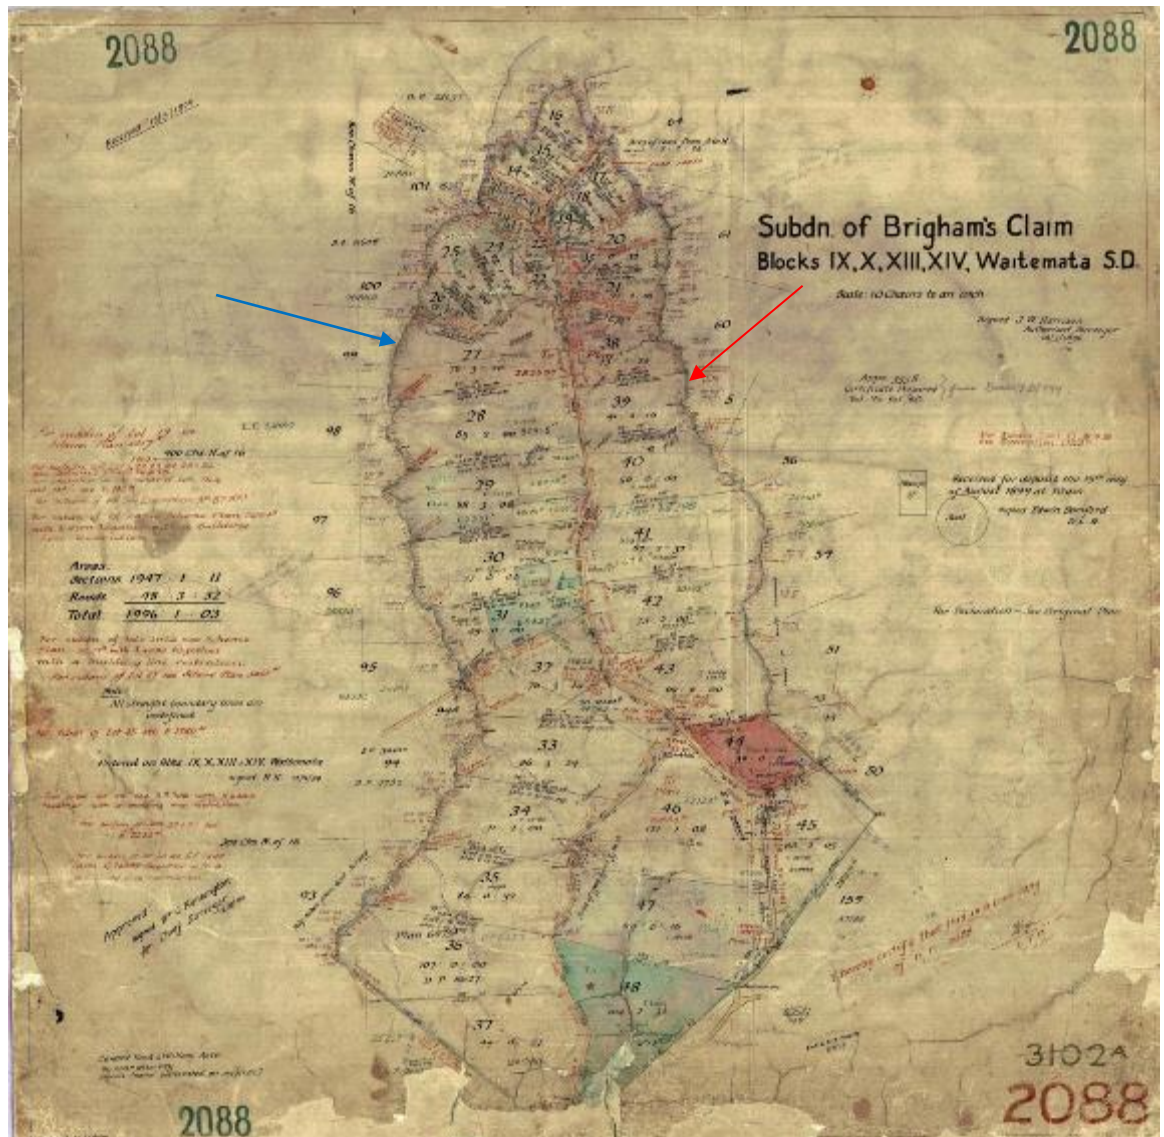
Figure 5. Subdivision of Brigham's Claim Blocks IX, X, XIII, XIV, Waitemata SD (DP 2088) dated 1896. The red arrow identifies Totara Creek which runs beneath Brigham Creek Road, and the blue arrow the Ngongetepara Stream which runs south from the western branch of Brigham Creek

A couple of advertisements for the sale of Brigham's Claim in the late 19th century (Figure 5) give some idea of the type of the land available. One dating to 1893 states:

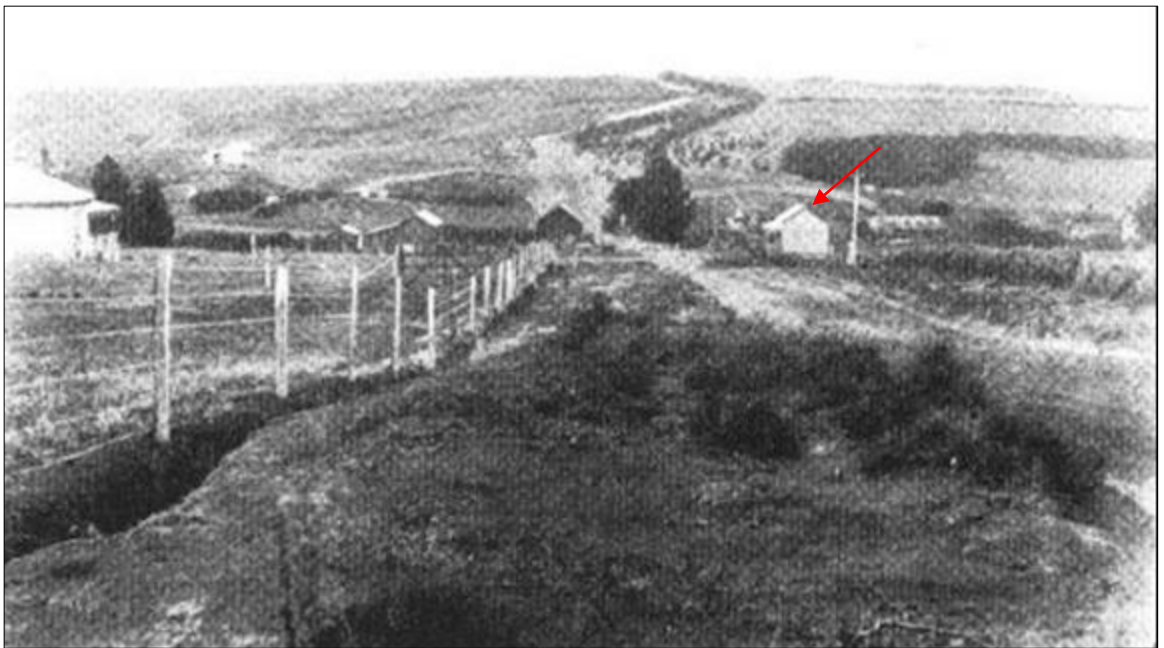
**Figure 7. Looking northwest from eastern side of creek c.1902, showing Alex Sinton's house (222a SH16, left), John Sinton's original house (left background), the Store (arrowed) and beyond it the original house and picket fence on the western side of the creek (from Madden 1966: 122)**

Janet, her son Alex, and his new wife Ellen were all living in a small house at the creek in the early 1890s (Figure 6 and Figure 7). Things became somewhat cramped after the arrival of Alex and Ellen's three eldest children. Alex remedied the housing situation by erecting two houses opposite each other on Great North Road (now Highway 16) in the late 19th century. Janet lived in one of these two bay villas (at 191 SH16) while Alex, Ellen and their children occupied the other (Morris 1995: 23).

A photograph dated c.1902 shows the location of the first Sinton homestead on the western side of Brigham Creek, north of the Great North Road (now SH16) (Figure 6). There was also a shed close to the road and bridge (Figure 6 and Figure 8). Hodder records that after John Sinton and his wife Lillian married in 1901 they lived in a small cottage on the western side of the creek, which is presumably this building (Hodder 1975; n.d.), though prior to this John appears to have lived on the southern side of the road (Figure 7). Most of the Sinton family buildings were located on the eastern side of the creek. These included the store, the gum store, Janet Sinton's house and Alex Sinton's house (Figure 6, Figure 7). The location of the store and gum store are shown on a later (1930) plan (Figure 10 and Figure 11).

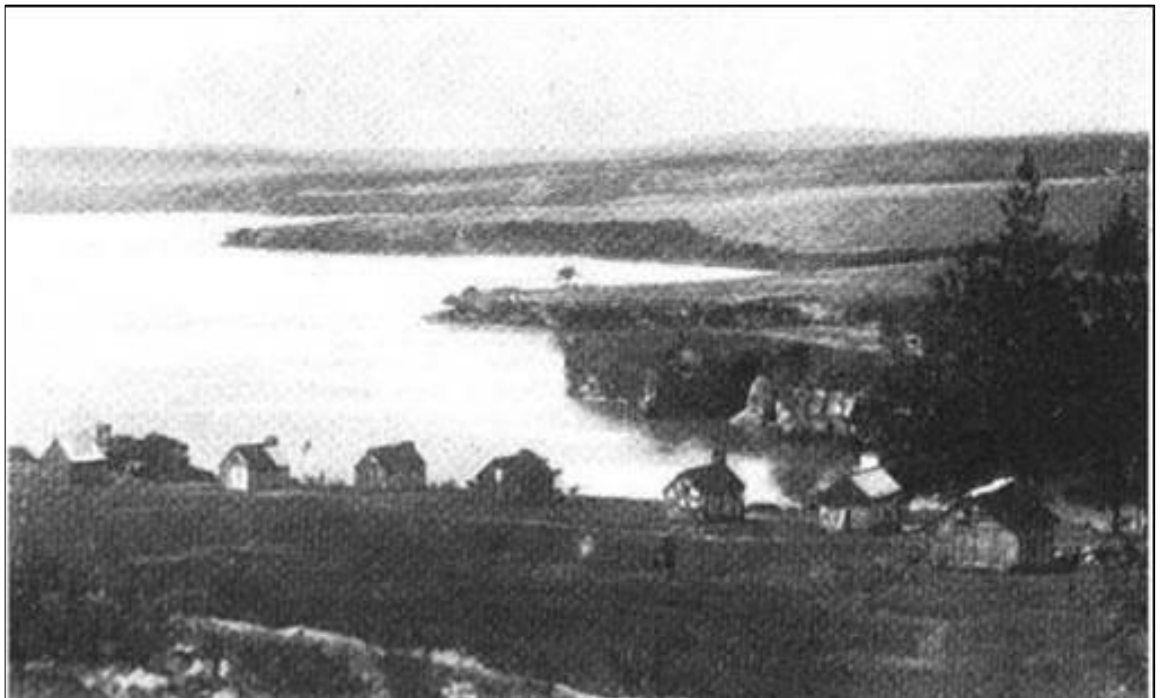
**Figure 9. Gumdiggers' huts on the Sinton property within the survey area, c.1902 (from Madden 1966: 112)**

Part of the Sinton property, including the area where the shed shown in Figure 6 and Figure 9 was located, was taken for road realignment purposes in 1930 (Figure 10 and Figure 11).

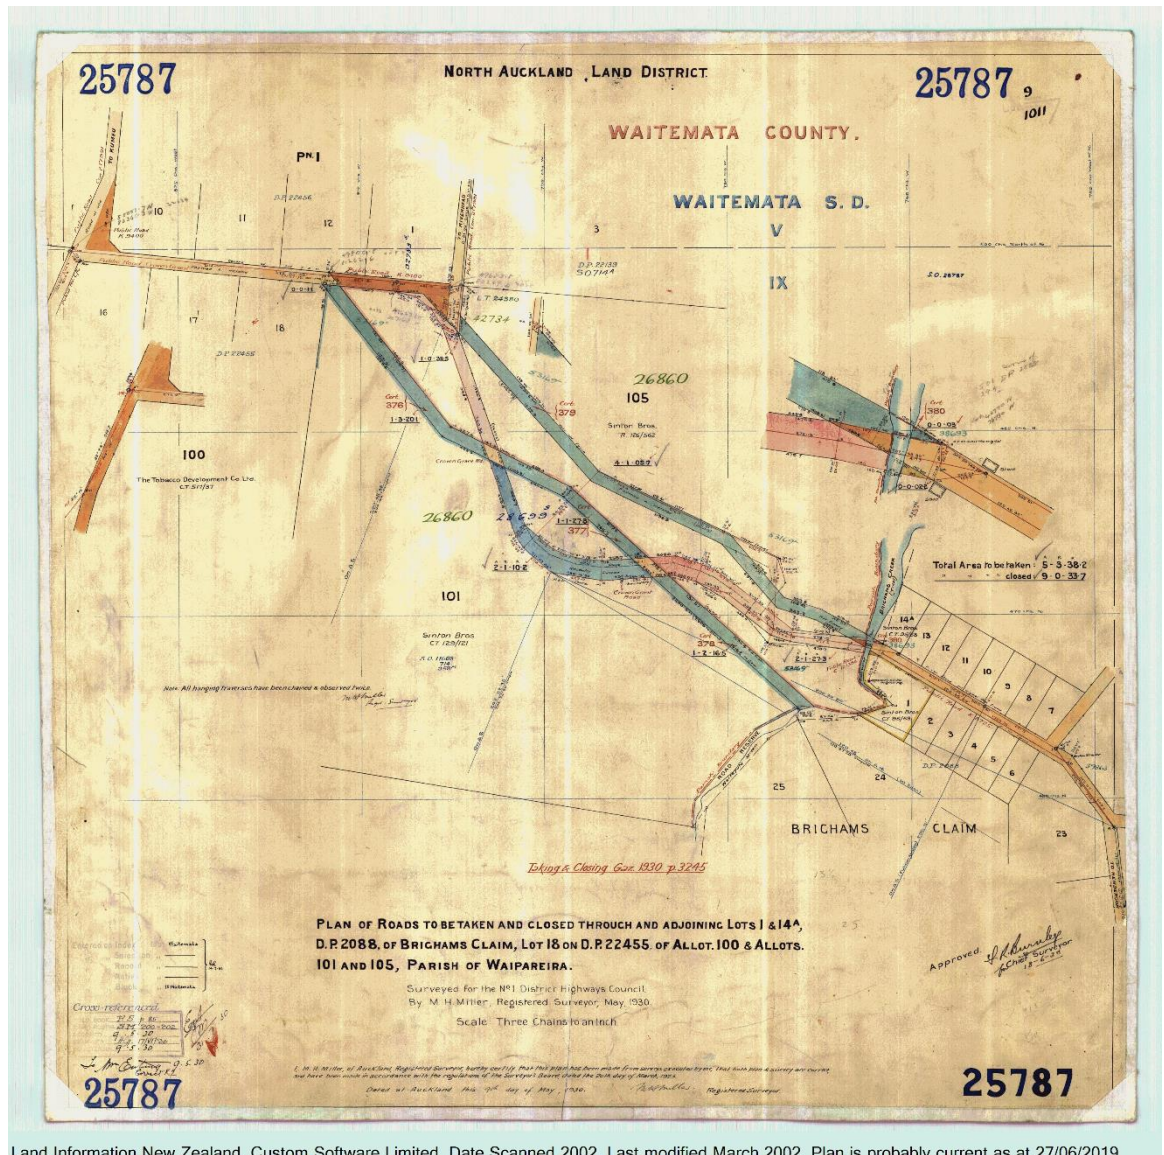
**Figure 10. SO 25787 (1930) 'Plan of Roads to be taken and closed through and adjoining Lots 1 & 14A, D.P. 2088 of Brighams Claim, Lot 18 on D.P. 22455 of Allot. 100 & Allots. 101 and 105, Parish of Waipareira'**

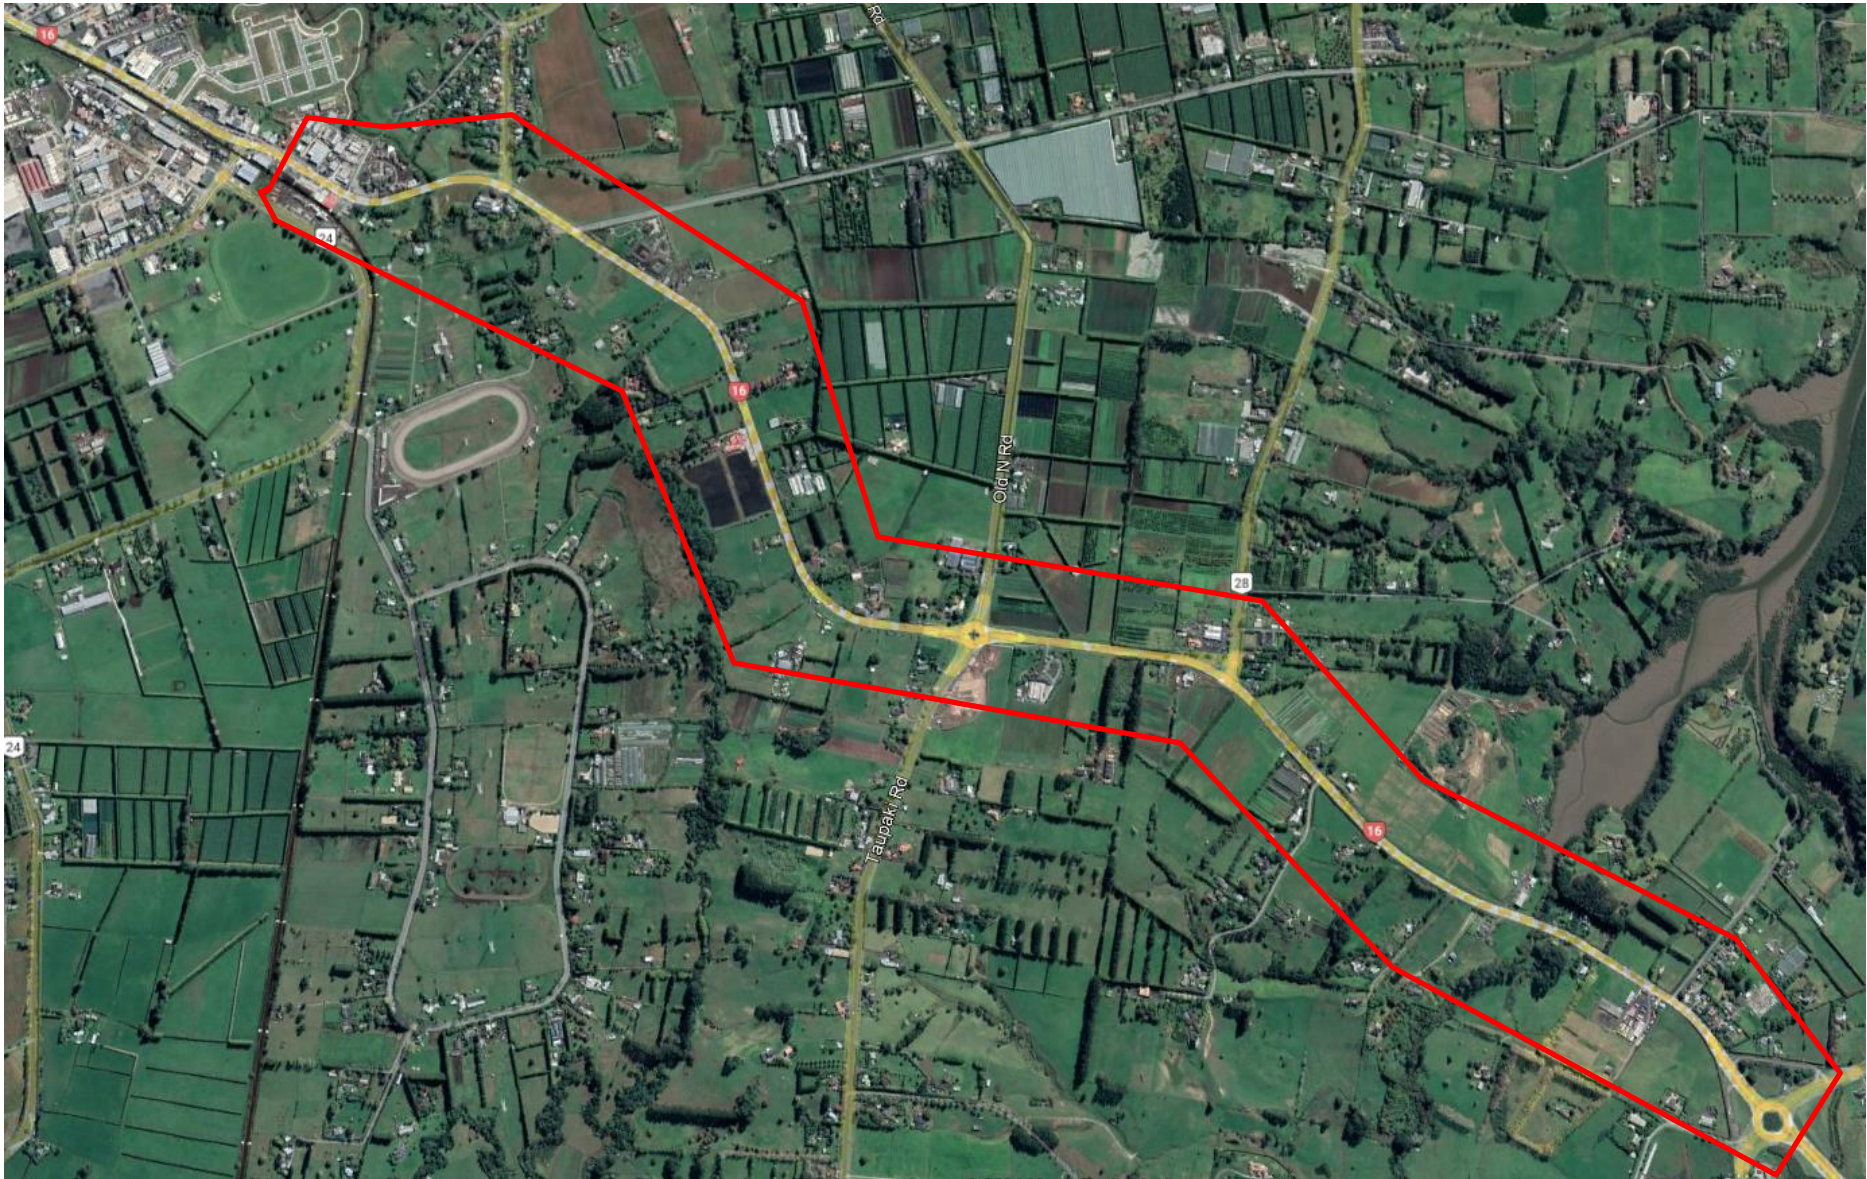
Figure 13. Aerial view of the Stage 2 project area (source: Google Earth)

State Highway 16 between the Brigham Creek Road roundabout and Kumeū runs through predominantly rural residential land (Figure 13). The road has been widened and upgraded over the years, including the construction of major roundabouts at the Brigham Creek Road intersection and Old North Road intersection (Figure 14), within the last decade.

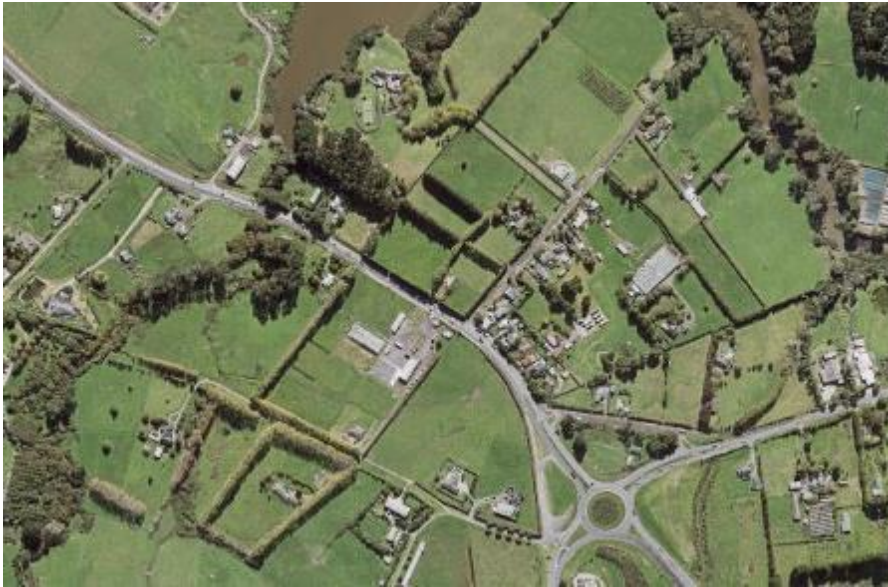
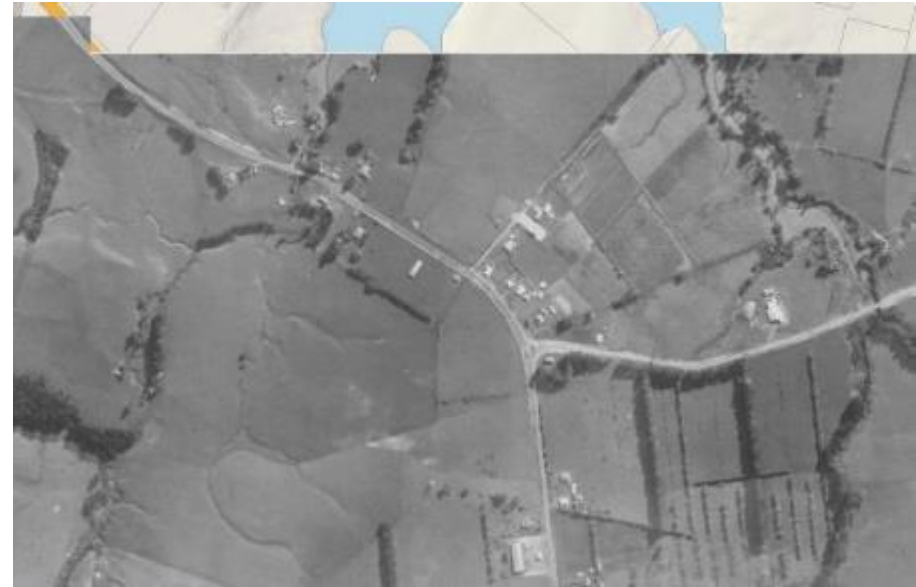
Figure 14. Brigham Creek Road roundabout in 2017 (left) and Brigham Creek Road turn-off in 1959 (source: Auckland Council GeoMaps)

None of the recorded heritage buildings will be affected by the proposed works as they are all located well away from proposed works. Nor will there be any effects on the site of a Sinton homestead north of SH16 on the eastern side of Brigham Creek (CHI 3379). A second reported site located at the Brigham Creek Road roundabout (CHI 3711) was the location of an early 20th century church which has been relocated to Clarks Lane in Hobsonville. This is not an archaeological site, and its former location has been extensively modified by construction works for the roundabout (Figure 14).

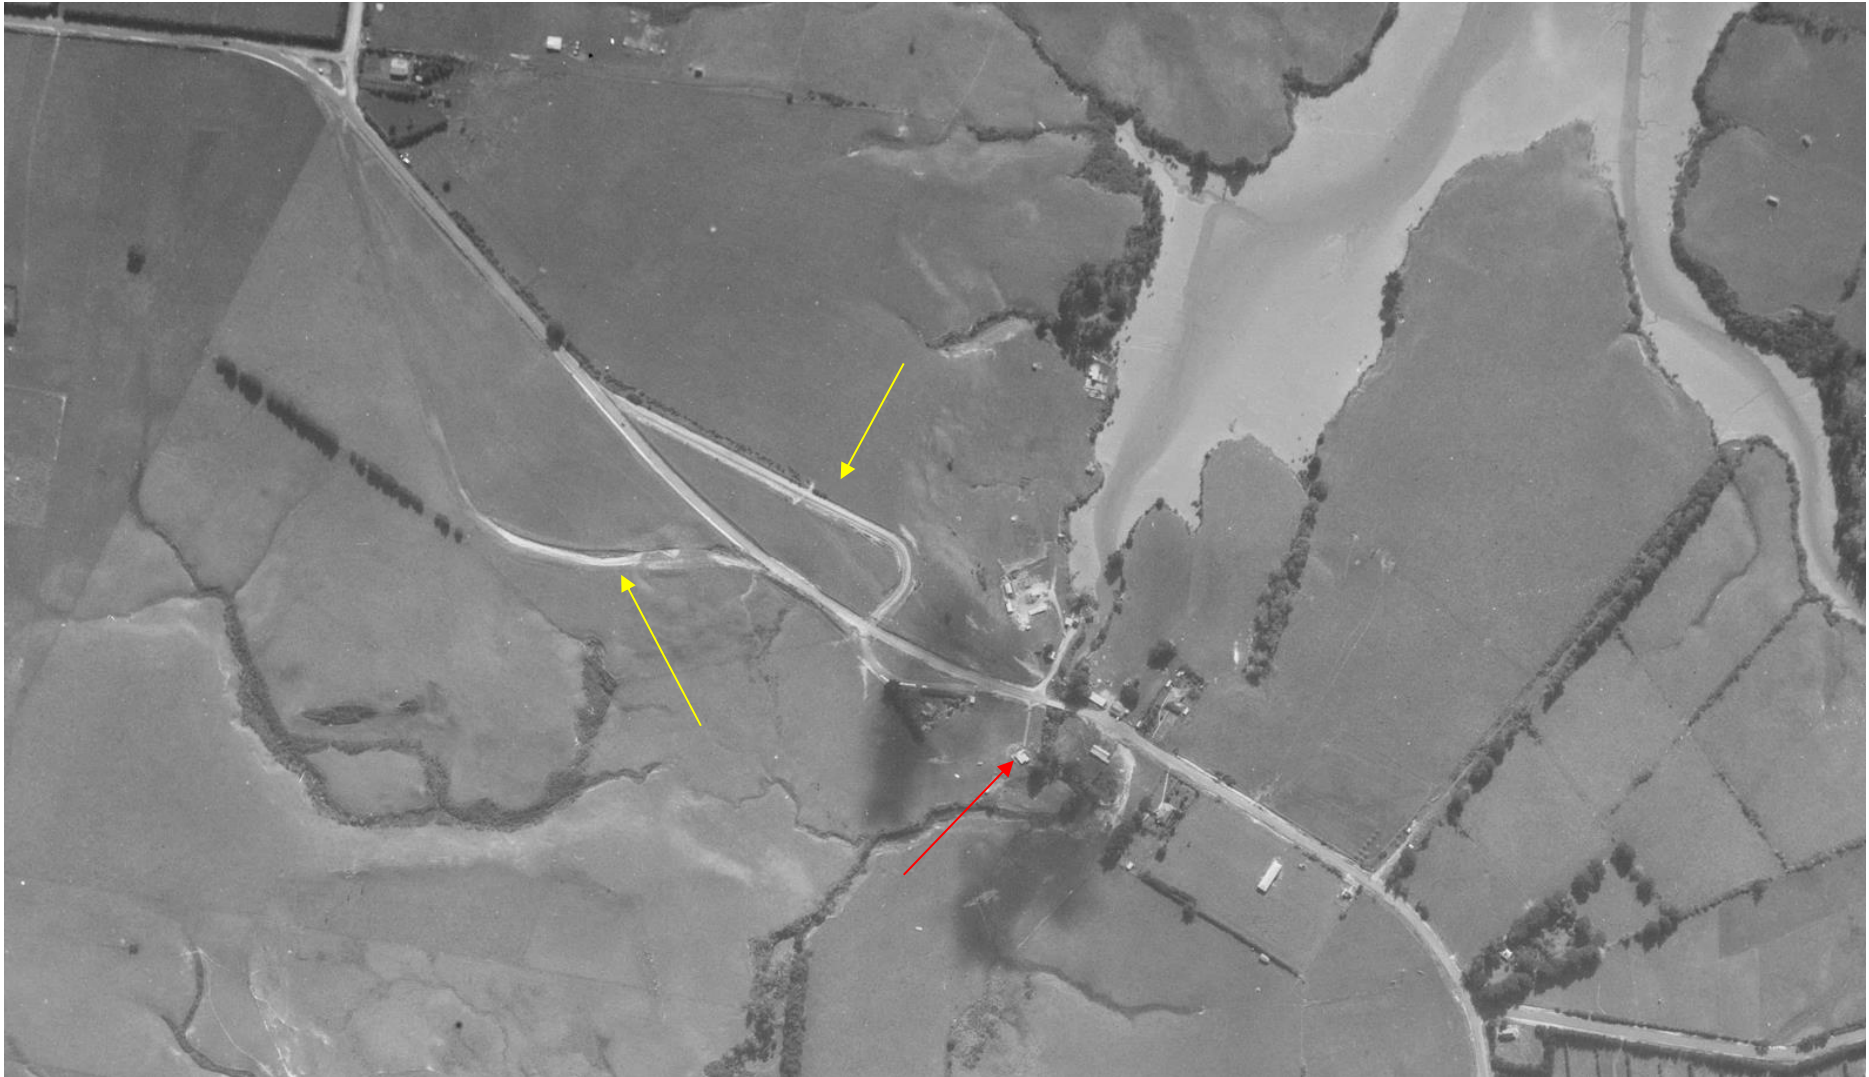
**Figure 22. Aerial photograph, dated 1940, showing the various road alignments (arrowed in yellow) on the western side of Brigham Creek, and a possible farm structure (arrowed in red) (source: Retrolens SN143 92-18)**

Historic plans for the Brigham Creek area reveal that the current road alignment was only established in the early 20th century, likely dating between 1930 and 1936. A plan from 1899 shows a road alignment survey which located the road further to the west of the modern road. Later plans suggest that this road remained a paper entity only (Figure 19). A plan from 1930 (see Figure 10) shows that the early alignment was to be closed, with two other road alignments, noted to be formed and metalled, being altered. A plan from 1936 (Figure 20) shows that those two alignments are now closed and the modern alignment is formed and in use. These historic plans have been georeferenced and layers showing the various development in the road layout have been created (Figure 21). An aerial from 1940 (Figure 22) shows the scars of the earlier road alignments are still quite visible, and a number of buildings are present around the landscape. This aerial has been georeferenced and the location of buildings compared with a modern aerial image. A number of the buildings that are present in both images are now recorded as historic structures, but the majority have been removed. Of some interest is the presence of a structure on the western side of Brigham Creek, which appears to have left to fall into ruin by the 1970s.

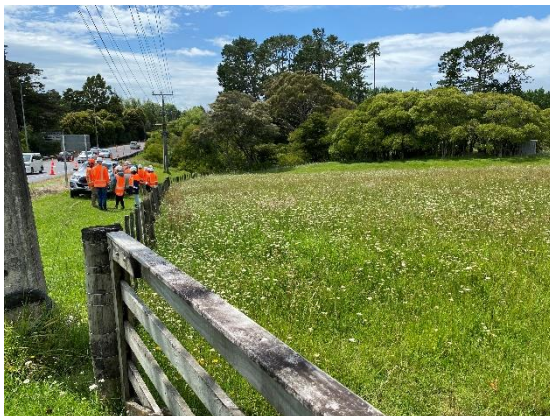
**Figure 23. View facing southeast from the entrance to 238 SH16 along the eastern boundary**

The boundary of 238 SH16 was examined but access to the property itself was not sought (Figure 23 to Figure 25). Current design plans for the works indicate that the altered designation boundary is 6m west of the current boundary, thereby extending into the AUP OP scheduled extent of place. No features of archaeological interest were noted in the area. It is noted that a stormwater pipe runs alongside SH16 within the berm.

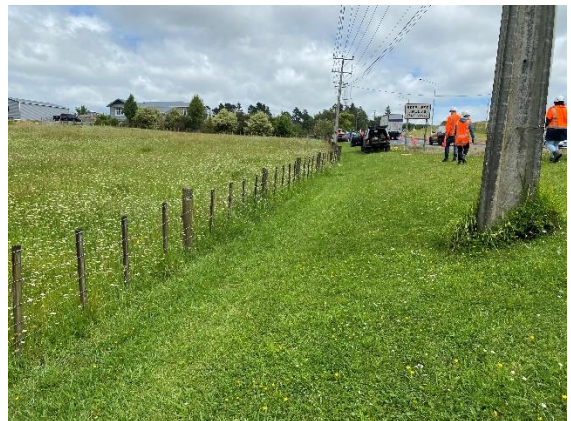
**Figure 24. View facing northwest along the eastern boundary of 238 SH16**

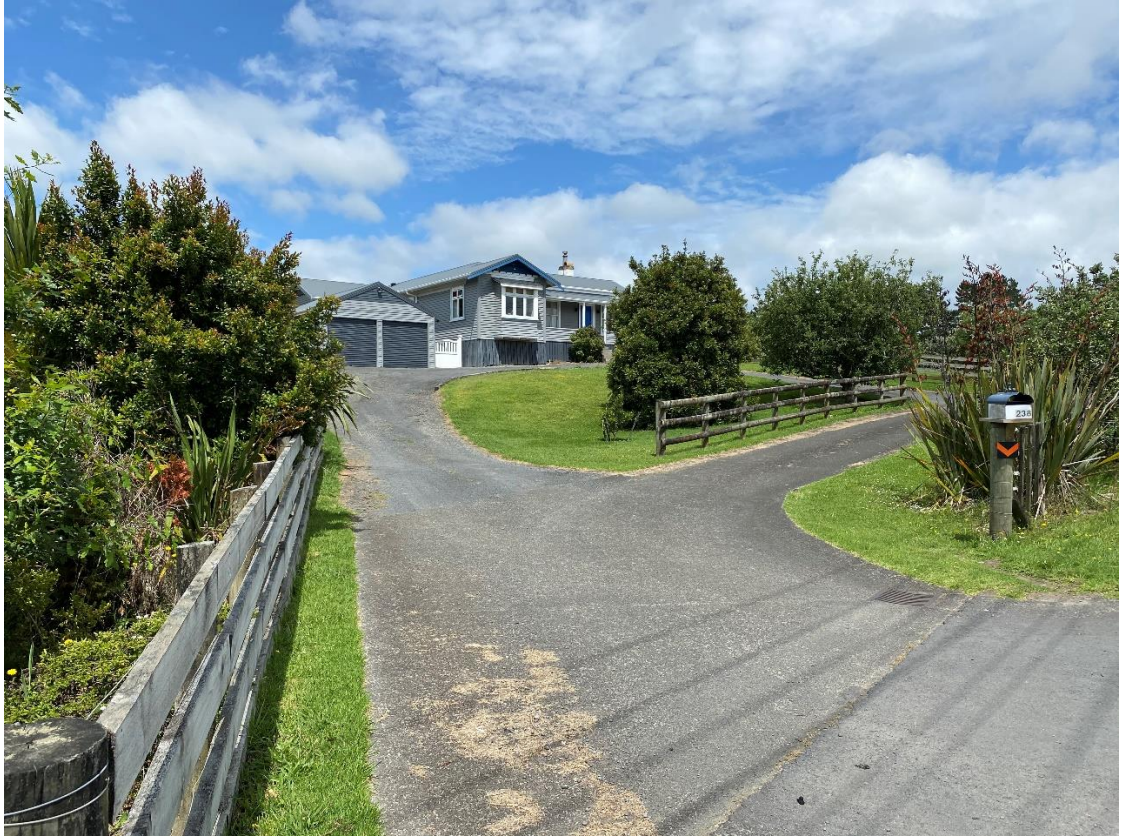
**Figure 25. View facing west showing the building at 238 SH16, being the Sinton House recorded as CHI ID 13241, R11/2828 and AUP OP ID 525**

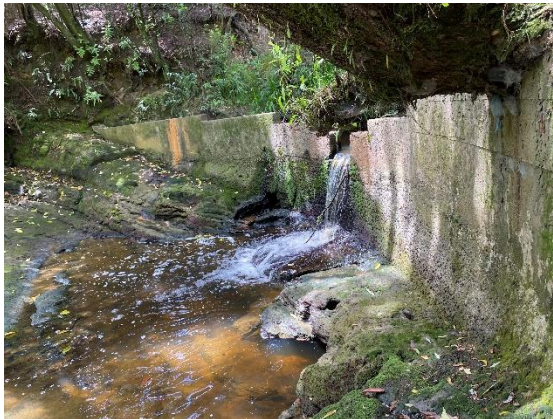
**Figure 26. Concrete weir to the east of the SH16 bridge at Brigham Creek**

The areas alongside the creek were also examined (Figure 26 to Figure 28), and in particular the area around the concrete weir, on the eastern side of the bridge. The eastern side will not be impacted by works. No features of archaeological interest were noted on the western side of the bridge.

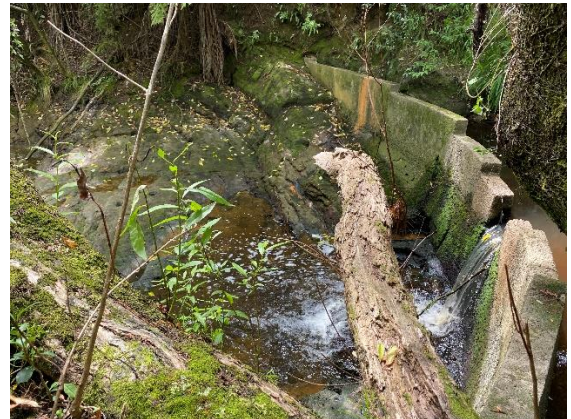
**Figure 27. Concrete weir to the east of the SH16 bridge at Brigham Creek**

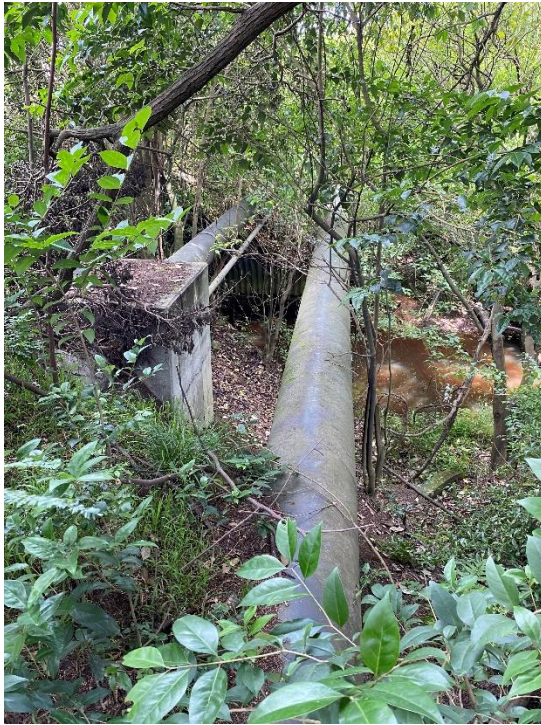
**Figure 28. View facing northwest showing water pipes crossing Brigham Creek to the east of the SH16 bridge**

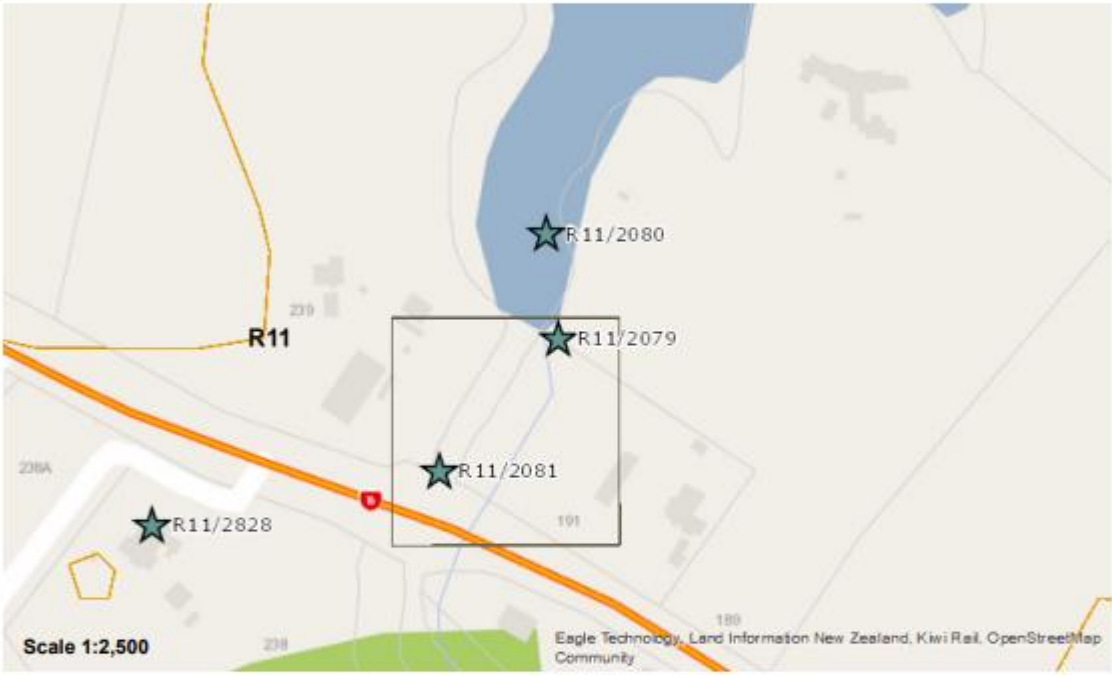
| <p><b>IMPERIAL SITE NUMBER:</b>      <b>METRIC SITE NUMBER:</b> R11/2079</p> | |

| <p><b>Finding aids to the location of the site</b></p> <p>Location updated from survey plan in original site record.<br/>In eastern bank of Brigham's Creek</p> | |
| <p><b>Brief description</b></p> <p>Midden</p> | |

| CHI No. | NZAA Site No. | Site Type | Description | NZTM Easting | NZTM Northing |
|---|---|---|---|---|---|
| 13587 | R11/2079 | Archaeological Site | Shell Midden, in eastern bank of Brigham Creek, at approximate junction of 191 SH16 and 8 Kennedys Road. Site consists of a few cockle shells in two small exposures about 1m apart. Probing conducted, no other midden found other than that eroding from bank. No real depth to the deposit. Eroding out of bank, likely to continue to do so. | 1742033 | 5926921 |

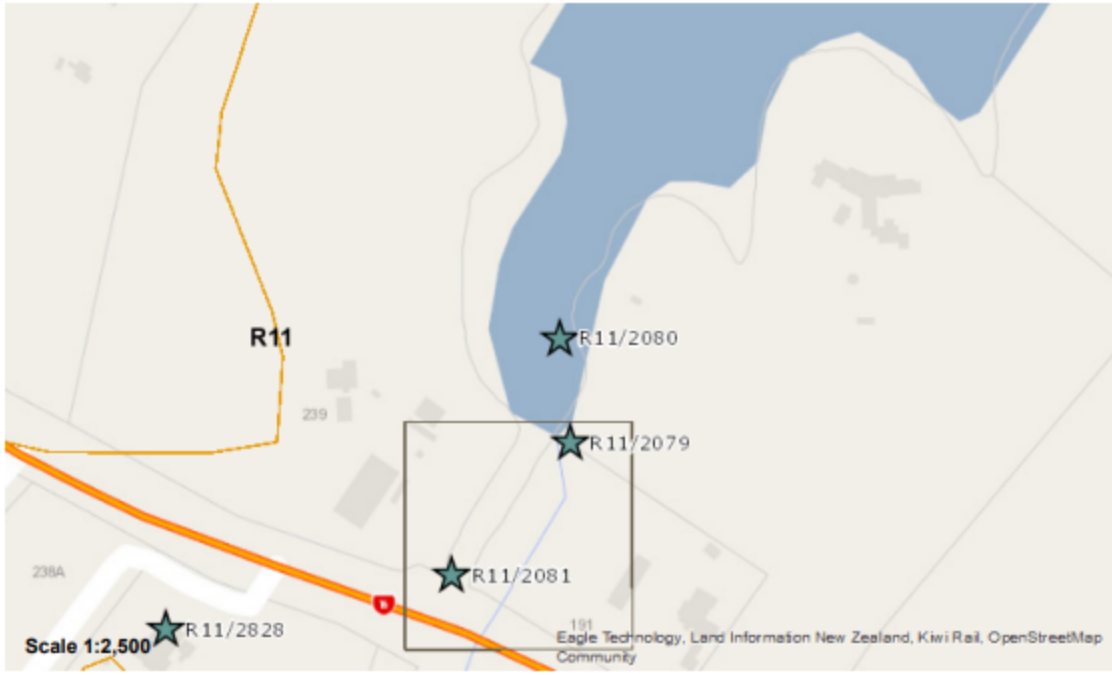
| <p><b>Finding aids to the location of the site</b></p> <p>Location updated from survey plan in original site record.<br/>The last wide point of Brigham's Creek before the Sh 16 bridge</p> | |
| <p><b>Brief description</b></p> <p>Landing area</p> | |

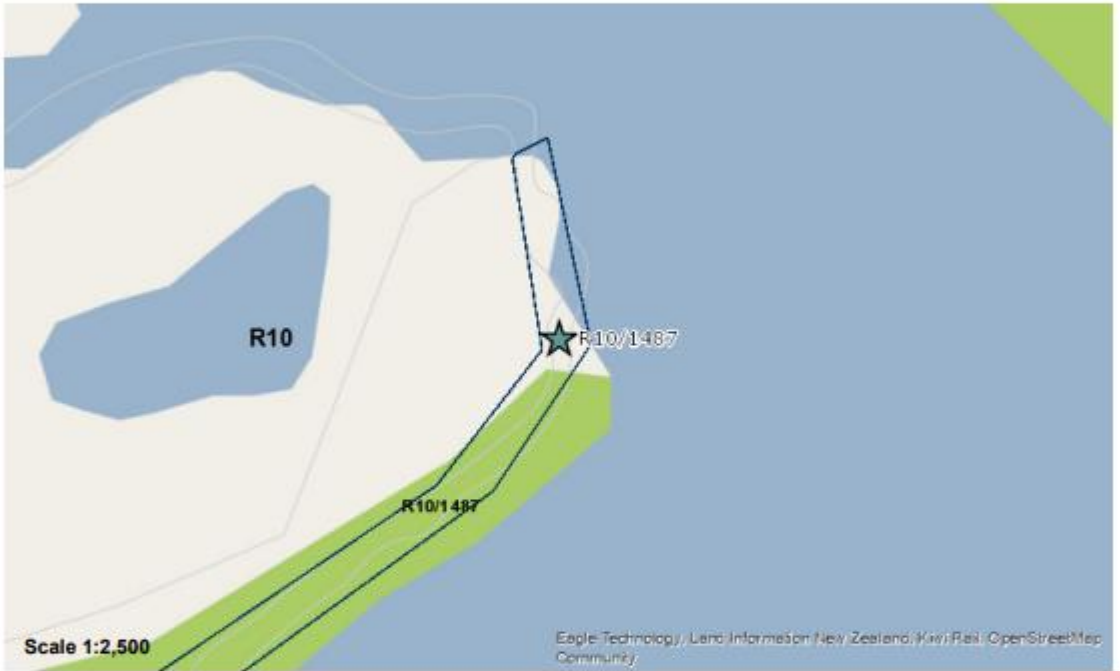
| <p><b>Finding aids to the location of the site</b></p> <p>Begins on property (Lot 2 DP 184890) to south of Huapai Golf Course, accessed from 107 Riverland Road, and runs along Old Railway Road, Riverhead.</p> | |
| <p><b>Brief description</b></p> <p>Railway alignment bench and structures</p> | |

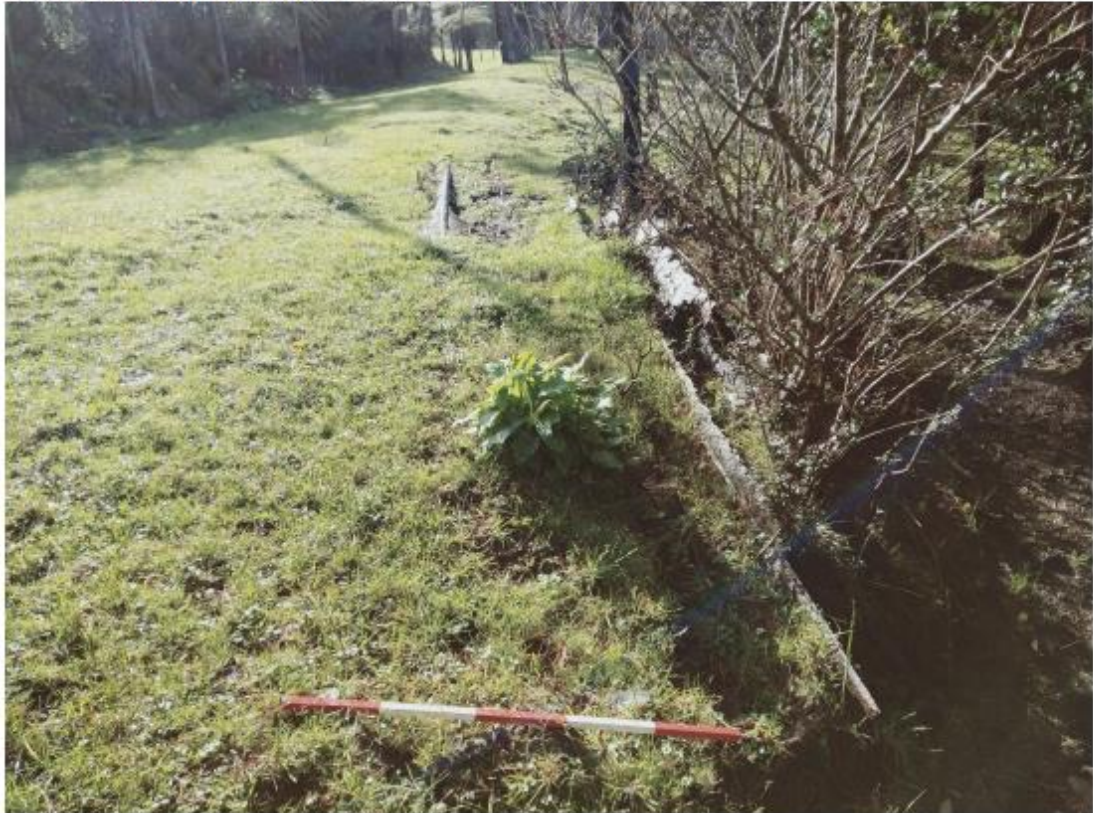
Bench for the Railway and some possibly related metal cylinders on western edge near a small creek that feeds into the Rangitopuni Stream (Image taken by Ella Ussher on 8 July 2020).

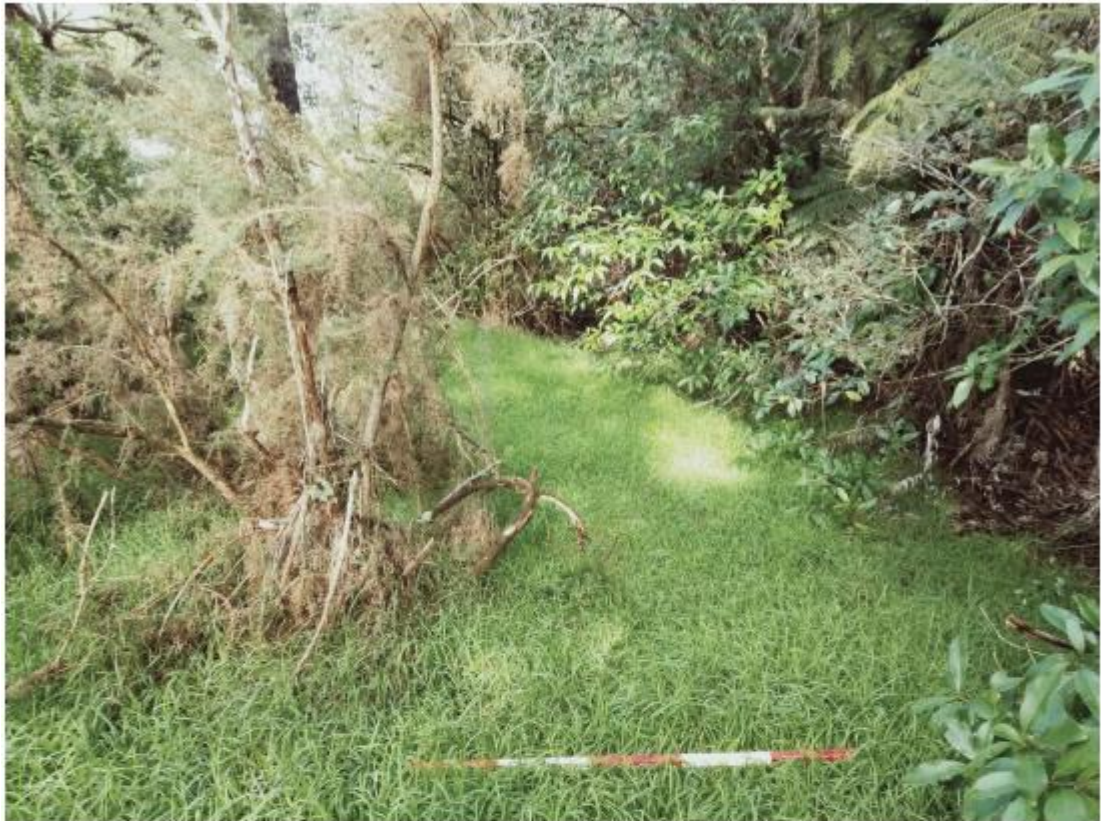
Bench for the Railway close to the old wharf location and terminus (Photo taken by Ella Ussher on 8 July 2020)

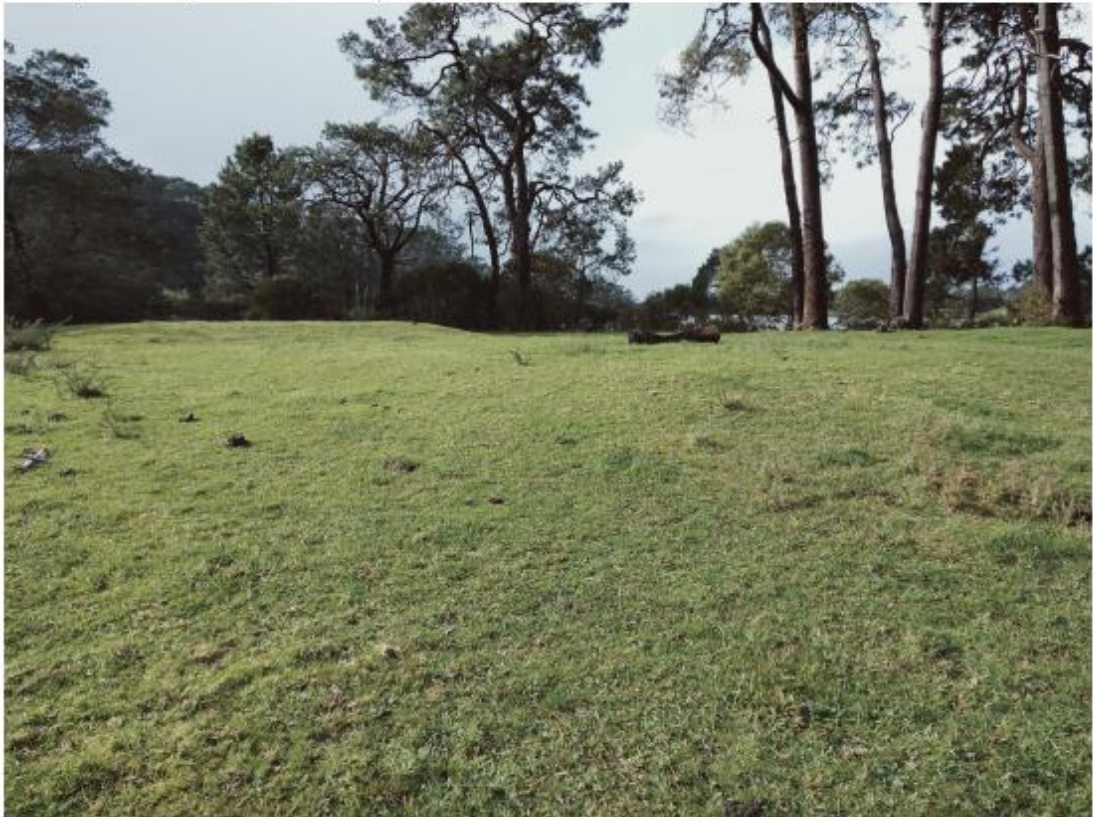
Raised platforms in paddock above railway line (Photo taken by Ella Ussher on 8 July 2020)

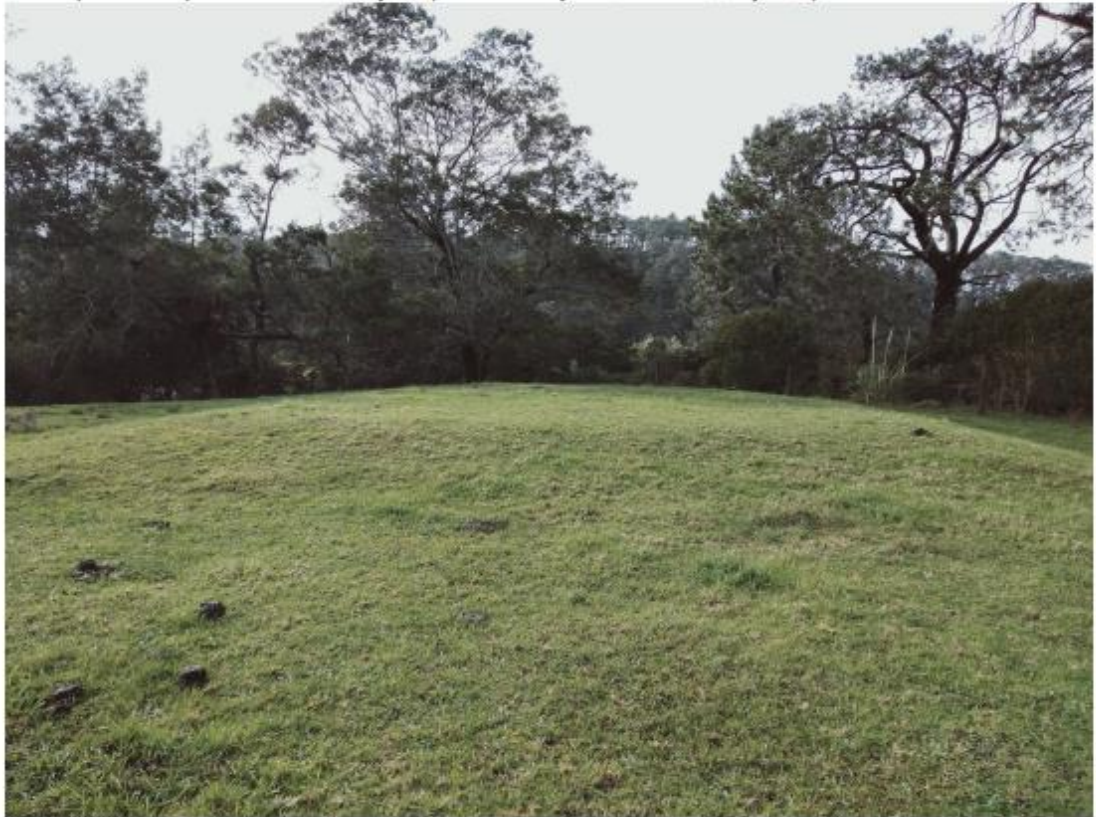
Raised platforms in paddock above railway line (Photo taken by Ella Ussher on 8 July 2020)

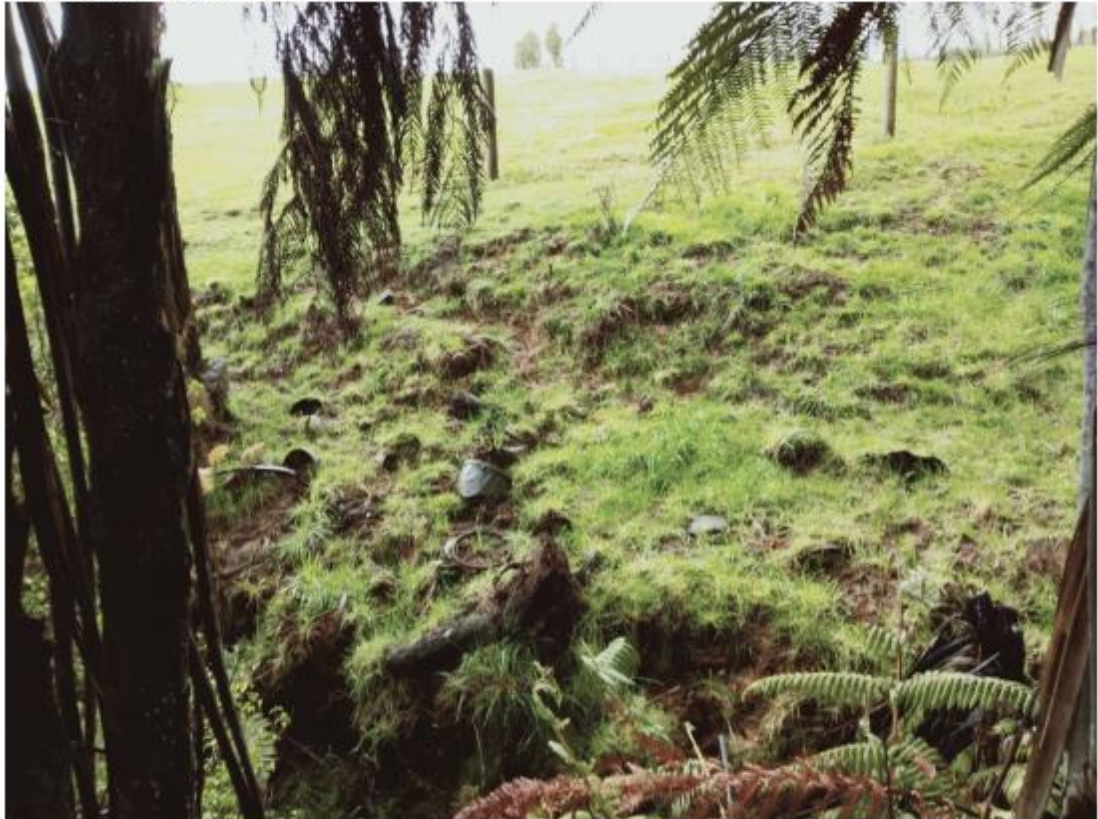
Night soil buckets from Sanitary Depot use of Harkins Point , on opposite bank of creek from railway bench (Photo taken by Ella Ussher 8 July 2020)

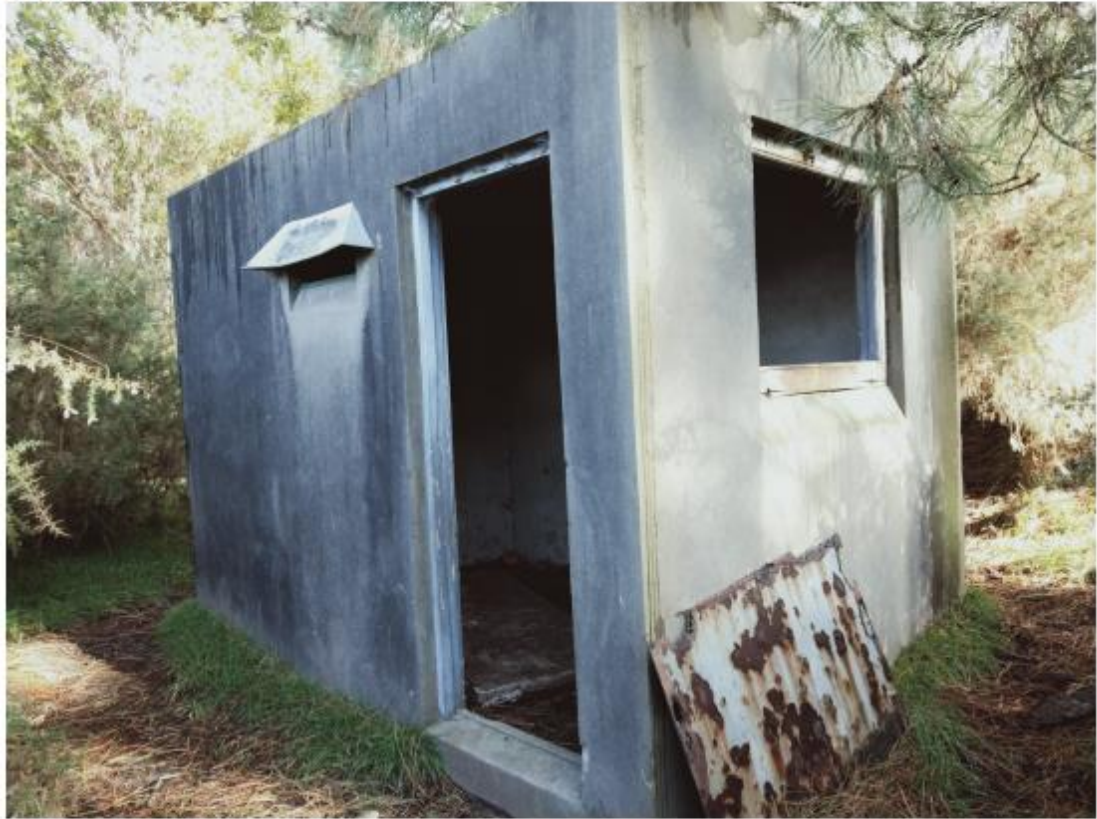
Pacific Cable Board shed on railway bench. Trans-tasman cable was trenched from Muriwai in 1930s (Photo taken by Ella Ussher 8 July 2020)
