Campana Road, Wiri

Geotechnical Appraisal Report

for: Campana Landowners Consortium c/ Capstone Projects Limited

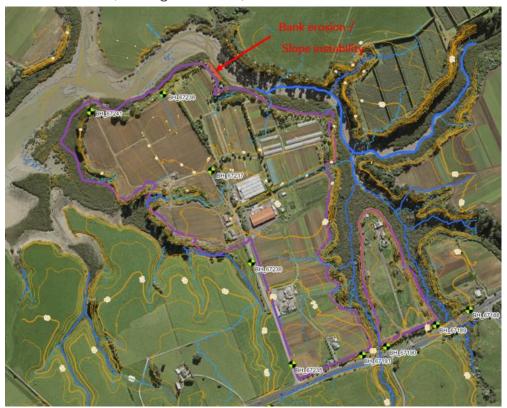
Figure 3: Location of bank erosion section

The majority of the site is bordered by \sim 5m high slopes that grade down to sea level at approximately 33 degrees (1V:1.5H). The majority of the slopes are heavily vegetated and well protected at the toe by mature mangroves. However, a \sim 50m long section along the northern site boundary shows signs of instability and coastal erosion (refer Figures 3 and 4).

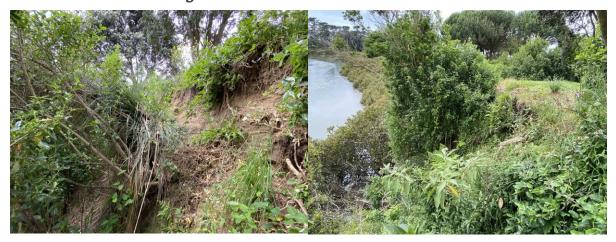
Figure 4: Slope instability due to bank erosion

Based on observations during the site walkover, the mangroves are less dense in this area and the course of the tributary leading to the Waokauri Creek is such that erosion resulting in undercutting of

Nevertheless, a Building Restriction Line (BRL) set 20m back from the slope crests is recommended, which will align with the proposed 20m wide Open Space zone and also provide mitigation against risk posed by coastal instability or erosion (refer Section 4.3).

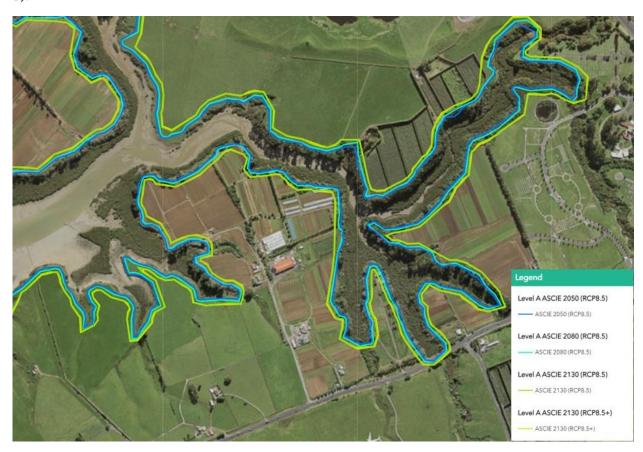
Figure 5: Excerpt of the Auckland Coastal Instability and Erosion Map

The site is mapped as being within an Area Susceptible to Coastal Instability and/or Erosion (ASCIE) on the Auckland Council GeoMaps website. Future erosion predictions for the 2130 RCP8.5 scenario suggests ~20m of land loss (approximately measured back from current slope crests) is possible (Figure 5).

It is noted that this assessment is based on a region wide study, and do not consider factors such as slope vegetation, mangrove protection, or coastal setting. Considering the benign (low energy) environment, the mangrove vegetation, and the fact the slopes are fronted by an infilling estuary, these projections are considered highly conservative.

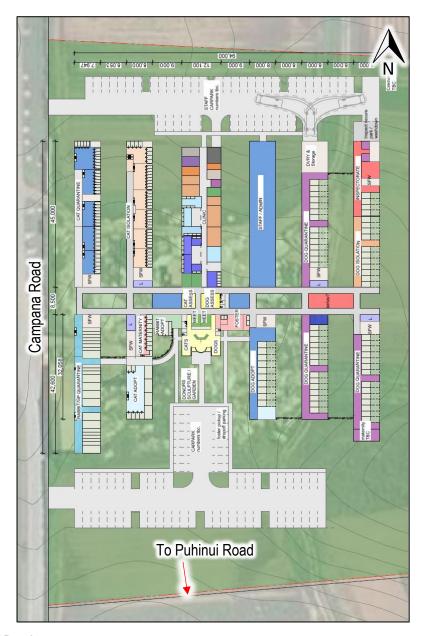
Figure 2: Proposed Development (Source: Site Plan by Chow Hill Architects)

buildings' as outlined by NZS3604. Site access and paved parking areas will be built to the north and south of the building. An indicative site plan is included as Figure 2.

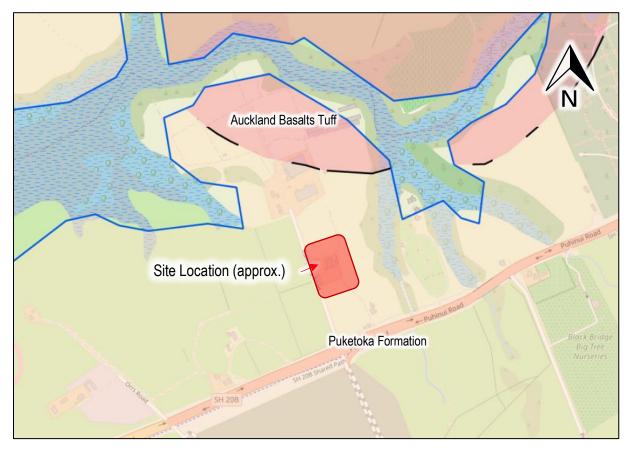
Figure 3: Geological Map (Source: GNS WebMaps Website)

Reference to the GNS New Zealand Geological Web Map 1:250,000 Geology map, indicates the site is underlain by recent alluvial soils of the Puketoka Formation. Auckland Basalts Tuff is mapped at the northern end of Campana Road (refer Figure 3).

Puketoka Formation alluvial deposits are described as "Pumiceous mud, sand and gravel with muddy peat and lignite: rhyolite pumice, including non-welded ignimbrite, tephra and alluvia". These soils can vary in their strength and nature over short vertical and lateral distances. These soils can vary in thickness and are typically underlain by soils and rock of the East Coast Bays Formation.

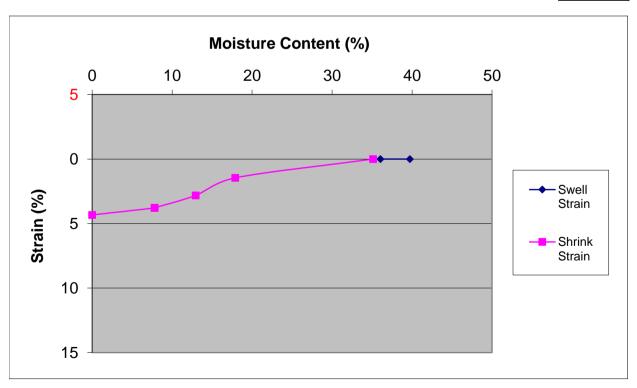
Initial moisture content (%) = 39.7 Final moisture content (%) = 36.0

Iss = 2.4 Strain per ΔpF (%)

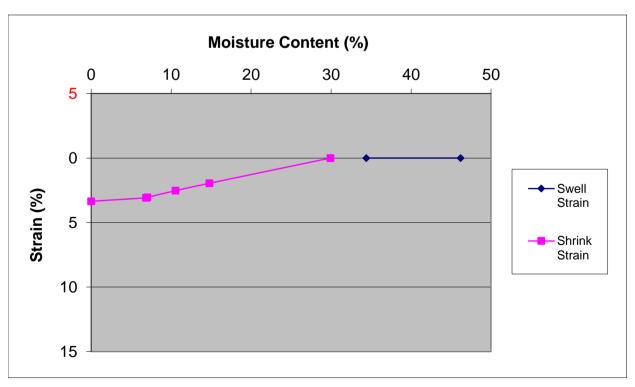
Initial moisture content (%) = 34.4 Final moisture content (%) = 46.2

Iss = 1.9 Strain per ∆pF (%)

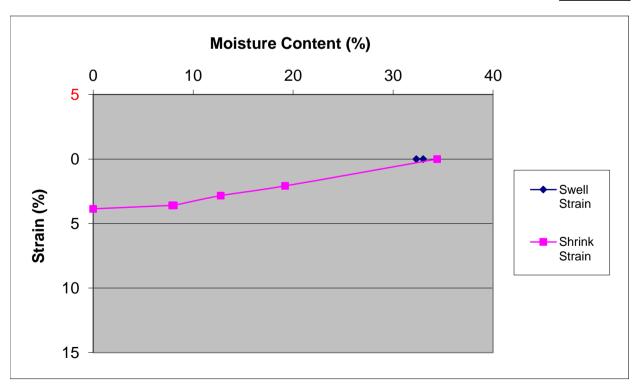
Initial moisture content (%) = 33.0 Final moisture content (%) = 32.3

Iss = 2.1 Strain per ∆pF (%)

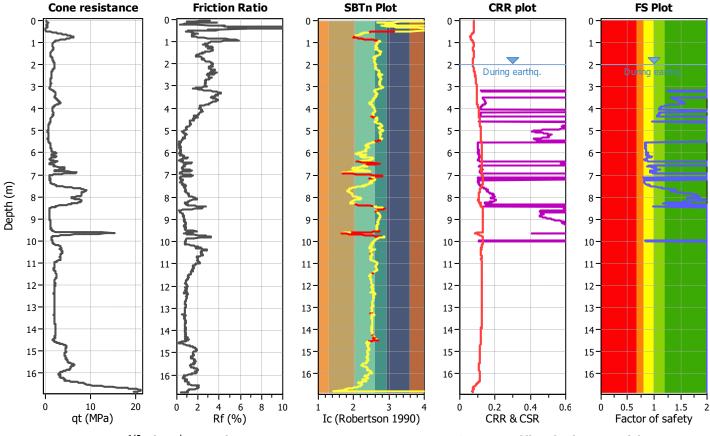
Zone A_1 : Cyclic liquefaction likely depending on size and duration of cyclic loading Zone A_2 : Cyclic liquefaction and strength loss likely depending on loading and ground geometry

Zone B: Liquefaction and post-earthquake strength loss unlikely, check cyclic softening Zone C: Cyclic liquefaction and strength loss possible depending on soil plasticity, brittleness/sensitivity, strain to peak undrained strength and ground geometry

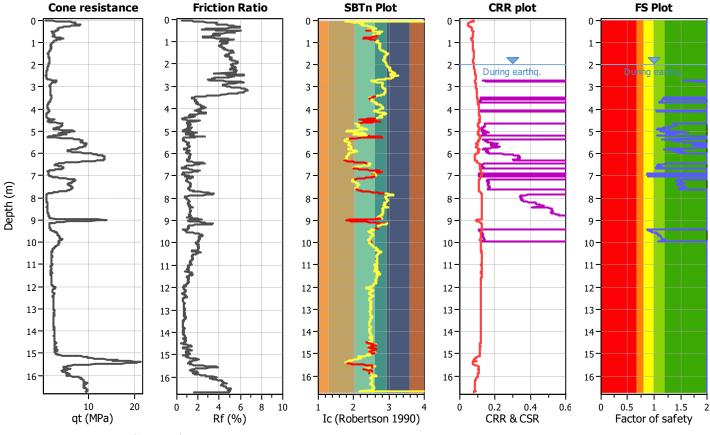
Zone A₁: Cyclic liquefaction likely depending on size and duration of cyclic loading Zone A₂: Cyclic liquefaction and strength loss likely depending on loading and ground

Zone B: Liquefaction and post-earthquake strength loss unlikely, check cyclic softening Zone C: Cyclic liquefaction and strength loss possible depending on soil plasticity. brittleness/sensitivity, strain to peak undrained strength and ground geometry

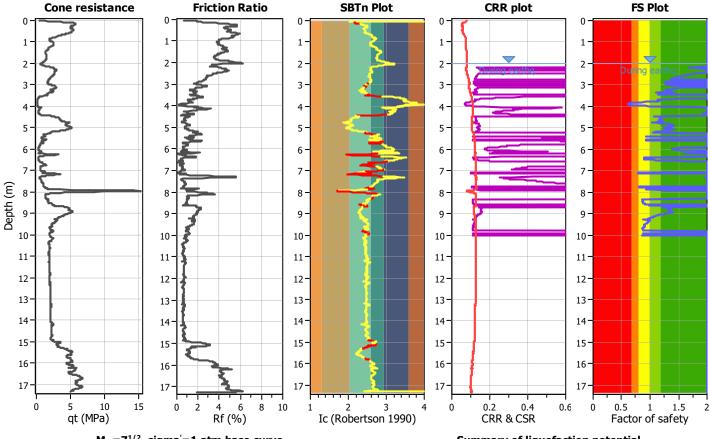
Zone A₁: Cyclic liquefaction likely depending on size and duration of cyclic loading Zone A₂: Cyclic liquefaction and strength loss likely depending on loading and ground depending

Zone B: Liquefaction and post-earthquake strength loss unlikely, check cyclic softening Zone C: Cyclic liquefaction and strength loss possible depending on soil plasticity, brittleness/sensitivity, strain to peak undrained strength and ground geometry

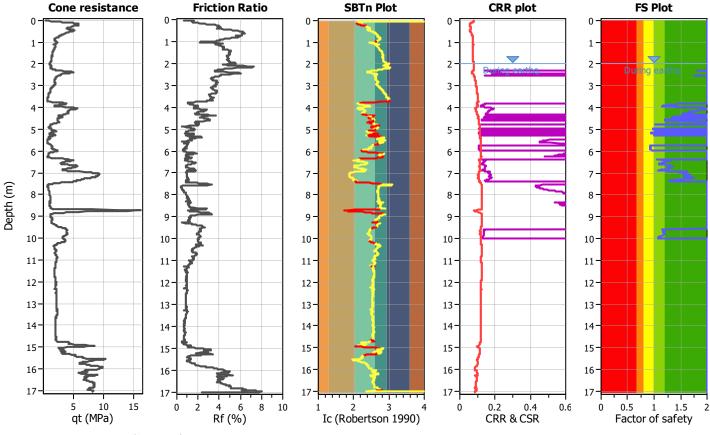
Zone A₁: Cyclic liquefaction likely depending on size and duration of cyclic loading Zone A₂: Cyclic liquefaction and strength loss likely depending on loading and ground

Zone B: Liquefaction and post-earthquake strength loss unlikely, check cyclic softening Zone C: Cyclic liquefaction and strength loss possible depending on soil plasticity. brittleness/sensitivity, strain to peak undrained strength and ground geometry
