Karaka Road, Drury

Preliminary Site Investigation (Ground Contamination)

FISHER & PAYKEL HEALTHCARE PROPERTIES LTD

WWLA0754 | Rev. 3

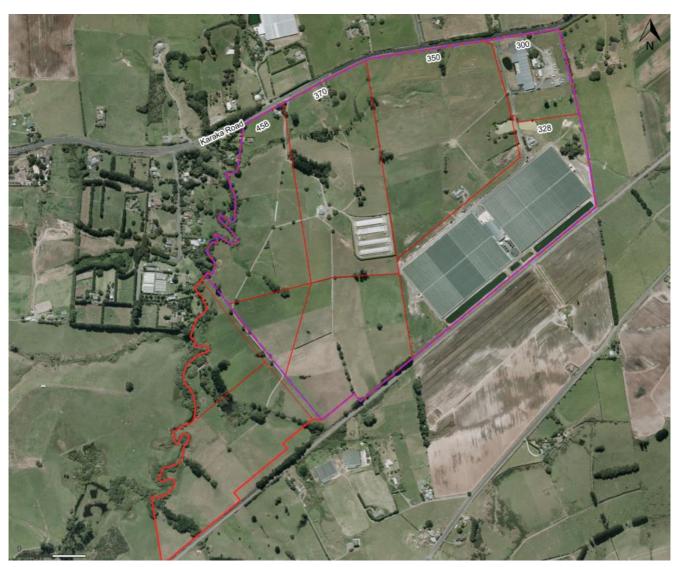
Figure 1. Location of the site (Image source: LINZ). Thick red outline indicates site extent, thinner internal lines show individual property boundaries. The purple dashed line shows the area subject to the Plan Change application.

The site comprises five (5) titles as described in **Table 1**. Refer to **Figure 1** for internal site boundaries. The site is bound by Karaka Road in the north, the main truck railway line in the south, and Oira Stream to the west. A 'paper road' is present in the southwest of the site.

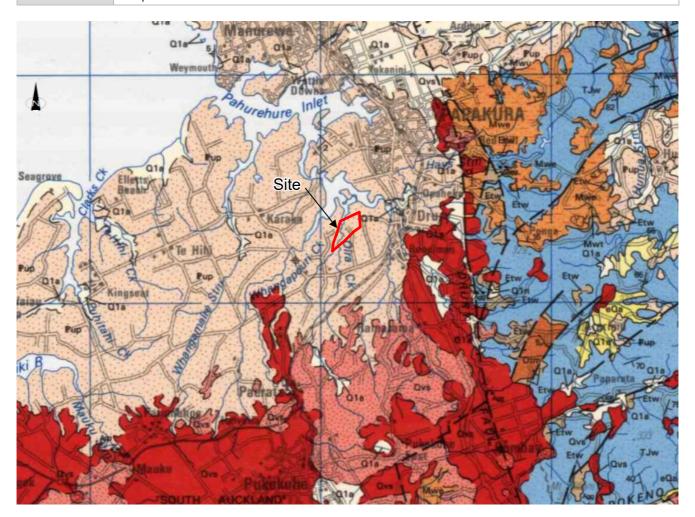
Figure 2. Published geology. Peach is Puketoka Formation, dark pink and red are volcanic deposits (Sourced from: Edbrook, S.W. 2001. Geology of the Auckland Area. GNS Geological Map 3, 1:250,000).

Topography	The topographical nature of the site impacts where contaminants might migrate to if present. The topography of the site generally slopes gently to the west from a maximum elevation of approximately 30m RL. The slope steepens on the western boundary dropping to approximately 7m RL where the site is bordered by the Oira Creek. There are also some isolated steeper gullies in the northern portion of the site.
Geology	Geological conditions are considered in the context of describing the preliminary conceptual site model (CSM) (Section 4) should a potential for contamination be identified by this desk study. For example, more porous soils can enable contaminants (if present) to move more quickly and potentially further than clay-rich soils that retain/ bind or prevent penetration of contaminants.
	The published geology (Figure 2) shows that the site is located on alluvial deposits of the Puketoka Formation (predominantly fine-grained sands, silts and clays with some peat). Volcanic units of the South Auckland Volcanic Field (basalt, scoria, ash and lapilli) are located a short distance to the south of the site.

Borehole data from the New Zealand Geotechnical Database (NZGD; www.nzgd.org.nz) shows that boreholes drilled within the site for water supply purposes encountered Puketoka Formation clay and silt with sandstone (Waitemata Group) encountered at depth (>30 m below ground level (BGL). Peat units were also intercepted (>20 m BGL) along with some surface fill (<2 m BGL). This is supported by site specific information in Section 3.2.3 .
Hydrogeology	Hydrogeological conditions affect potential risk of contaminants (if present) entering and being transported in groundwater. Puketoka Formation sediments can hold perched groundwater units, although are unlikely to host a regional groundwater aquifer. The presence of a stream on the western boundary of the site indicates that shallow perched groundwater is likely with flow expected to follow topography. Regional groundwater units are likely to exist at depth (>30 m).

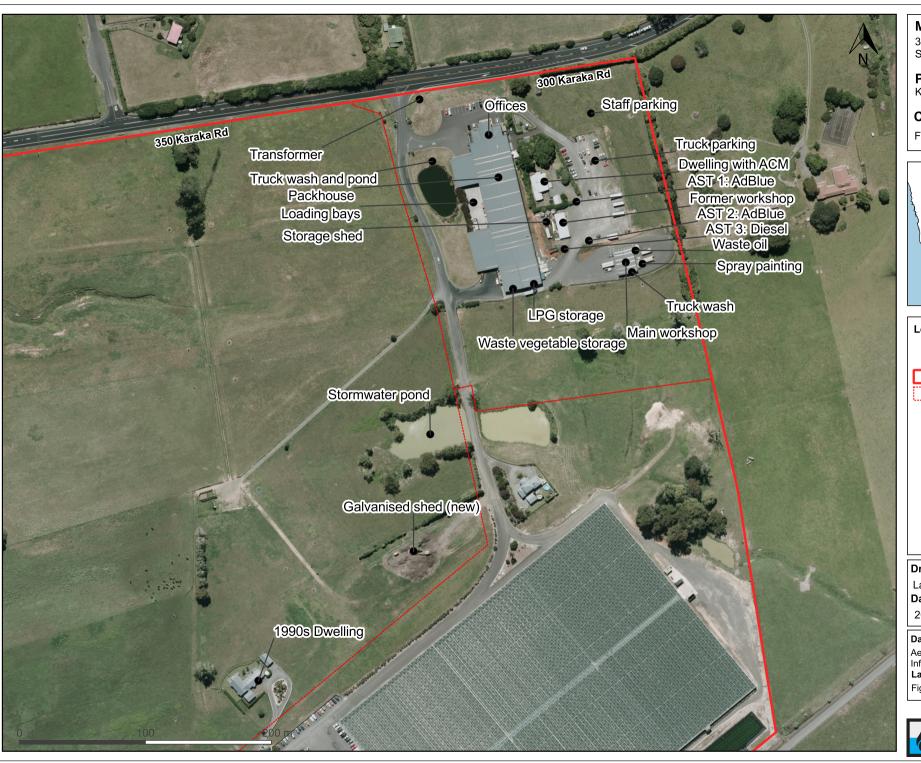
Figure 3 300+350 site features

300 and 350 Karaka Road: Site Features

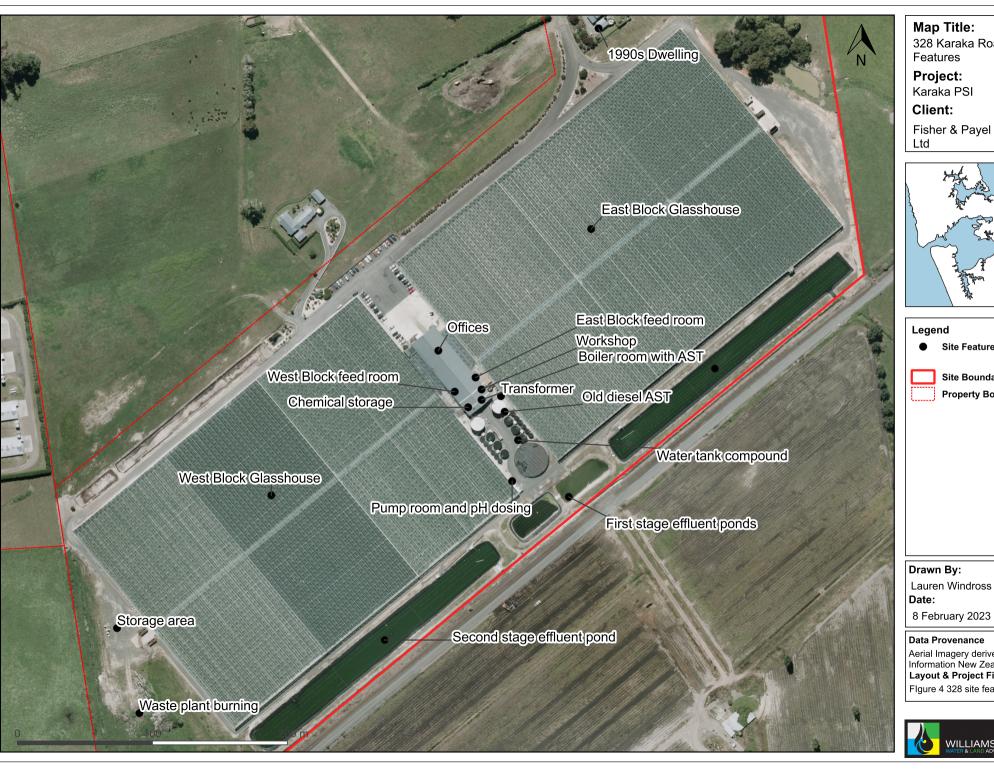
Figure 4 328 site features

328 Karaka Road: Site

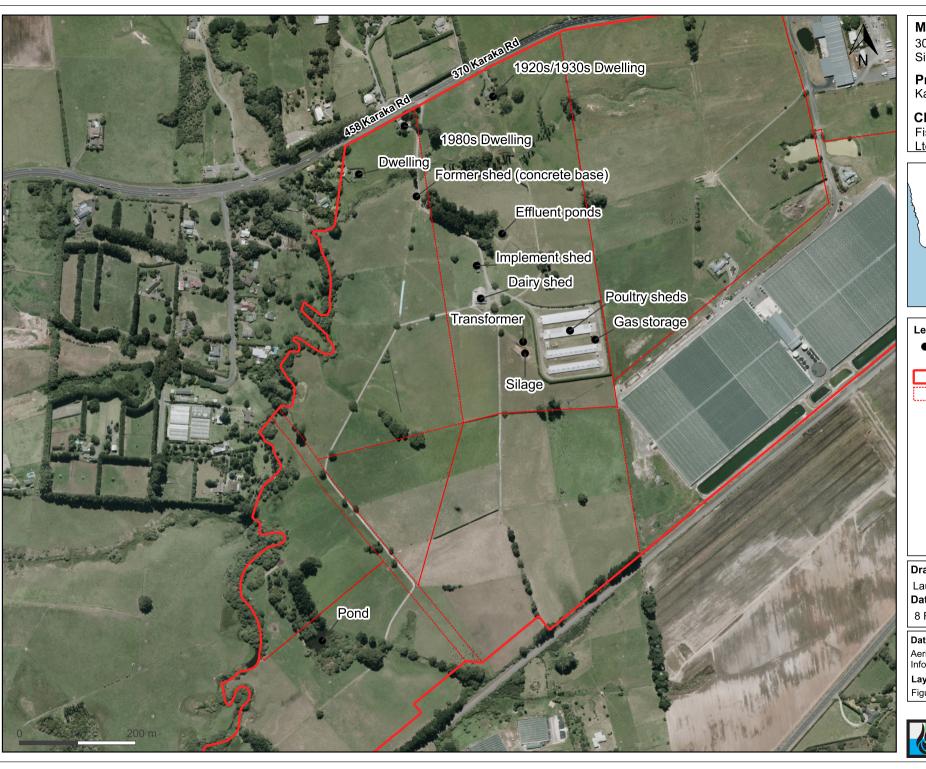
300 & 350 Karaka Road: Site Features

This property is operated by Hot House NZ Ltd. The SQEP was accompanied by Health, Safety and Compliance Manager, Loy Martinez, for the visit. The information below includes comments from Mr Martinez. Refer **Figure 4**.

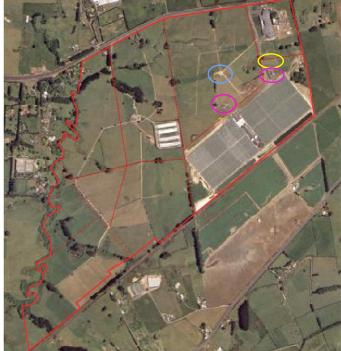
small shed has been demolished at 350

Karaka Road (blue circle).

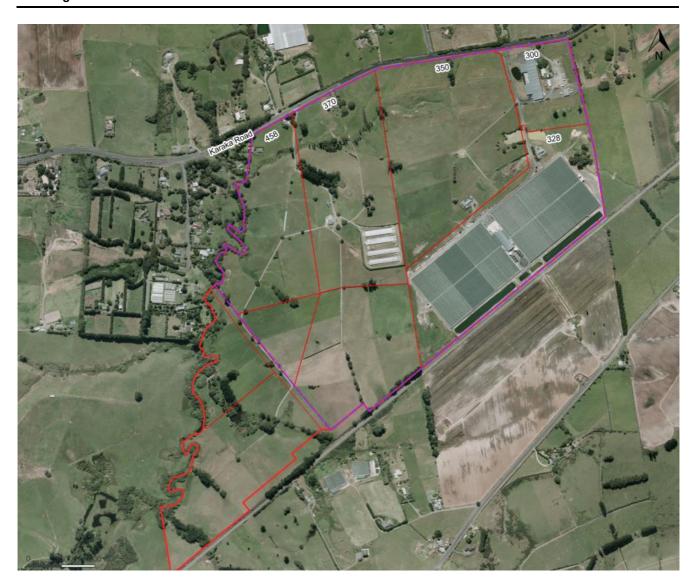
Figure 1. Location of the site (Image source: LINZ). Thick red outline indicates wider extent, thinner internal lines show individual property boundaries. The purple dashed line shows the Plan Change area to which this SMP applies.

The site comprises five (5) titles as described in **Table 1**. This SMP applies only to the Plan Change area (purple outline on **Figure 1**), although the wider landholding is included in Figure 1 for completeness. The site is bound by Karaka Road in the north, the main railway line in the south, and Oira Stream to the west. A 'paper road' forms the southwest boundary.

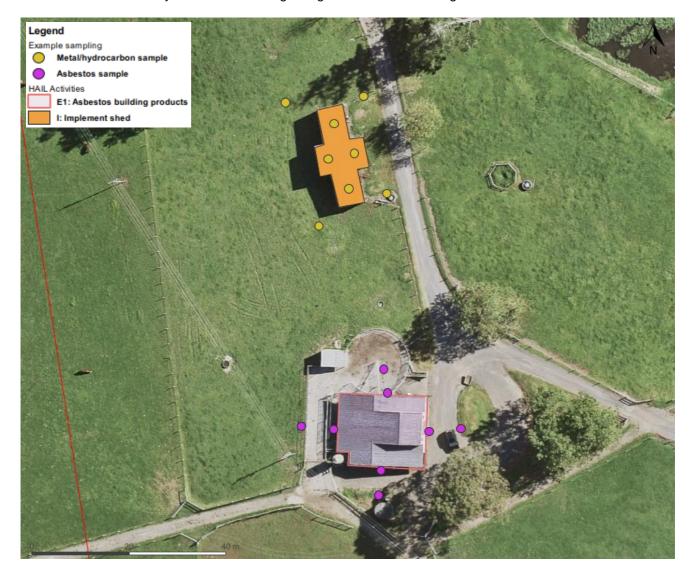
Figure 2: Example sampling plan; actual sampling plan to be determined on a case-by-case basis by SQEP.

- Materials encountered will be logged in general accordance with the NZ Geotechnical Society "Guidelines for the classification and field description of soils and rocks for engineering purposes".
- Soil sampling will be in general accordance with the MfE's CLMG5, including:
 - Collection of samples using freshly gloved hands, directly from the excavated ground, and placement into laboratory supplied glass jars to avoid cross contamination between sample positions.
 - Decontamination of equipment (trowel) between sample locations using a phosphate-free detergent and freshwater rinses.
 - Couriering samples chilled, under chain of custody documentation, the same day they are collected.
- All samples will be sent to an IANZ accredited laboratory for testing.
