# Whenuapai – Private Plan Change

## Coastal Hazard Assessment

### Cabra Developments Limited

### SLR Consulting New Zealand

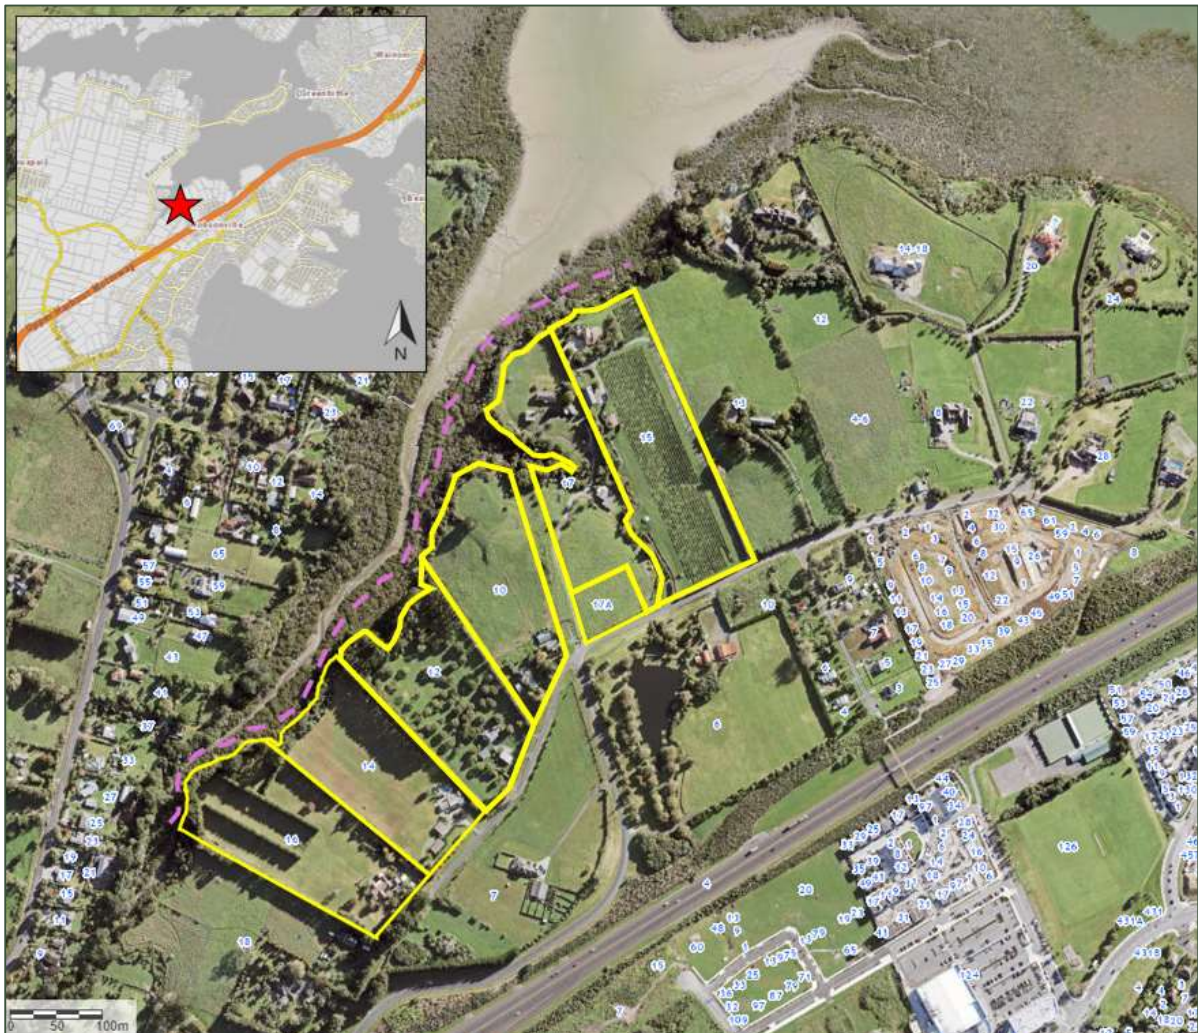
**Figure 1: Location of the project coastline at Sinton Road and Clarks Lane, Whenuapai. The extent of the coastal hazard assessment is indicated in pink. Source: Auckland Council GeoMaps.**

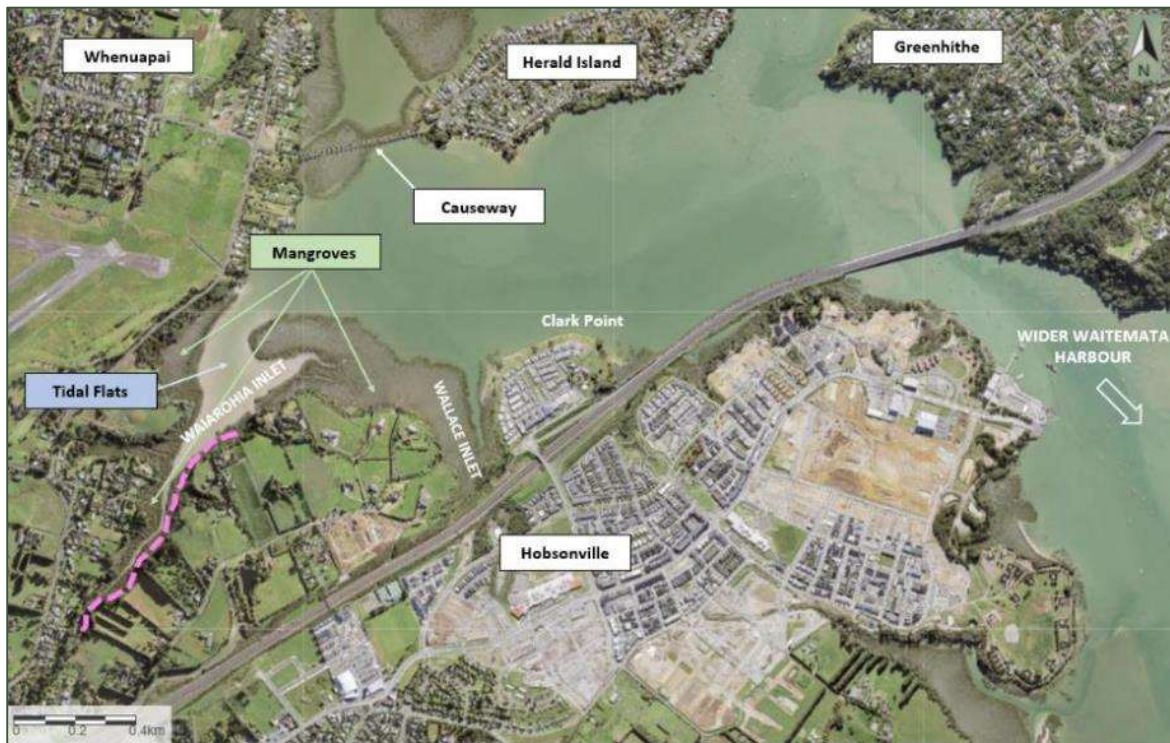
**Figure 3: Annotated map of the coastal geomorphic setting of the plan change area. Subject coastline indicated in pink. Source: Auckland Council GeoMaps.**

Historic photographs also show the construction of the vehicle causeway joining Whenuapai and Herald Island north of the study area (**Figure 3**) in the 1950's, effectively reducing fetch distances from the northwest from 3km to 1km and thus reducing the exposure of the subject coastline to wind waves. The sheltering effects of the causeway are likely to have contributed to the observed mangrove expansion.

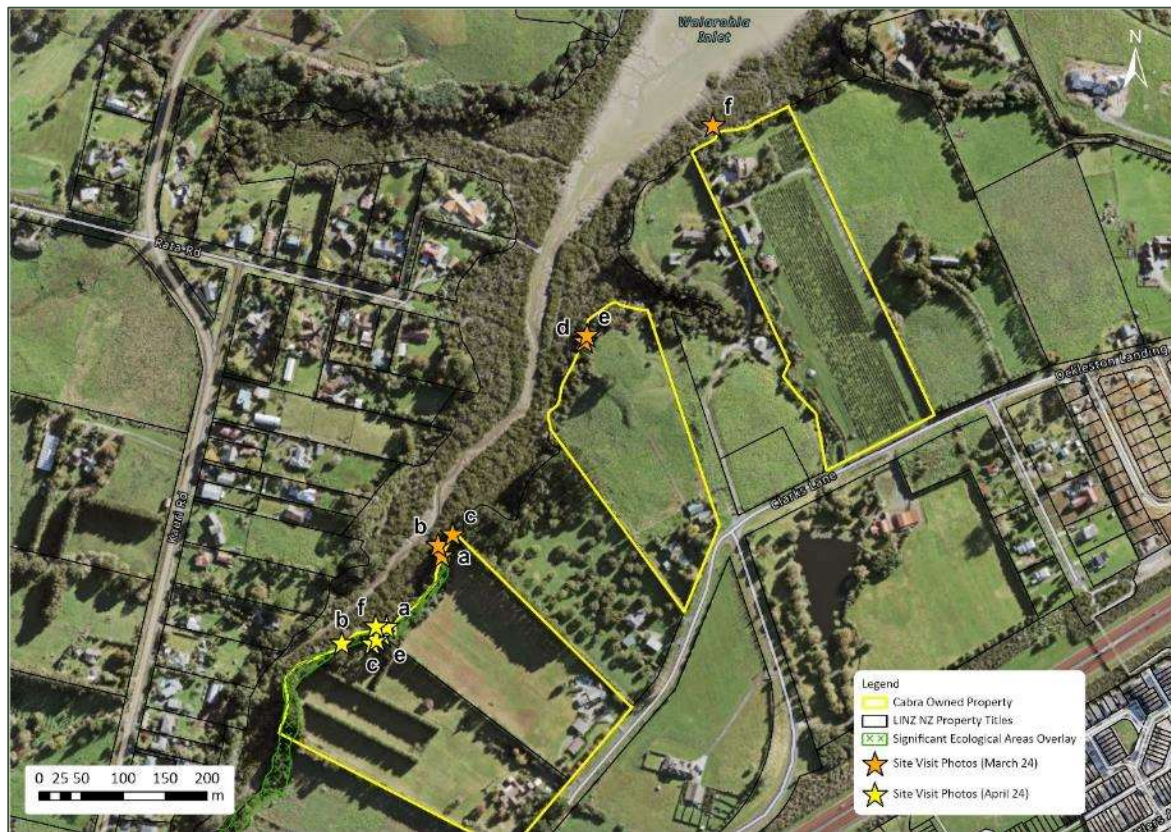
**Figure 5: Locations of coastal edge characteristics and erosional features observed during site visit (orange stars). Subject site property boundaries shown by the yellow polygons.**

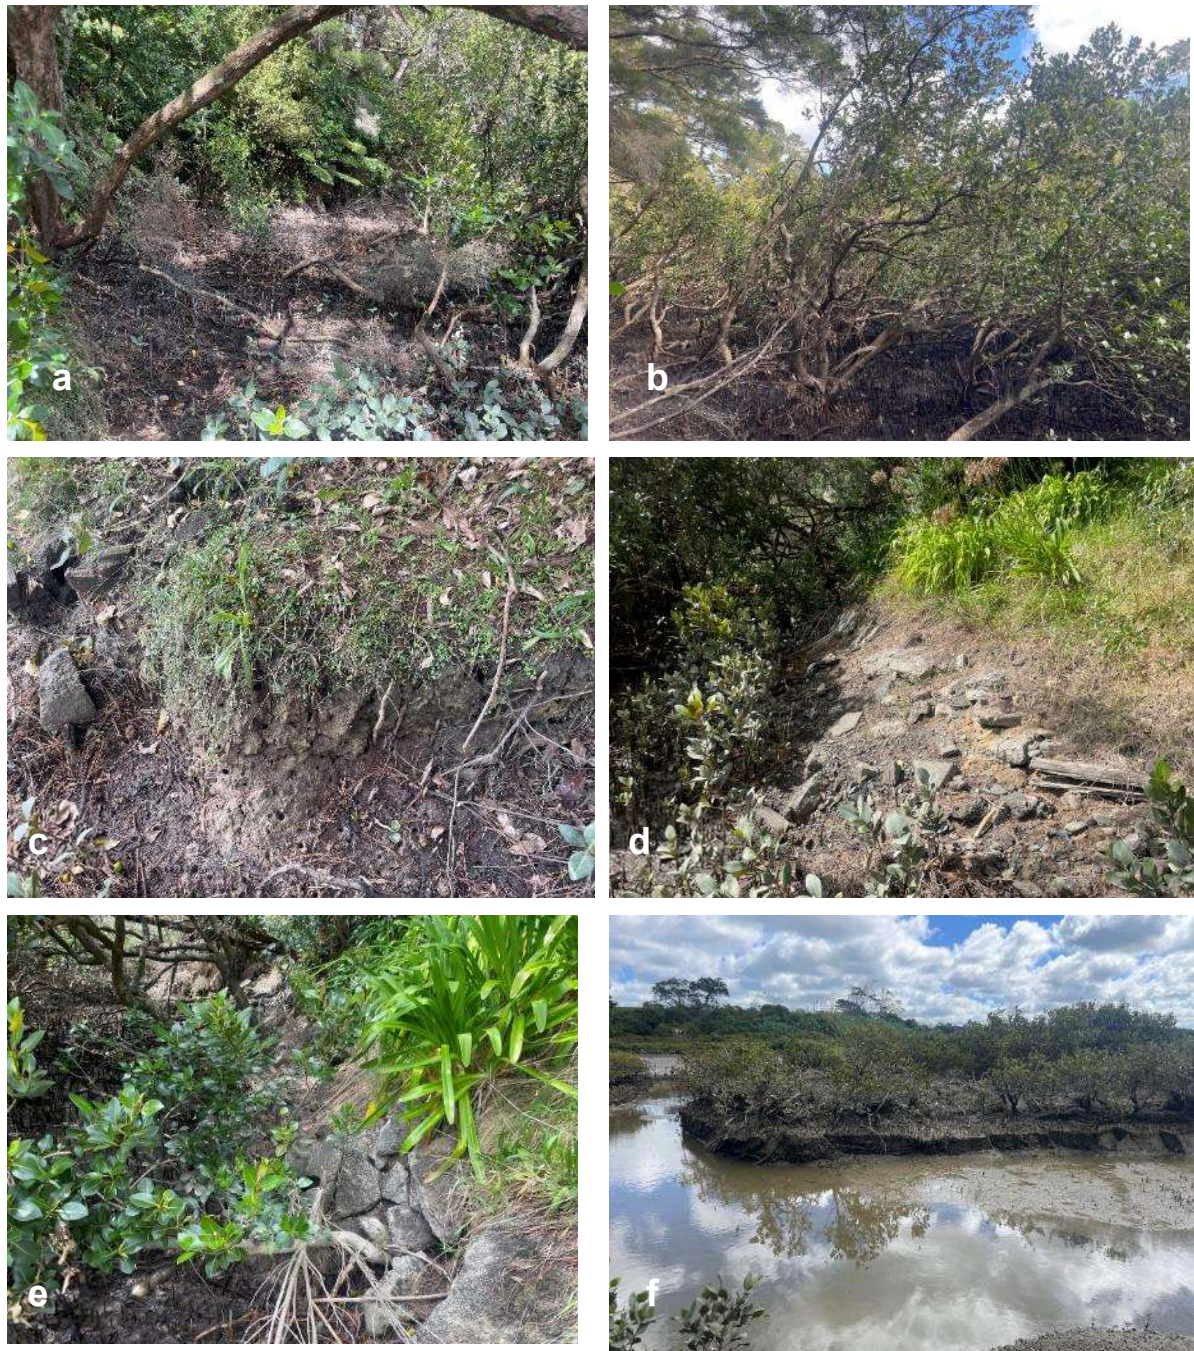
**Figure 6: Site observations of the vegetated bank looking west towards the Significant Ecological Area (a, SEA\_T\_4733), fronted by mangroves and tidal flats (b), section of the bank toe with mud crab holes and cracks (c), riprap and concrete of an informal seawall (d, e) and evidence of dug sections of the mudflat by machinery for boating access (e).**

The coastal margin at 15 Clarks Lane, 10 and 14 Sinton Road were observed to be relatively uniform, characterised by a vegetated low-lying bank (1- 5m), intertidal mudflats and large mature mangroves (over 2-3m in height, **Figure 6b**). The steepest banks were found on the northeastern boundary of the site on 15 Clarks Lane approximately 4m high and with a maximum slope of roughly 50°. The lower bank was cracking at the toe and had mud crab holes causing instability in places at the coastal interface, but no other obvious signs of erosion were observed (**Figure 6c**). There was an informal riprap seawall in poor condition at the toe of the bank at 14 Sinton Road (**Figure 6d, e**). The mudflats at 15 Clarks Lane have been dug out with machinery at the boat ramp to presumably enable boating access (**Figure 6f**).

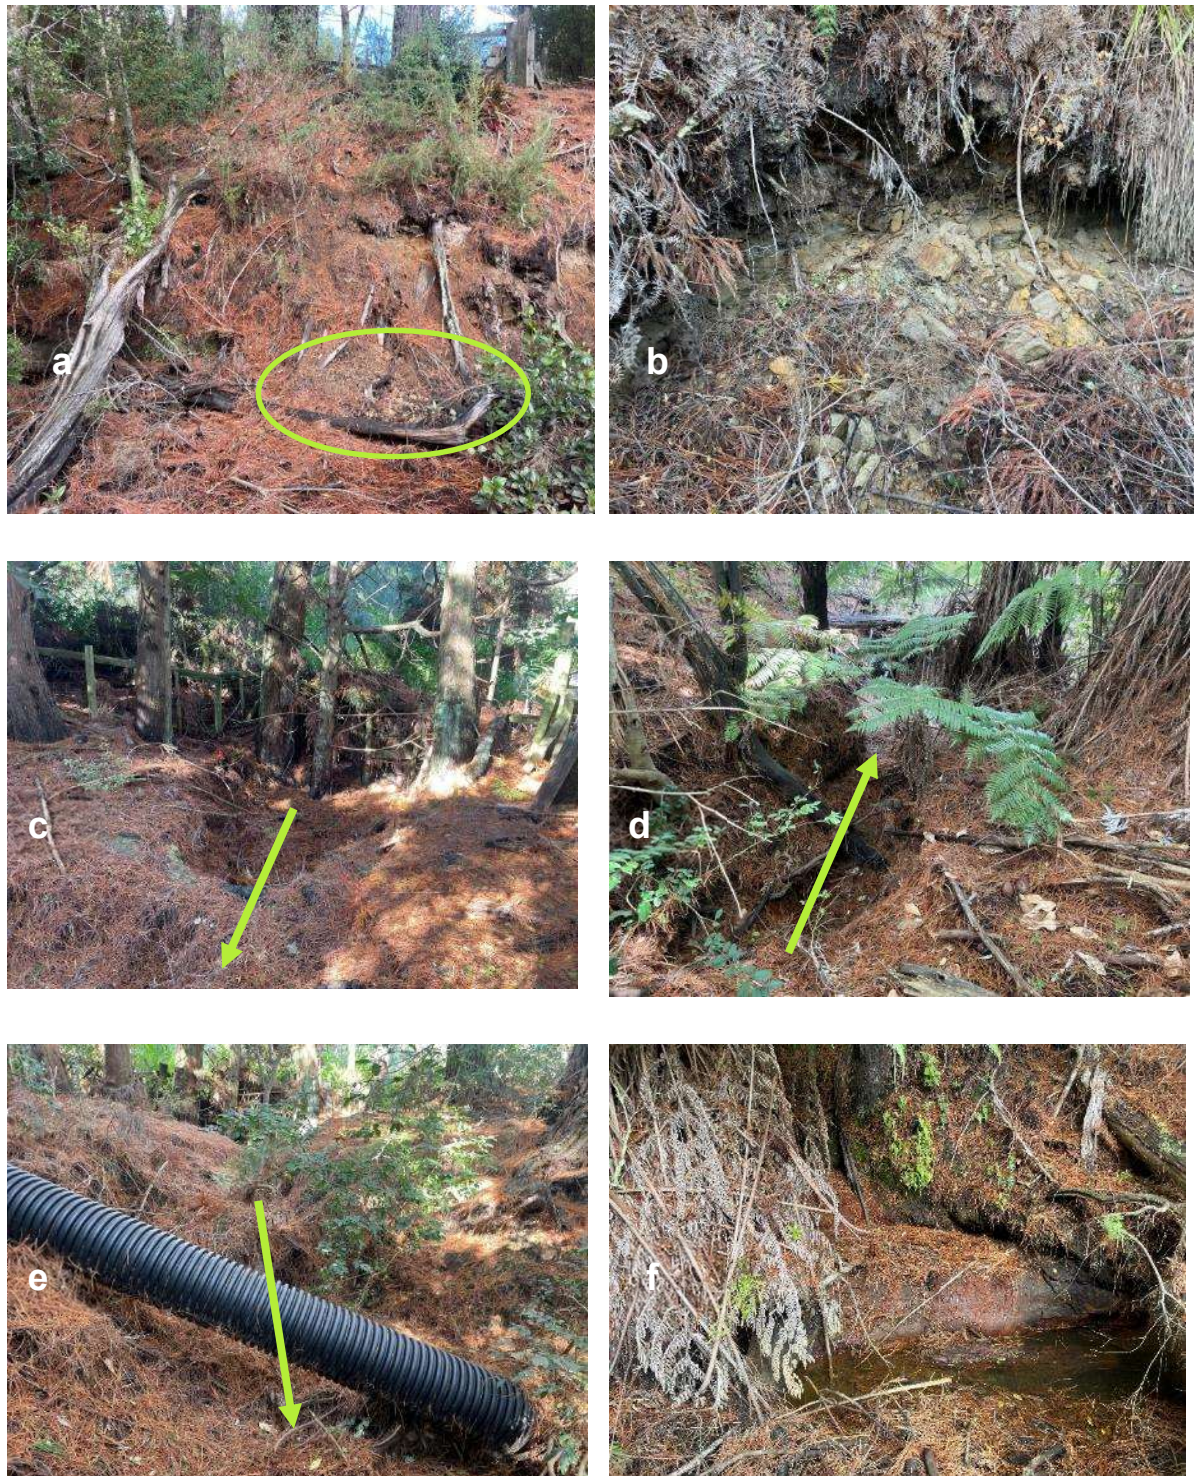
**Figure 7: Site observations of the coastal edge at 16 Sinton Road. Observations of bank slumping (see green circle in photo a) undercutting and erosion of the bank toe (b), OLFP (c, d with arrow showing likely direction of flow), nova coil pipe that sits above the OLFP (e, arrow showing direction of flow of OLFP) and exposed sandstone and pool in CMA (f).**

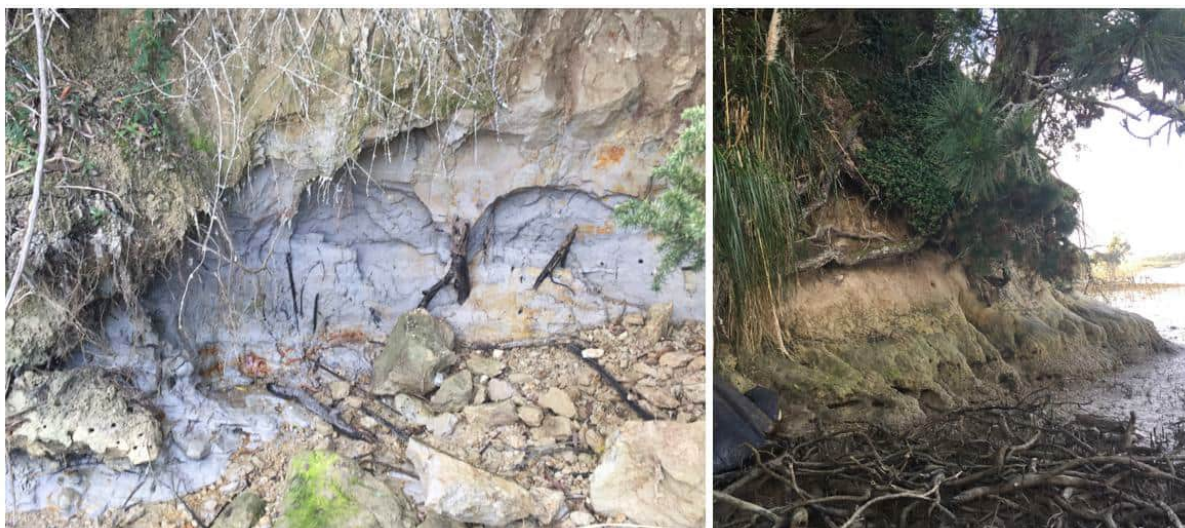
Figure 3-2 - Outcrops of PF in Cell A

Our site observations confirmed the presence of PF coastal cliff outcrops within the section of coast denoted as Cell A in Figure 3-1 (photographs of outcrops in Figure 3-2 and Figure 3-7).

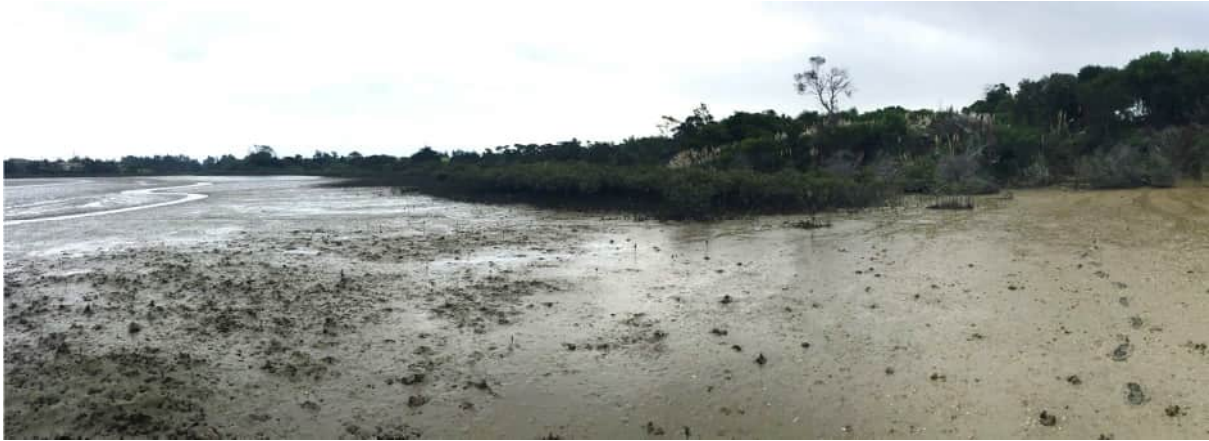
*Figure 3-4 Photograph looking south within Cell A*

In areas such as Figure 3-4 within the southern end of Cell A where an established mangrove forest exists, other forms of vegetation have colonised weathered material at the base of these cliffs. With the majority of these areas typically inundated every high tide the increased vegetation provides an areas for debris and beach sediment to collect.

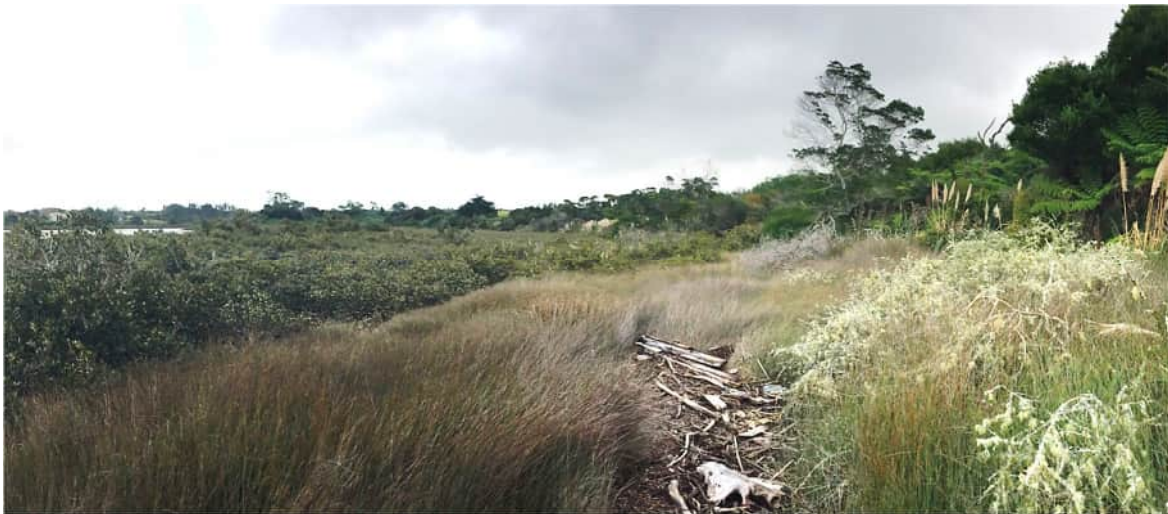
*Figure 3-5 View south from Cell A where an established mangrove forest exists and other forms of vegetation have colonised weathered material at the base of these cliffs*

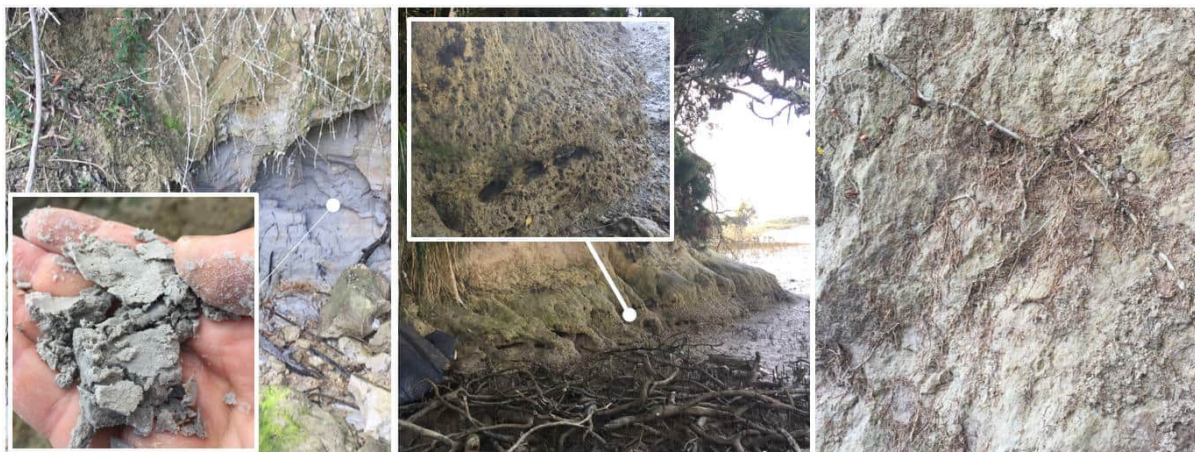
*Figure 3-6 Surface weathering, bio-erosion and root pressure*

During our walkover inspection signs of erosion in exposed areas included surface weathering (Figure 3-6 left), bio-erosion (Figure 3-6 centre) and root pressure (Figure 3-6 right).

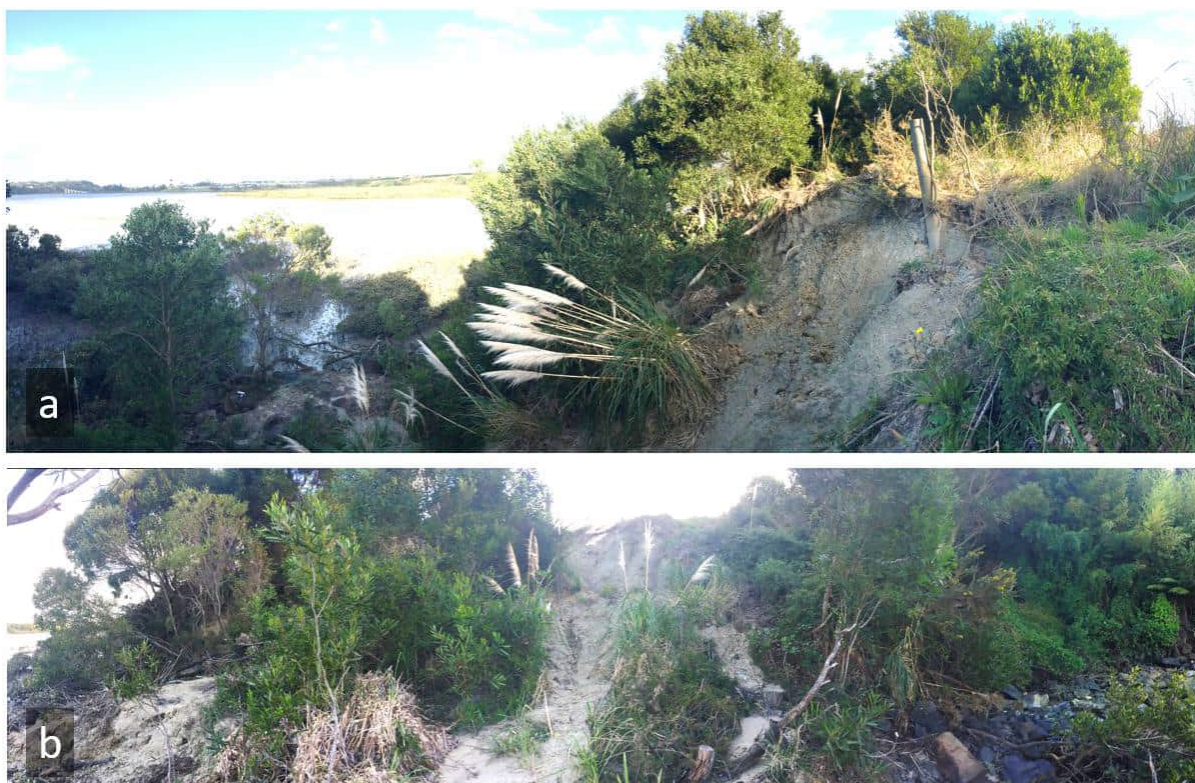
*Figure 3-7 Instability within Cell A PF exposures (Photo top and bottom taken at the same location)*

Slopes in Cell A with less mangrove protection were less densely vegetated, with shallow landslips and related instability being more common in these areas (Figure 3-7). Exposures in ECBF or fill material were less visible due to vegetation cover and lack of access.
