# Appendix C – Groundwater and soil parameters

# Appendix E– Shafts groundwater settlement analysis

# Appendix G– Shafts settlement damage assessment

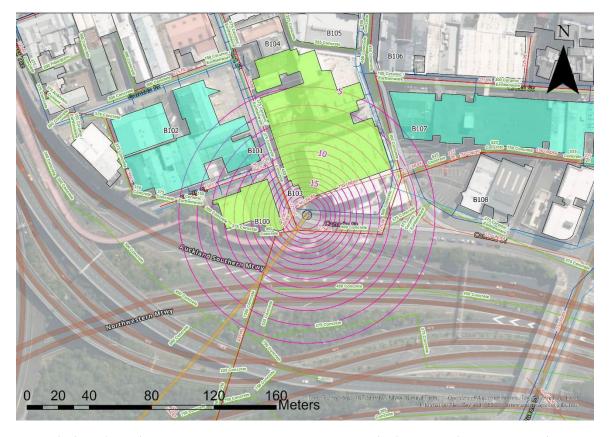
Appendix Figure G4: Estimated total settlement contours (mm) shown in pink. Excavation area shown with black hatching. The green buildings are assessed to be at slight risk [Burland 2012 Risk Category 2]. The blue buildings are assessed as very slight risk [Burland 2012 Risk Category 1]. Utilities sourced from Auckland Council Geo Maps. Building outlines from LINZ. Aerial basemap from OpenStreetMap.

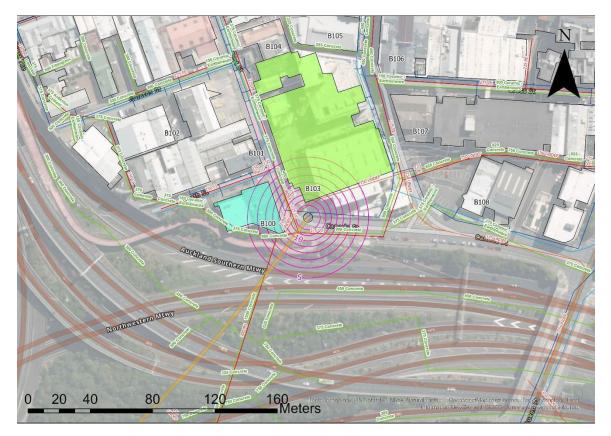
Appendix Figure G6: Estimated total settlement contours (mm) shown in pink. Excavation area shown with black hatching. The green buildings are assessed to be at slight risk [Burland 2012 Risk Category 2]. The blue buildings are assessed as very slight risk [Burland 2012 Risk Category 1]. Utilities sourced from Auckland Council GeoMaps. Building outlines from LINZ. Aerial basemap from OpenStreetMap.

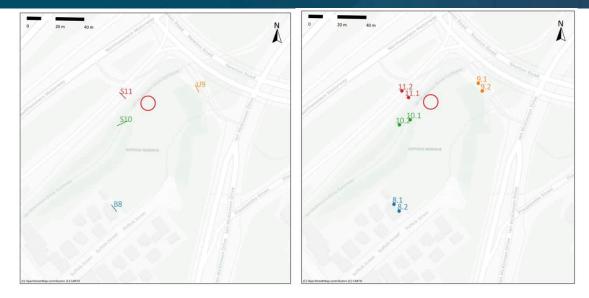
Appendix Figure G9: Location of the proposed excavation, and point pairs used to calculate settlement and differential settlement.

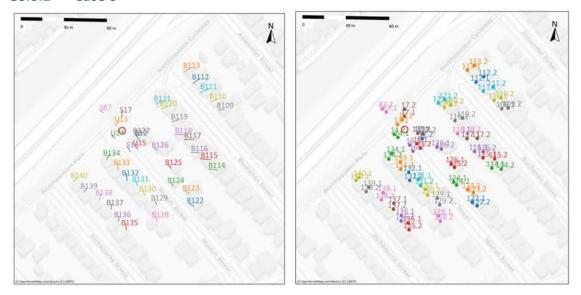
Appendix Figure G15: Location of the proposed excavation, and point pairs used to calculate settlement and differential settlement.

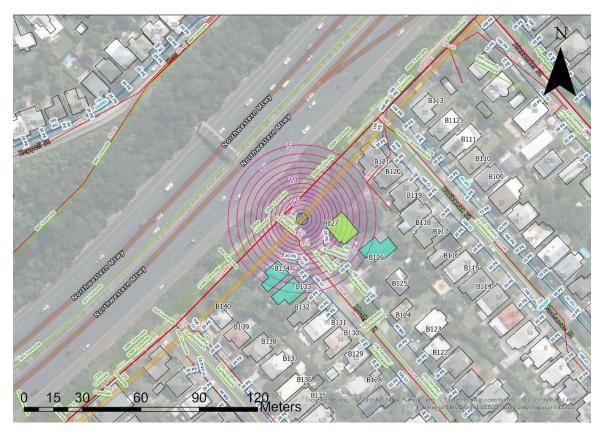
Appendix Figure G16: Estimated total settlement contours (mm) shown in pink. Excavation area shown with black hatching. The green buildings are assessed to be at slight risk [Burland 2012 Risk Category 2]. The blue buildings are assessed as very slight risk [Burland 2012 Risk Category 1]. Utilities sourced from Auckland Council GeoMaps. Building outlines from LINZ. Aerial basemap from OpenStreetMap.

ID	Settlement at point 1	Settlement at point 2	Distance between point pairs	Differential settlement (V:H)	Building or structure description	Maximum allowable differential settlement (V:H)	Assessment criteria (pass / fail)
B12	13 mm	11 mm	6 m	1 in 2500	1-storey dwelling, brick and plaster clad, tile roof	1 in 500	Pass
S16	12 mm	10 mm	6 m	1 in 2500	Mostyn Street Road	1 in 500	Pass
S17	14 mm	11 mm	7 m	1 in 2000	Nearby Pathway	1 in 500	Pass
S87	9 mm	7 mm	5 m	1 in 3000	Northwestern Motorway	1 in 500	Pass
B126	6 mm	5 mm	4 m	1 in 4000	23 Mostyn Street	1 in 500	Pass
B127	13 mm	11 mm	5 m	1 in 2500	25 Mostyn Street	1 in 500	Pass
B133	7 mm	5 mm	7 m	1 in 4000	20 Mostyn Street	1 in 500	Pass
B134	9 mm	7 mm	6 m	1 in 3000	22 Mostyn Street	1 in 500	Pass

ID	Settlement at point 1	Settlement at point 2	Distance between point pairs	Differential settlement (V:H)	Utility description	Screening differential settlement (V:H)	Assessment criteria (pass / fail)
U13	16 mm	15 mm	6 m	1 in 10000	525 CONC Wastewater Pipeline	1 in 500	Pass
U14	15 mm	15 mm	5 m	1 in 15500	225 Ceramic Earthenware Stormwater Pipeline	1 in 500	Pass
U15	12 mm	9 mm	5 m	1 in 2000	40 MS Water Pipeline	1 in 500	Pass

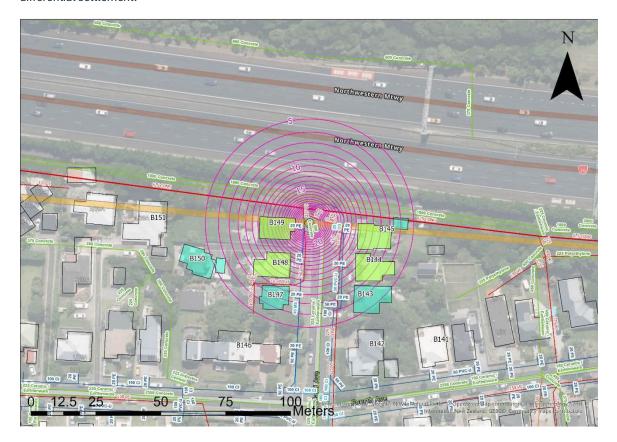
Appendix Figure G22: Estimated total settlement contours (mm) shown in pink. Excavation area shown with black hatching. The green buildings are assessed to be at slight risk [Burland 2012 Risk Category 2]. The blue buildings are assessed as very slight risk [Burland 2012 Risk Category 1]. Utilities sourced from Auckland Council GeoMaps. Building outlines from LINZ. Aerial basemap from OpenStreetMap.

ID	Settlement at point 1	Settlement at point 2	Distance between point pairs	Differential settlement (V:H)	Building or structure description	Maximum allowable differential settlement (V:H)	Assessment criteria (pass / fail)
B23	15 mm	13 mm	4 m	1 in 1600	1-storey dwelling, timber clad, corrugated metal roof	1 in 500	Pass
S26	17 mm	14 mm	4 m	1 in 1400	Kingsland Avenue Road	1 in 500	Pass
S27	11 mm	9 mm	6 m	1 in 2500	Northwestern Motorway	1 in 500	Pass
B143	7 mm	6 mm	6 m	1 in 4000	37 Kingsland Avenue	1 in 500	Pass
B144	10 mm	8 mm	5 m	1 in 2500	39 Kingsland Avenue	1 in 500	Pass
B145	11 mm	8 mm	7 m	1 in 2500	41 Kingsland Avenue	1 in 500	Pass
B148	15 mm	11 mm	7 m	1 in 1700	50 Kingsland Avenue	1 in 500	Pass
B149	23 mm	17 mm	6 m	1 in 850	52 Kingsland Avenue	1 in 500	Pass
B150	5 mm	4 mm	9 m	1 in 6500	50B Kingsland Avenue	1 in 500	Pass

ID	Settlement at point 1	Settlement at point 2	Distance between point pairs	Differential settlement (V:H)	Utility description	Screening differential settlement (V:H)	Assessment criteria (pass / fail)
U24	28 mm	23 mm	5 m	1 in 900	225 Ceramic Earthenware Stormwater Pipeline	1 in 500	Pass
U25	28 mm	24 mm	4 m	1 in 1300	40 MS Water Pipeline	1 in 500	Pass

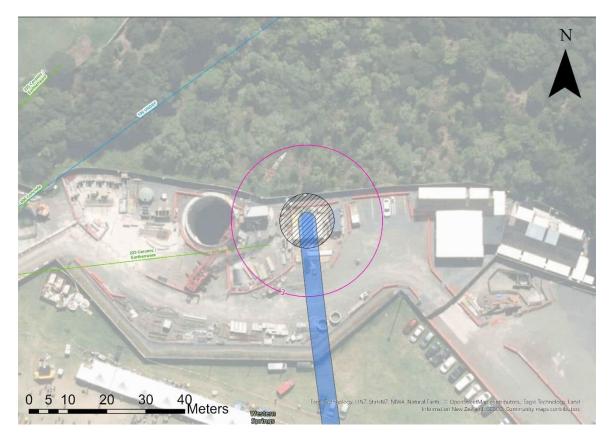
Appendix Figure G34: Estimated total settlement contours (mm) in pink. Excavation area shown with black hatch. Utilities sourced from Auckland Council GeoMaps. Building outlines sourced from LINZ. Aerial basemap sourced from OpenStreetMaps.

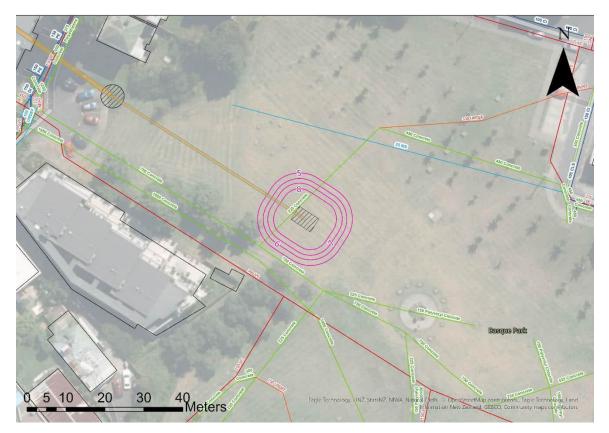
Appendix Figure G42: Estimated total settlement contours (mm) in pink. Excavation area shown with black hatch. Utilities sourced from Auckland Council GeoMaps. Building outlines sourced from LINZ. Aerial basemap sourced from OpenStreetMaps.

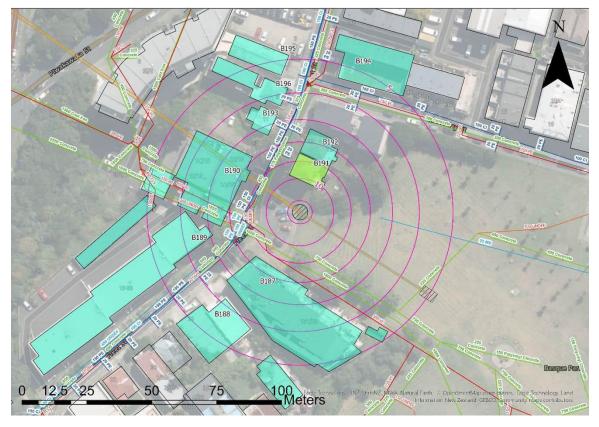
Appendix Figure G44: Estimated total settlement contours (mm) shown in pink. Excavation area shown with black hatching. The green buildings are assessed to be at slight risk [Burland 2012 Risk Category 2]. The blue buildings are assessed as very slight risk [Burland 2012 Risk Category 1]. Utilities sourced from Auckland Council GeoMaps. Building outlines from LINZ. Aerial basemap from OpenStreetMap.

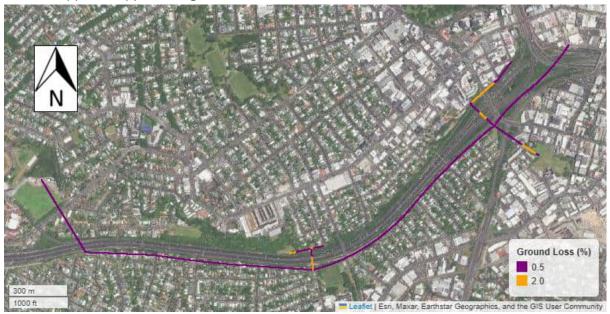
Appendix Figure H2: The modelled Ground Loss across the tunnel network. Tunnel Segments contained in rock are considered to have lower ground loss.

The methodology relies on an estimate for the ground loss to obtain the unit settlement volume,  $V_s$ . The ground loss is estimated based on the ground conditions and the tunnel construction method. For this analysis, a ground loss percentage 0.5% has been adopted for areas of the tunnel which are contained in the weathered to unweathered ECBF rock material. A higher percentage of 2.0% has been used for other areas which contain more compressible material.

This is mapped in Appendix Figure H2.
